Defect Listing

Pipe Segment Refere... C8-6_C8-5	City Oliver Springs	Street Hermitage Dr	Material Fibreglass Reinforc...	Location C... Light High...	Sewer Use Sanitary
Upstream MH C8-6	Total Length 118.8	Year Laid	Shape Circular	Location Details	
DS Manhole C8-5	Length surveyed 118.8	Year Renewed	Height 8	Width 8	Pipe Joint... N/A

SPR N/A	MPR N/A	PO Number 4397-03		Customer GRW	
SPRI N/A	MPRI N/A	Work Order 4397-02		Purpose Pre-Rehabilitation Survey	
QSR N/A	QMR N/A				
OPR N/A	Surveyed By Barry Rogers	Direction Downstream	Date 20150720	Media label	
OPRI N/A	Certificate Number U-1012-16405	Pre-Cleaning Jetting	Time 14:21	Weather Light Rain	
Date Cleaned 20150720			End Time 14:31	Additional Info

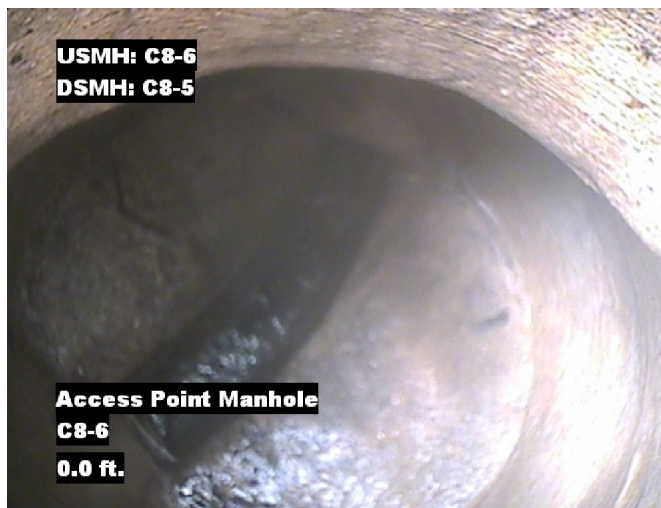
Distance: 0.0 ft. Grade: 0
Condition: Access Point Manhole
Remarks: C8-6

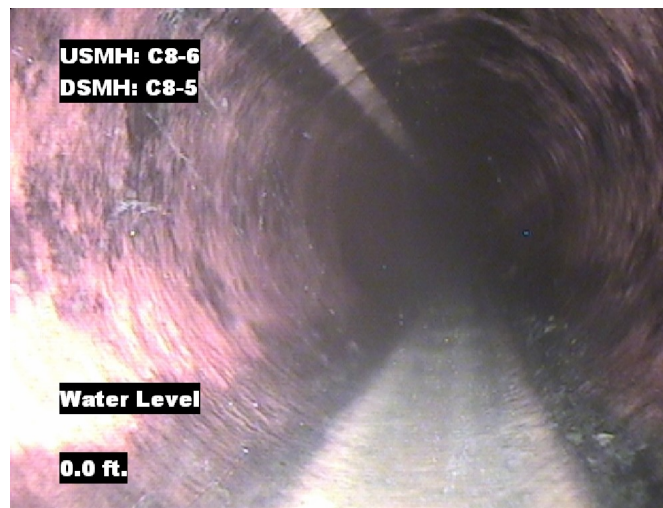
Distance: 0.0 ft. Grade: 0
Condition: Water Level
Remarks: N/A

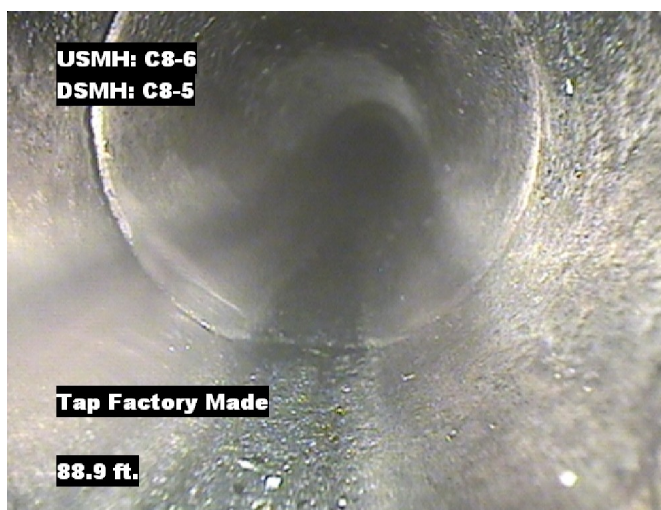
Distance: 88.9 ft. Grade: 0
Condition: Tap Factory Made
Remarks: N/A

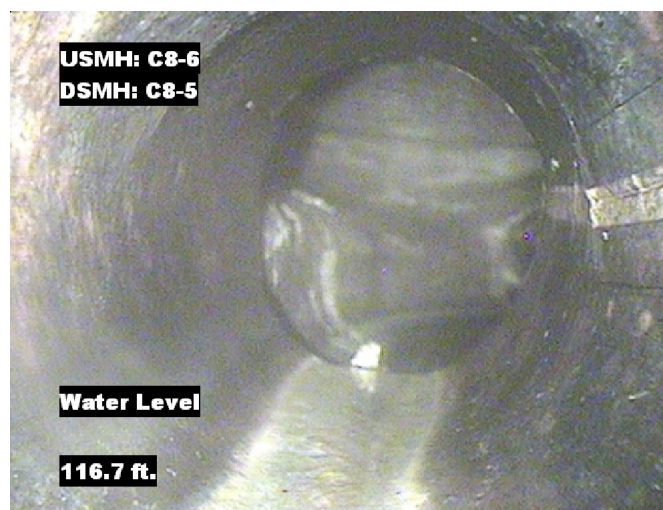
Distance: 116.7 ft. Grade: 0
Condition: Water Level
Remarks: N/A

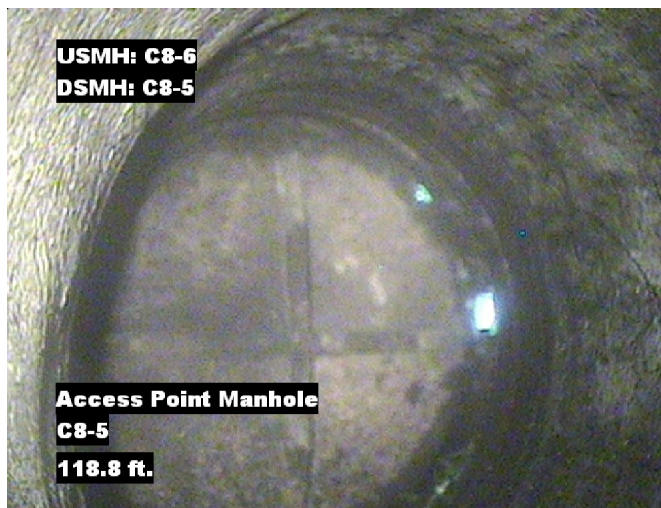
Distance: 118.8 ft. Grade: 0
Condition: Access Point Manhole
Remarks: C8-5
