Defect Listing

Pipe Segment Refere... C8-7_C8-6	City Oliver Springs	Street Herimtage Dr	Material Concrete Pipe (non-...	Location C... Light High...	Sewer Use Sanitary
Upstream MH C8-7	Total Length 254.8	Year Laid	Shape Circular	Location Details	
DS Manhole C8-6	Length surveyed 254.8	Year Renewed	Height 8	Width 8	Pipe Joint... 4

Image Report 4/Page

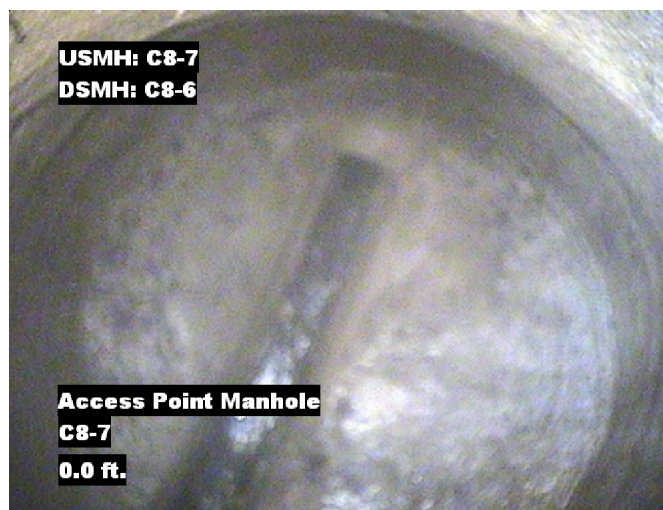
Distance: 0.0 ft. Grade: 0
Condition: Access Point Manhole
Remarks: C8-7

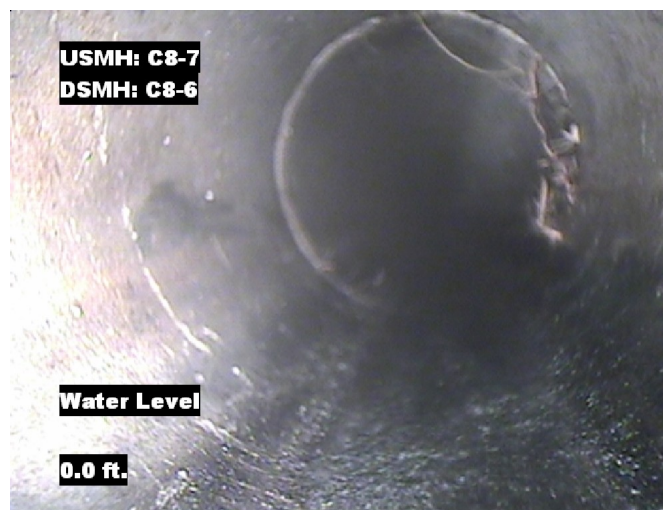
Distance: 0.0 ft. Grade: 0
Condition: Water Level
Remarks: N/A

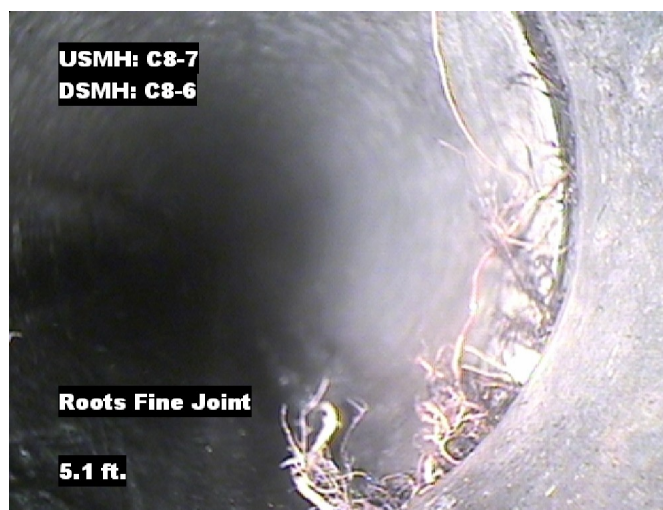
Distance: 5.1 ft. Grade: 1
Condition: Roots Fine Joint
Remarks: N/A

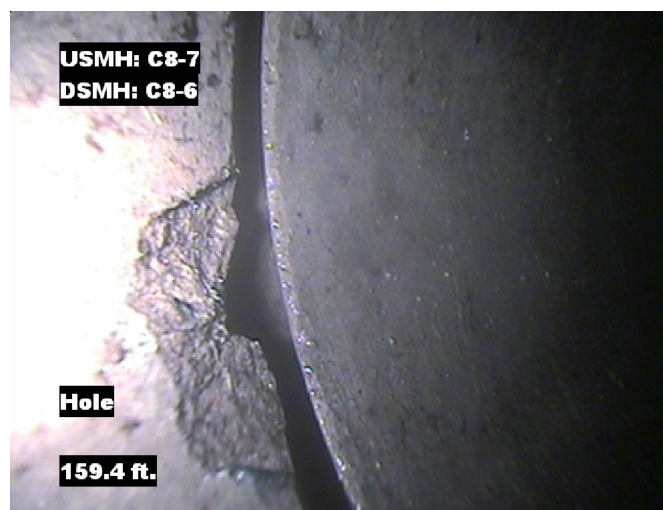
Distance: 159.4 ft. Grade: 3
Condition: Hole
Remarks: N/A

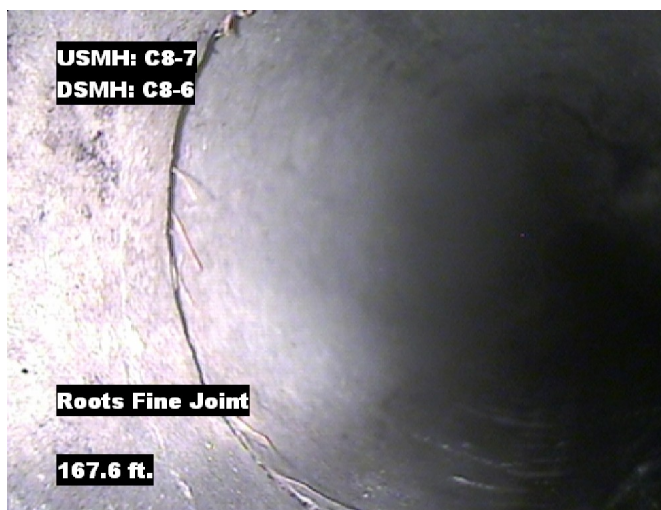
Distance: 167.6 ft. Grade: 1
Condition: Roots Fine Joint
Remarks: N/A

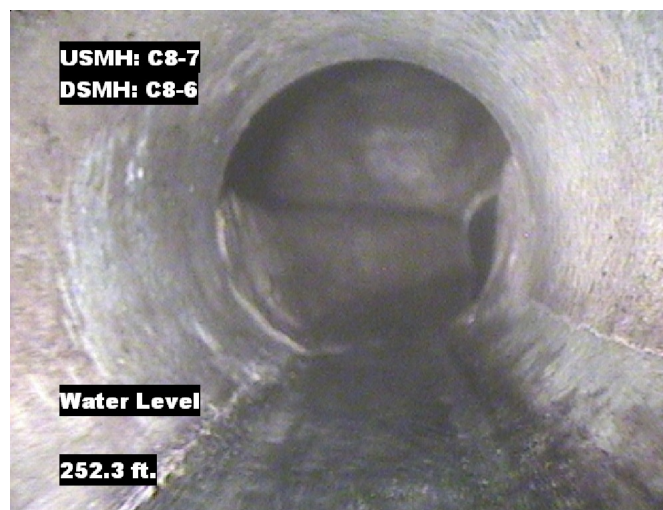
Distance: 252.2 ft. Grade: 0
Condition: Water Level
Remarks: N/A

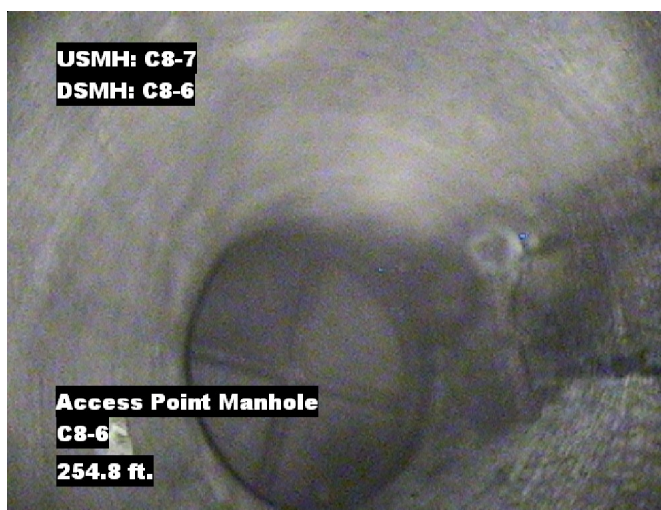
Distance: 254.8 ft. Grade: 0
Condition: Access Point Manhole
Remarks: C8-6
