Defect Listing

Pipe Segment Refere... C8-8_C8-7	City Oliver Springs	Street HermitageDr	Material Concrete Pipe (non-...	Location C... Light High...	Sewer Use Sanitary
Upstream MH C8-8	Total Length 208.3	Year Laid	Shape Circular	Location Details	
DS Manhole C8-7	Length surveyed 208.3	Year Renewed	Height 8	Width 8	Pipe Joint... 4

SPR N/A	MPR N/A	PO Number 4397-03		Customer GRW	
SPRI N/A	MPRI N/A	Work Order 4397-02		Purpose Pre-Rehabilitation Survey	
QSR N/A	QMR N/A				
OPR N/A	Surveyed By Barry_Rogers	Direction Downstream	Date 20150720	Media label	
OPRI N/A	Certificate Number U-1012-16405	Pre-Cleaning Jetting	Time 13:44	Weather Dry	
Date Cleaned 20150720			End Time 13:56	Additional Info

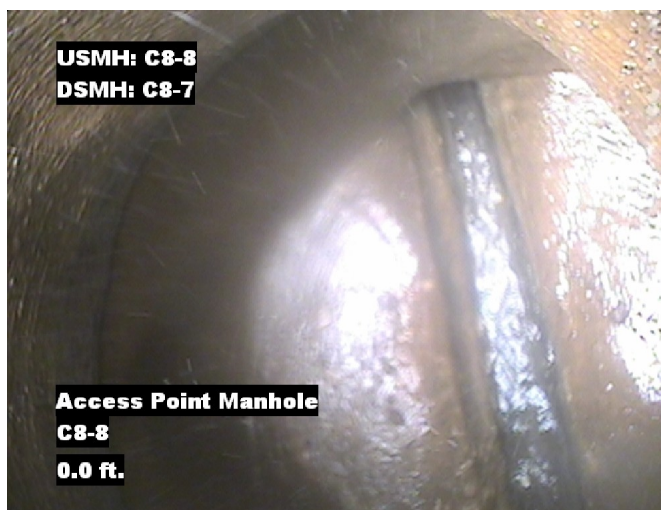
Distance: 0.0 ft. Grade: 0
Condition: Access Point Manhole
Remarks: C8-8

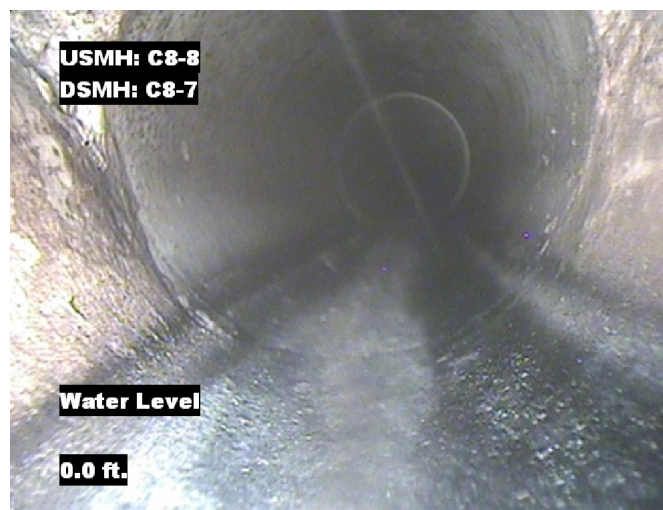
Distance: 0.0 ft. Grade: 0
Condition: Water Level
Remarks: N/A

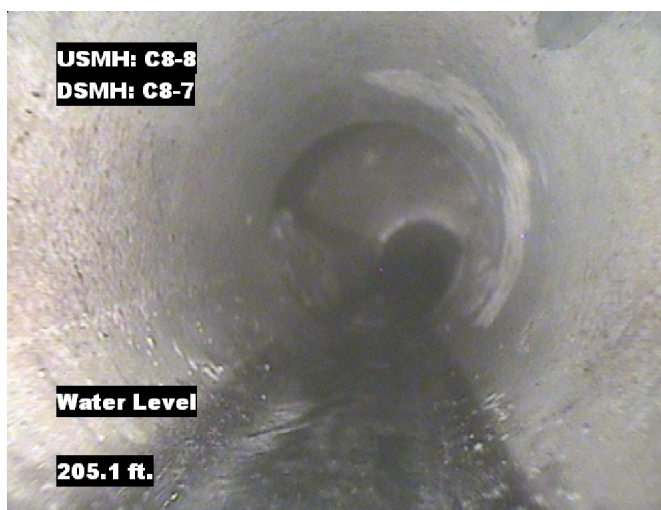
Distance: 205.1 ft. Grade: 0
Condition: Water Level
Remarks: N/A

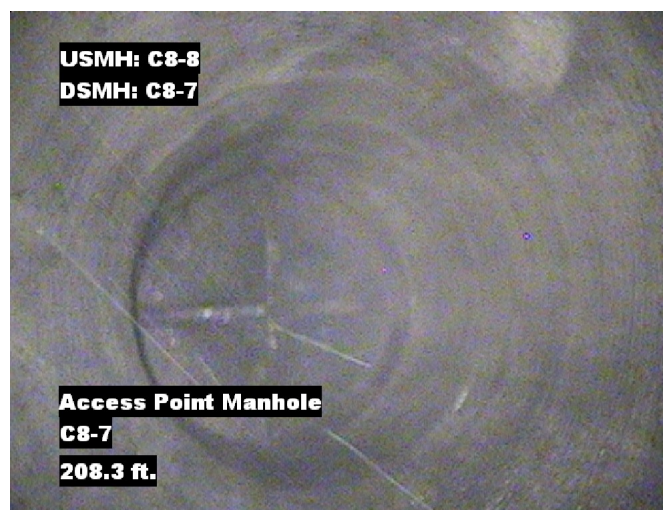
Distance: 208.3 ft. Grade: 0
Condition: Access Point Manhole
Remarks: C8-7
