## Defect Listing

Pipe Segment Refere... <b>C8-8A_C8-8</b>	City <b>Oliver Springs</b>	Street <b>Dellwood DR</b>	Material <b>Concrete Pipe (non-...</b>	Location C... <b>Light High...</b>	Sewer Use <b>Sanitary</b>
Upstream MH <b>C8-8A</b>	Total Length <b>283.8</b>	Year Laid	Shape <b>Circular</b>	Location Details	
DS Manhole <b>C8-8</b>	Length surveyed <b>283.8</b>	Year Renewed	Height <b>8</b>	Width <b>8</b>	Pipe Joint... <b>4</b>

SPR <b>N/A</b>	MPR <b>1</b>	PO Number <b>4397-03</b>	Customer <b>GRW</b>
SPRI <b>N/A</b>	MPRI <b>1</b>	Work Order <b>4397-02</b>	Purpose <b>Pre-Rehabilitation Survey</b>
QSR <b>N/A</b>	QMR <b>1100</b>		
OPR <b>1</b>	Surveyed By <b>Barry Rogers</b>	Direction <b>Downstream</b>	Date <b>20150720</b>
OPRI <b>1</b>	Certificate Number <b>U-1012-16405</b>	Pre-Cleaning <b>Heavy Cleaning</b>	Time <b>12:57</b>
	Date Cleaned <b>20150720</b>	End Time <b>13:20</b>	Weather <b>Dry</b>
			Additional Info <b>Used root saw to re...</b>

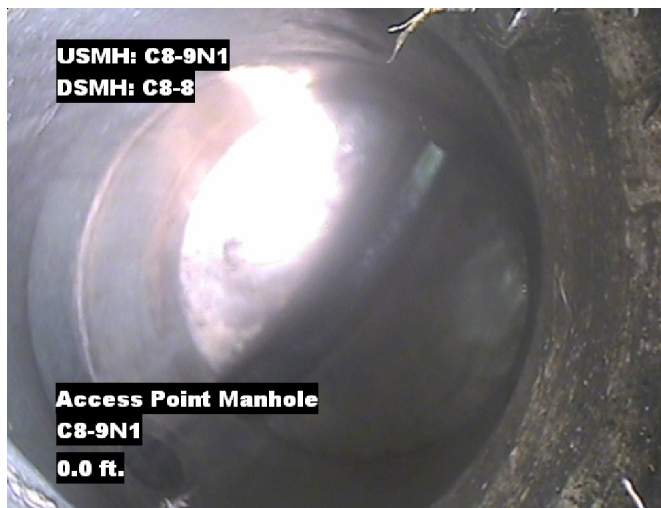
Distance: 0.0 ft. Grade: 0  
Condition: Access Point Manhole  
Remarks: C8-8A

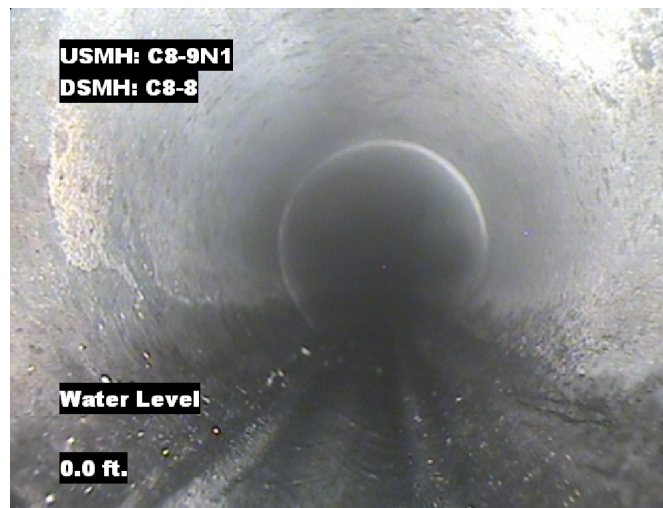
Distance: 0.0 ft. Grade: 0  
Condition: Water Level  
Remarks: N/A

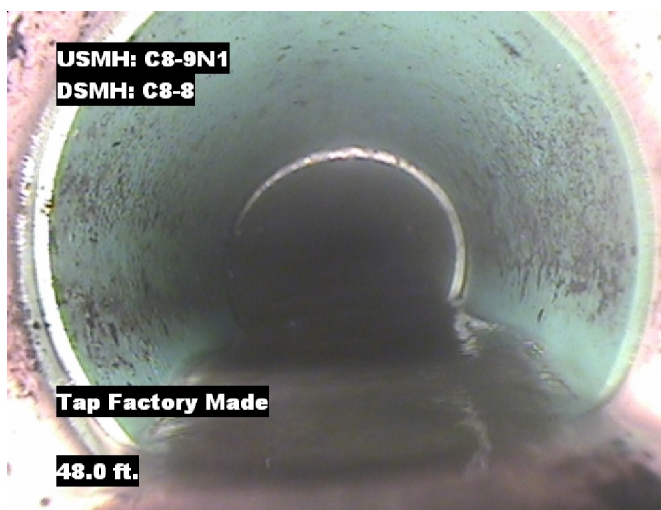
Distance: 48.0 ft. Grade: 0  
Condition: Tap Factory Made  
Remarks: N/A

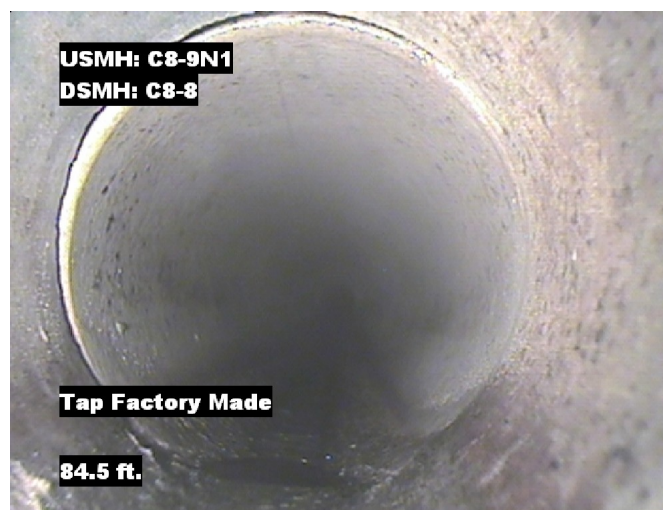
Distance: 84.5 ft. Grade: 0  
Condition: Tap Factory Made  
Remarks: N/A

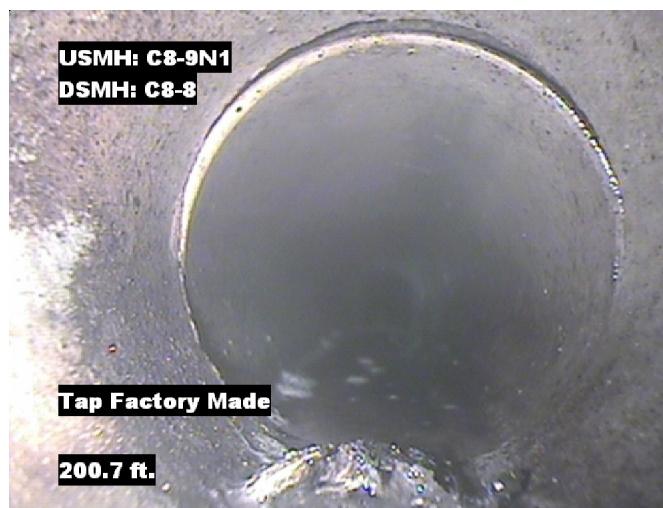
Distance: 200.7 ft. Grade: 0  
Condition: Tap Factory Made  
Remarks: N/A

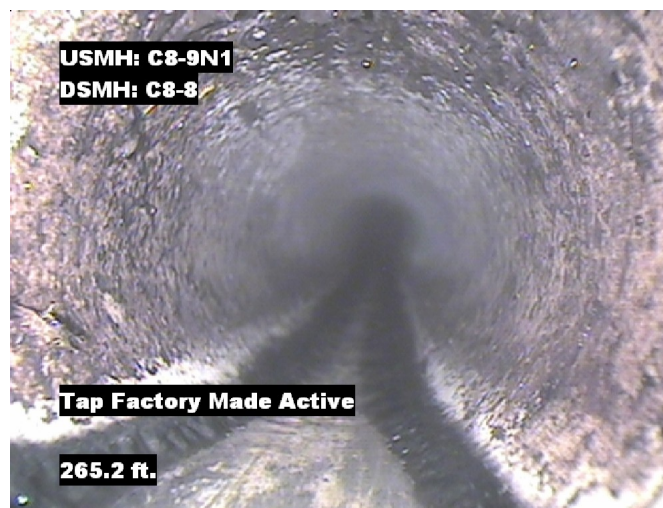
Distance: 265.2 ft. Grade: 0  
Condition: Tap Factory Made Active  
Remarks: N/A

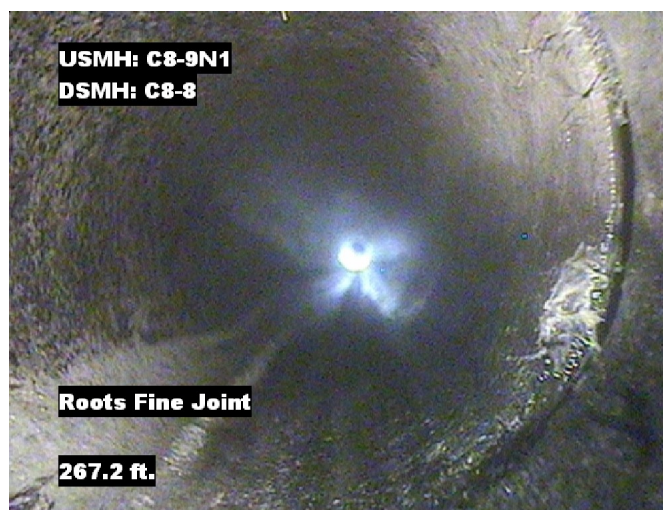
Distance: 267.2 ft. Grade: 1  
Condition: Roots Fine Joint  
Remarks: N/A

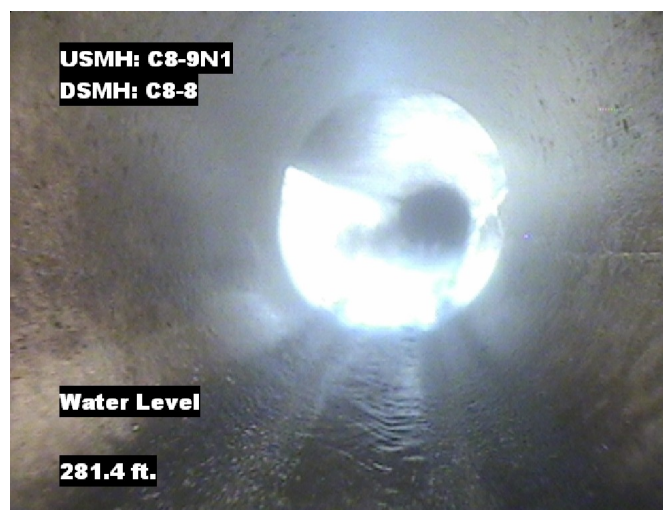
Distance: 281.4 ft. Grade: 0  
Condition: Water Level  
Remarks: N/A

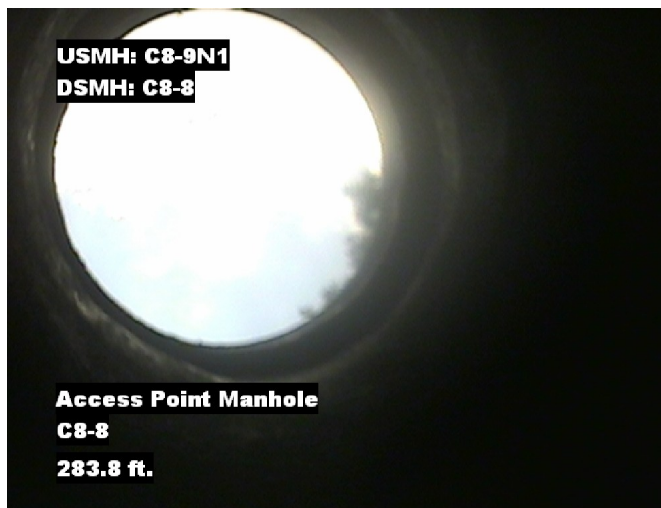
Distance: 283.8 ft.      Grade: 0  
Condition: Access Point Manhole  
Remarks: C8-8
