Defect Listing

Pipe Segment Refere... C8-9_C8-8A	City Oliver Springs	Street Dellwood Dr	Material Concrete Pipe (non-...	Location C... Light High...	Sewer Use Sanitary
Upstream MH C8-9	Total Length 207.7	Year Laid	Shape Circular	Location Details	
DS Manhole C8-8A	Length surveyed 207.7	Year Renewed	Height 8	Width 8	Pipe Joint... 4

SPR N/A	MPR 1	PO Number 4397-03	Customer GRW
SPRI N/A	MPRI 1	Work Order 4397-02	Purpose Pre-Rehabilitation Survey
QSR N/A	QMR 1100		
OPR 1	Surveyed By Barry Rogers	Direction Downstream	Date 20150720
OPRI 1	Certificate Number U-1012-16405	Pre-Cleaning Jetting	Time 12:03
	Date Cleaned 20150720	End Time 12:19	Weather Dry
			Additional Info

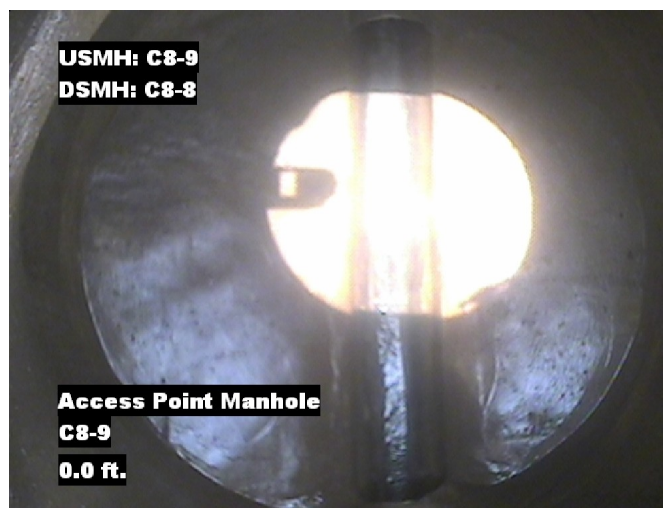
Distance: 0.0 ft. Grade: 0
Condition: Access Point Manhole
Remarks: C8-9

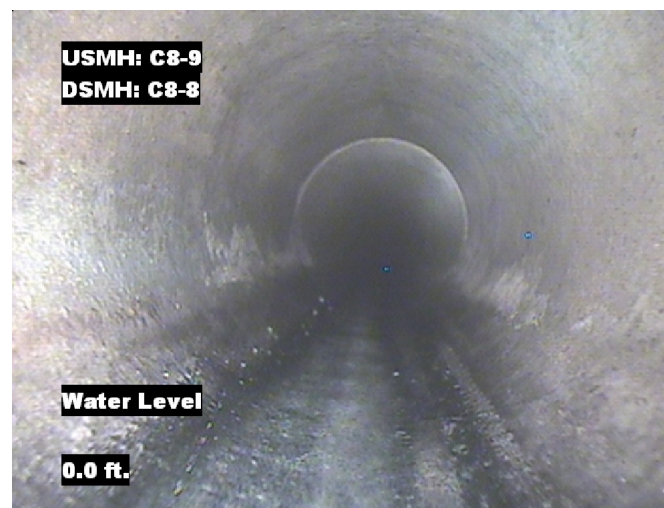
Distance: 0.0 ft. Grade: 0
Condition: Water Level
Remarks: N/A

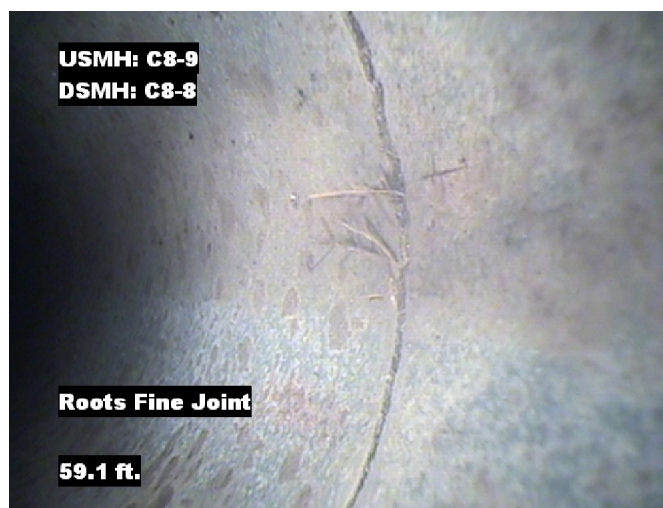
Distance: 59.1 ft. Grade: 1
Condition: Roots Fine Joint
Remarks: N/A

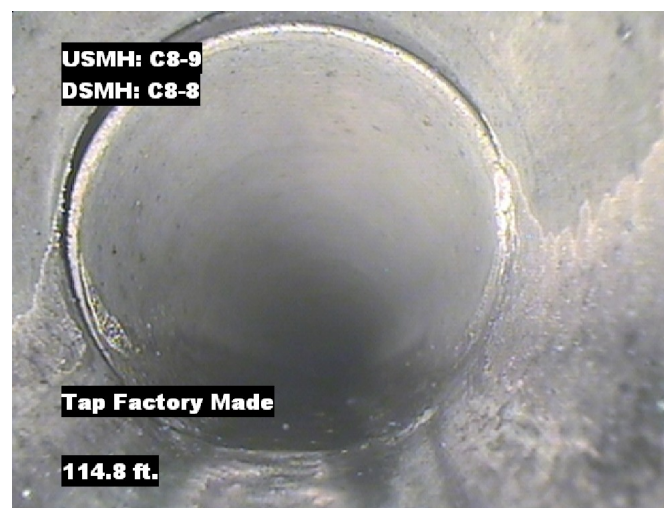
Distance: 114.8 ft. Grade: 0
Condition: Tap Factory Made
Remarks: N/A

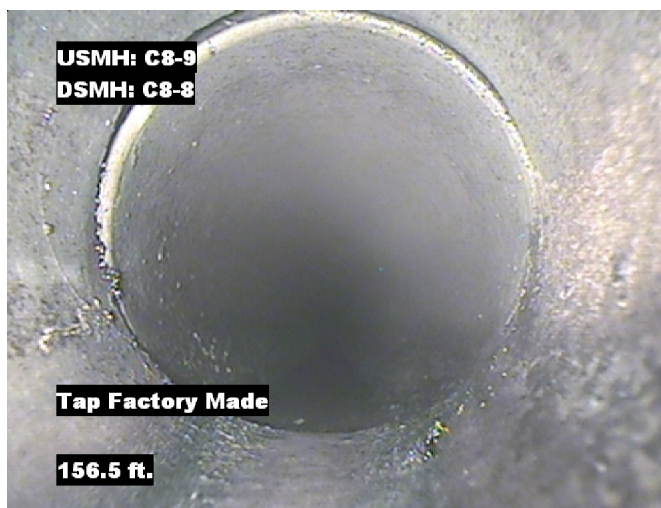
Distance: 156.5 ft. Grade: 0
Condition: Tap Factory Made
Remarks: N/A

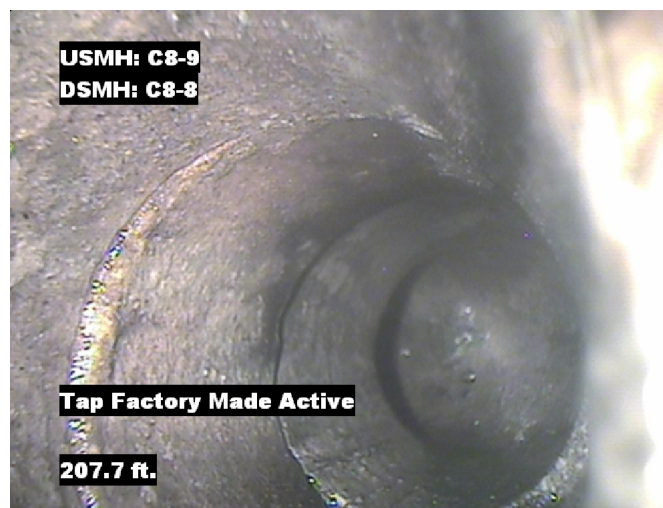
Distance: 207.7 ft. Grade: 0
Condition: Tap Factory Made Active
Remarks: N/A

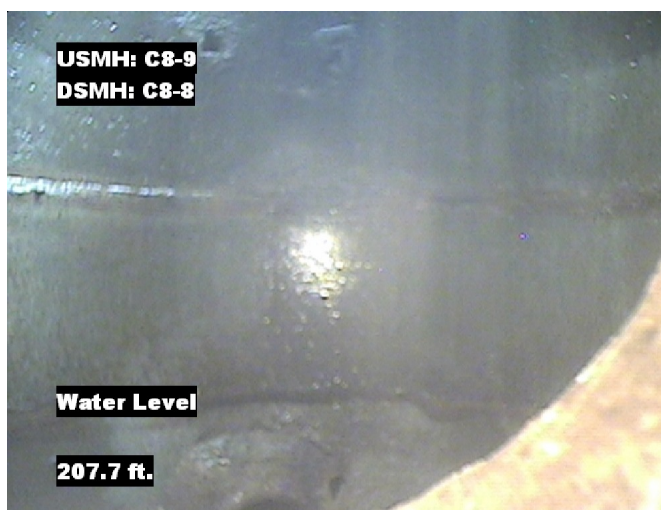
Distance: 207.7 ft. Grade: 0
Condition: Water Level
Remarks: N/A

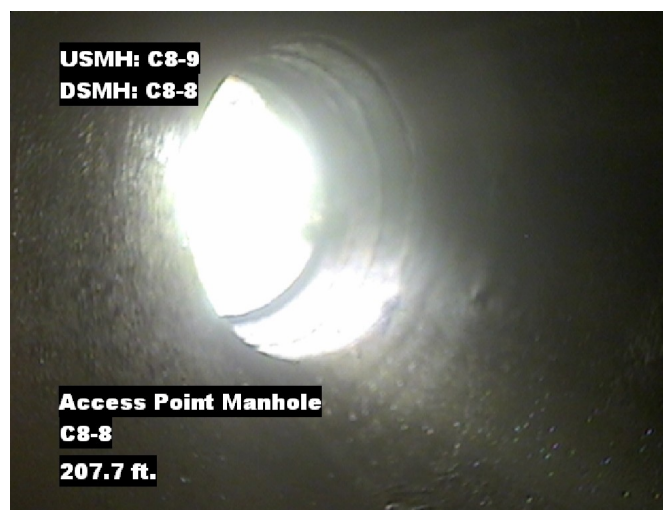
Distance: 207.7 ft. Grade: 0
Condition: Access Point Manhole
Remarks: C8-8A
