Defect Listing

Pipe Segment Refere... C9-1_C8-4	City Oliver Springs	Street Tower Dr	Material Concrete Pipe (non-...	Location C... Light High...	Sewer Use Sanitary
Upstream MH C9-1	Total Length 209.9	Year Laid	Shape Circular	Location Details	
DS Manhole C8-4	Length surveyed 209.9	Year Renewed	Height 8	Width 8	Pipe Joint... 4

SPR 1	MPR 2	PO Number 4397-03	Customer GRW
SPRI 1	MPRI 2	Work Order 4397-02	Purpose Pre-Rehabilitation Survey
QSR 1100	QMR 2100		
OPR 3	Surveyed By Barry Rogers	Direction Downstream	Date 20150721
OPRI 1.5	Certificate Number U-1012-16405	Pre-Cleaning Jetting	Time 08:23
	Date Cleaned 20150721	End Time 08:40	Weather Damp
			Media label
			Additional Info

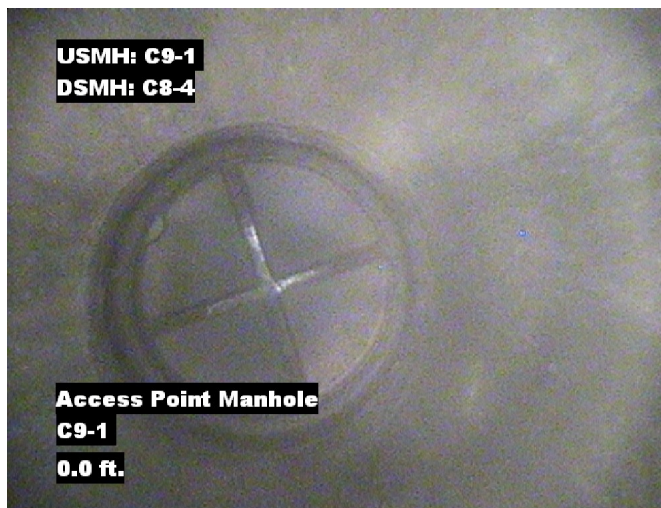
Distance: 0.0 ft. Grade: 0
Condition: Access Point Manhole
Remarks: C9-1

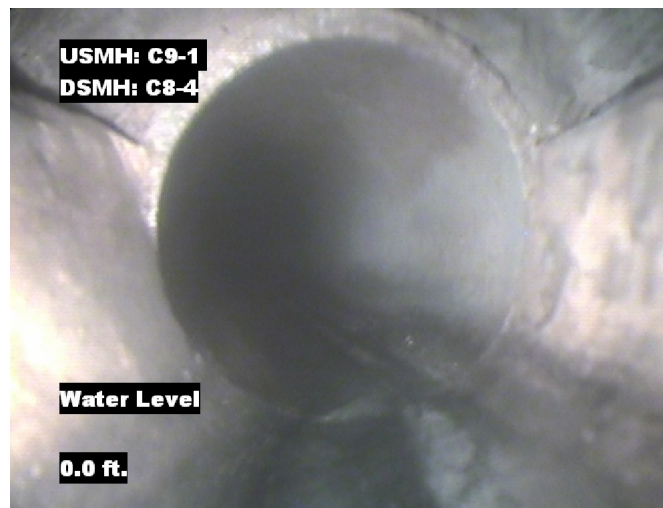
Distance: 0.0 ft. Grade: 0
Condition: Water Level
Remarks: N/A

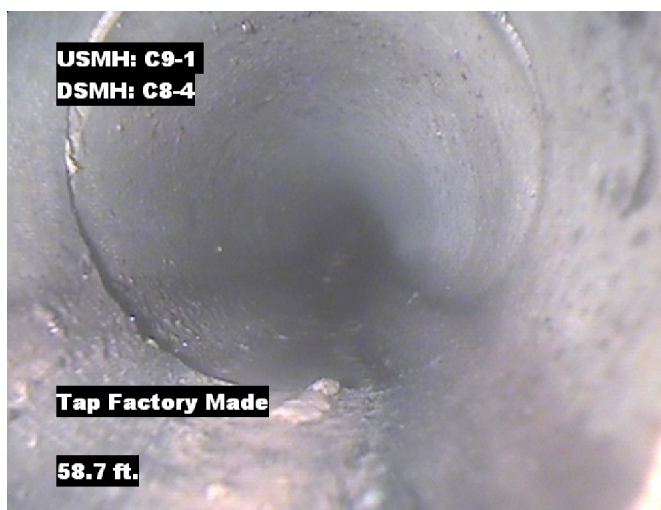
Distance: 58.7 ft. Grade: 0
Condition: Tap Factory Made
Remarks: N/A

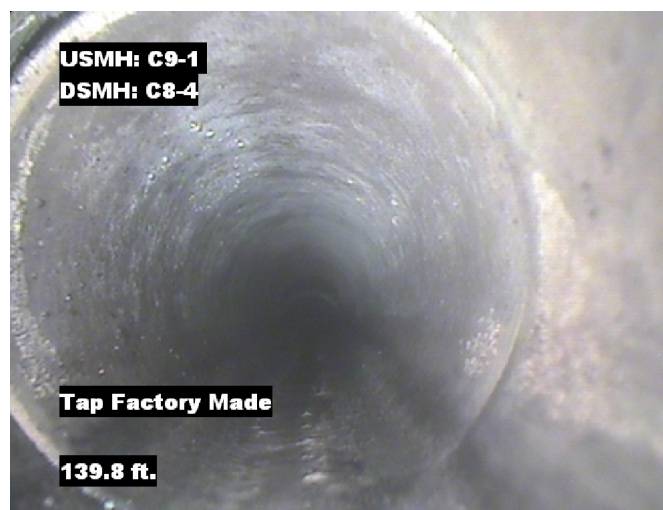
Distance: 139.8 ft. Grade: 0
Condition: Tap Factory Made
Remarks: N/A

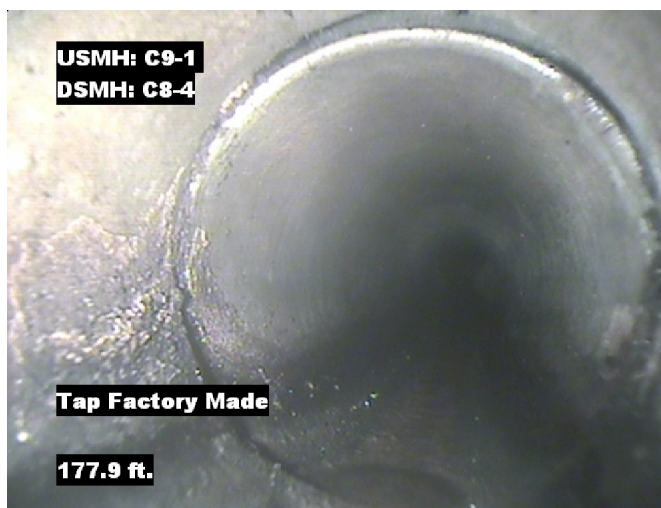
Distance: 177.9 ft. Grade: 0
Condition: Tap Factory Made
Remarks: N/A

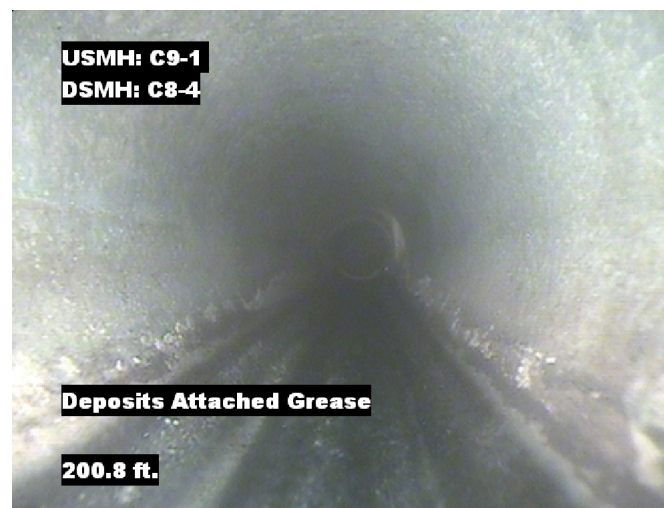
Distance: 200.8 ft. Grade: 2
Condition: Deposits Attached Grease
Remarks: N/A

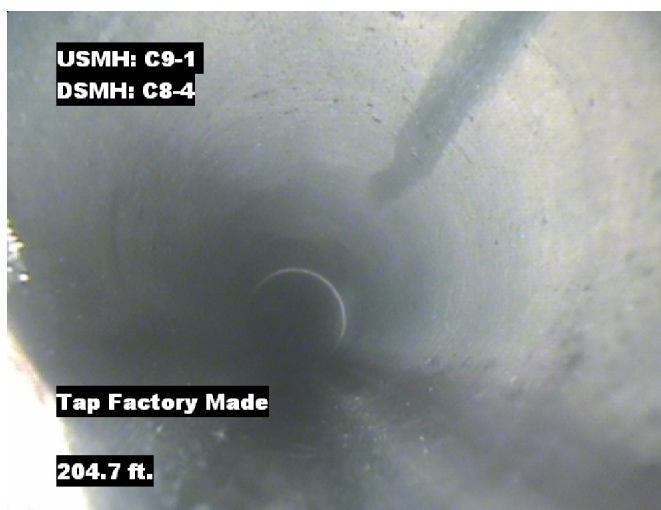
Distance: 204.7 ft. Grade: 0
Condition: Tap Factory Made
Remarks: N/A

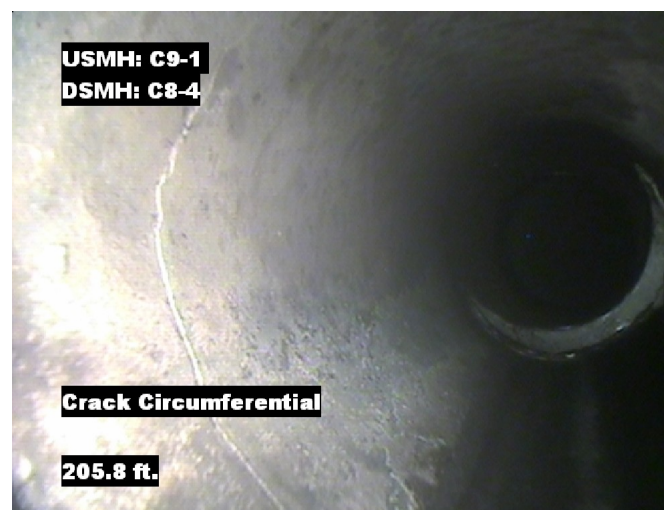
Distance: 205.8 ft. Grade: 1
Condition: Crack Circumferential
Remarks: N/A

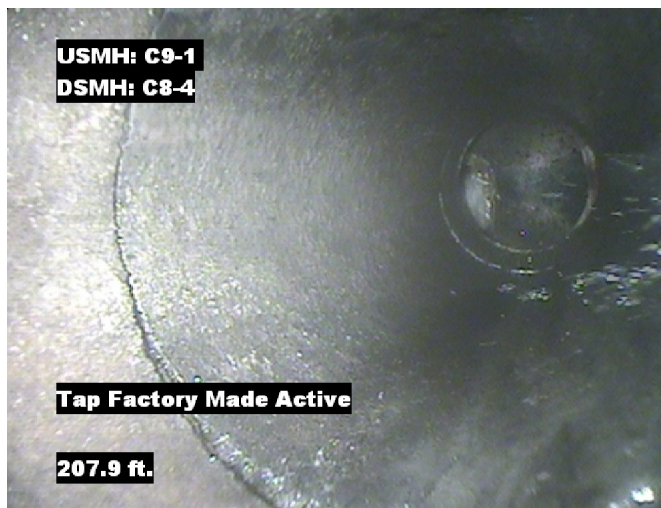
Distance: 207.9 ft. Grade: 0
Condition: Tap Factory Made Active
Remarks: N/A

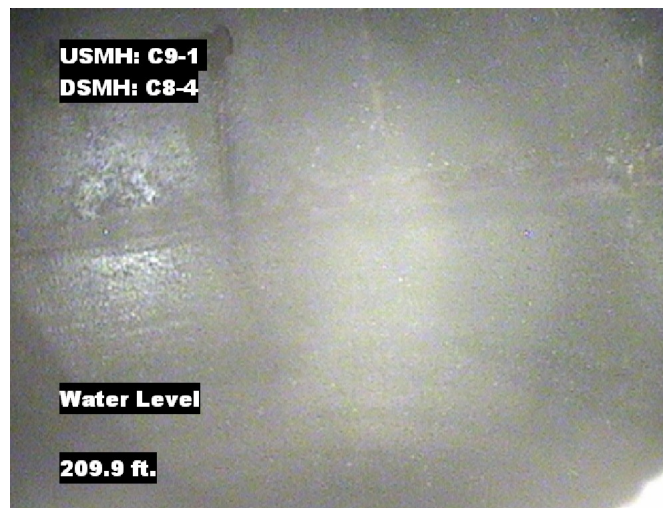
Distance: 209.9 ft. Grade: 0
Condition: Water Level
Remarks: N/A

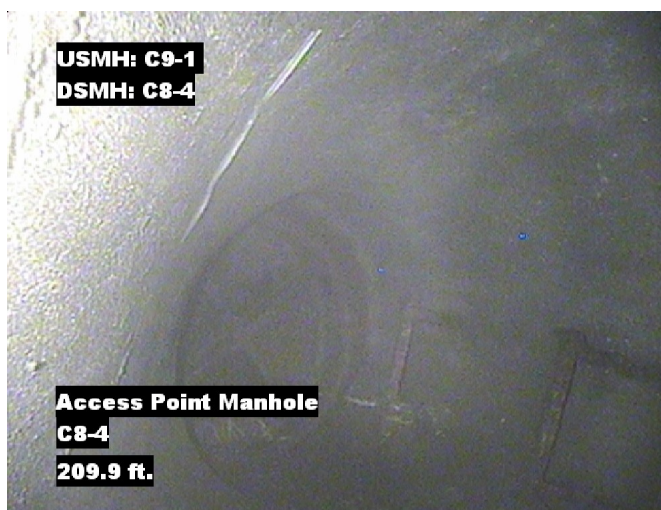
Distance: 209.9 ft. Grade: 0
Condition: Access Point Manhole
Remarks: C8-4
