Defect Listing

Pipe Segment Refere... C9-2_C9-1	City Oliver Springs	Street Tower Dr	Material Concrete Pipe (non-...	Location C... Light High...	Sewer Use Sanitary
Upstream MH C9-2	Total Length 207.4	Year Laid	Shape Circular	Location Details	
DS Manhole C9-1	Length surveyed 207.4	Year Renewed	Height 8	Width 8	Pipe Joint... 4

SPR N/A	MPR 2	PO Number 4397-03	Customer GRW
SPRI N/A	MPRI 2	Work Order 4397-02	Purpose Pre-Rehabilitation Survey
QSR N/A	QMR 2100		
OPR 2	Surveyed By Barry Rogers	Direction Downstream	Date 20150721
OPRI 2	Certificate Number U-1012-16405	Pre-Cleaning Jetting	Time 08:02
	Date Cleaned 20150721	End Time 08:18	Weather Damp
			Media label
			Additional Info

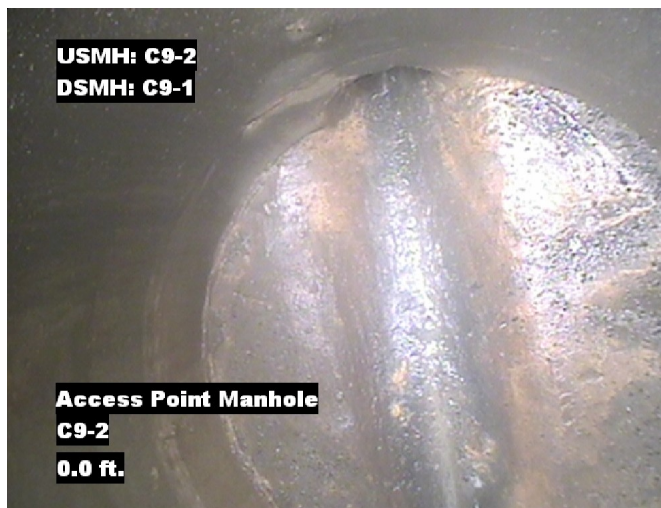
Distance: 0.0 ft. Grade: 0
Condition: Access Point Manhole
Remarks: C9-2

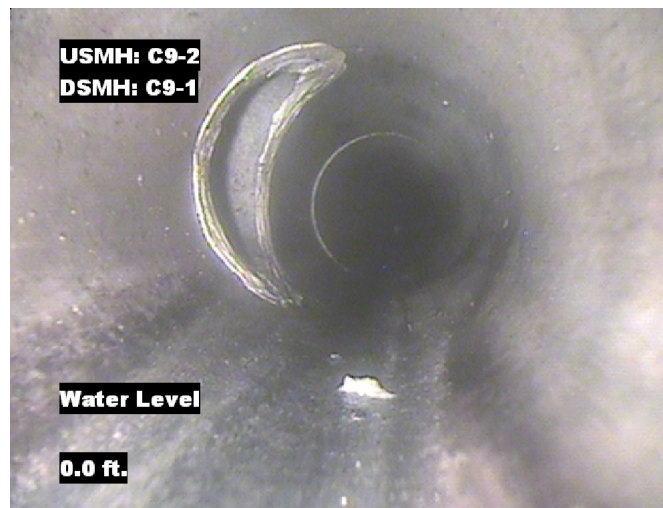
Distance: 0.0 ft. Grade: 0
Condition: Water Level
Remarks: N/A

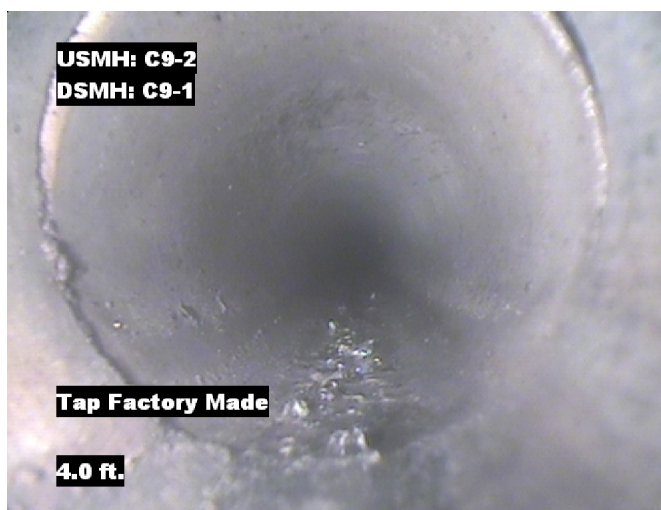
Distance: 4.0 ft. Grade: 0
Condition: Tap Factory Made
Remarks: N/A

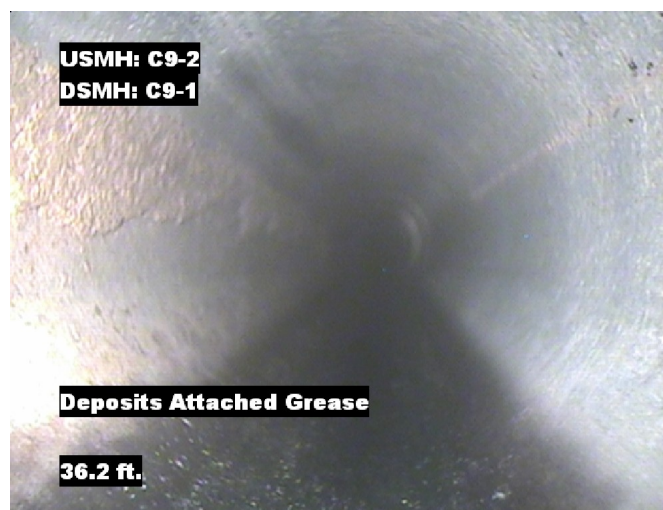
Distance: 36.2 ft. Grade: 2
Condition: Deposits Attached Grease
Remarks: N/A

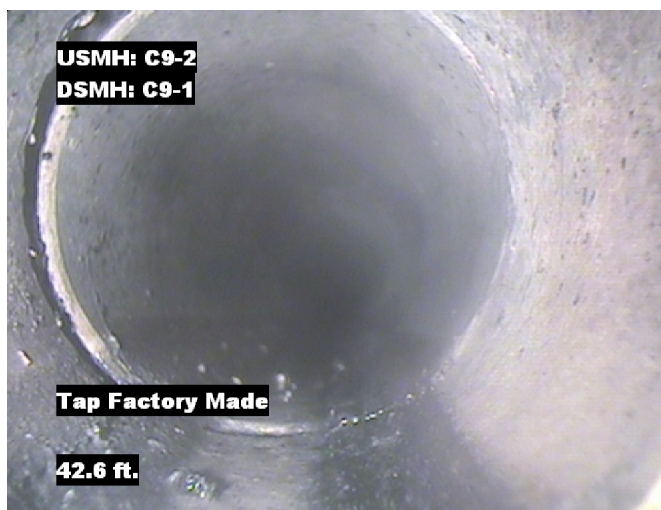
Distance: 42.6 ft. Grade: 0
Condition: Tap Factory Made
Remarks: N/A

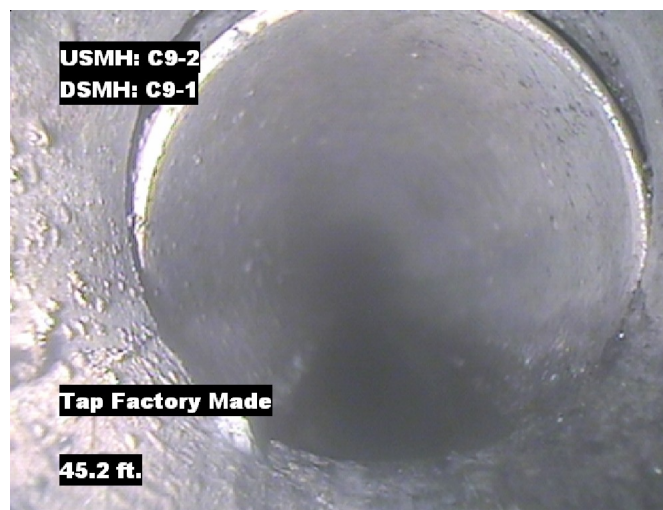
Distance: 45.2 ft. Grade: 0
Condition: Tap Factory Made
Remarks: N/A

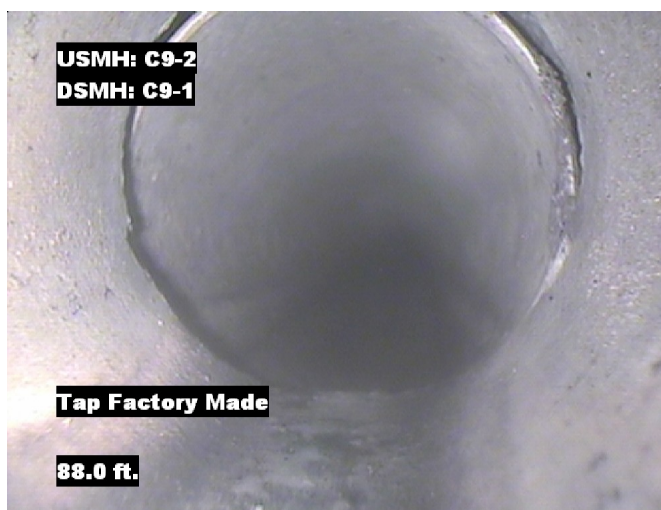
Distance: 88.0 ft. Grade: 0
Condition: Tap Factory Made
Remarks: N/A

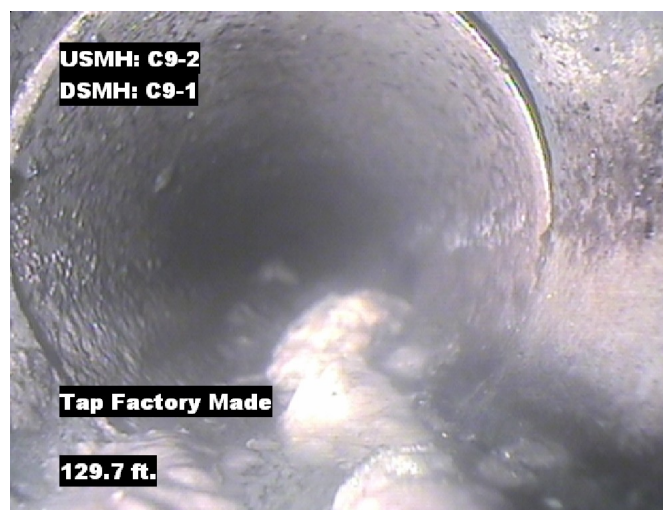
Distance: 129.7 ft. Grade: 0
Condition: Tap Factory Made
Remarks: N/A

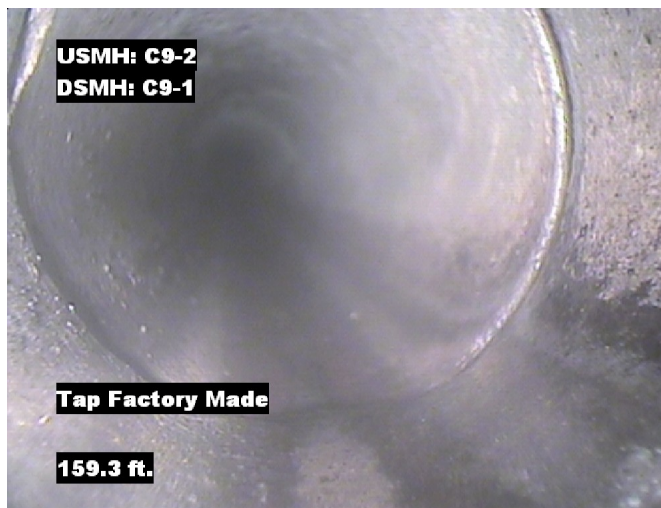
Distance: 159.3 ft. Grade: 0
Condition: Tap Factory Made
Remarks: N/A

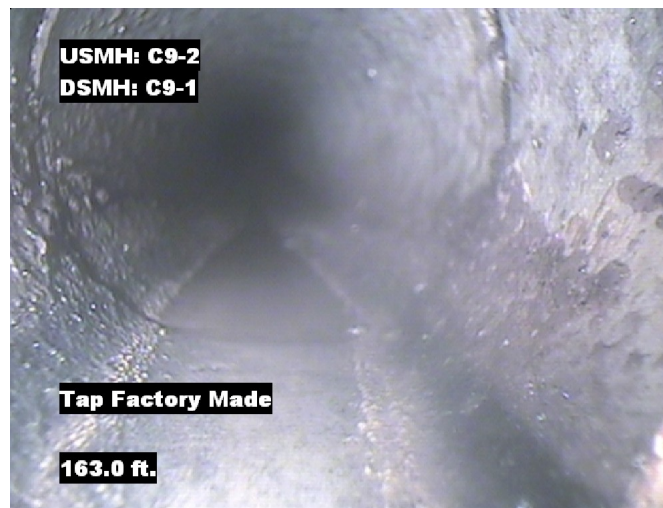
Distance: 163.0 ft. Grade: 0
Condition: Tap Factory Made
Remarks: N/A

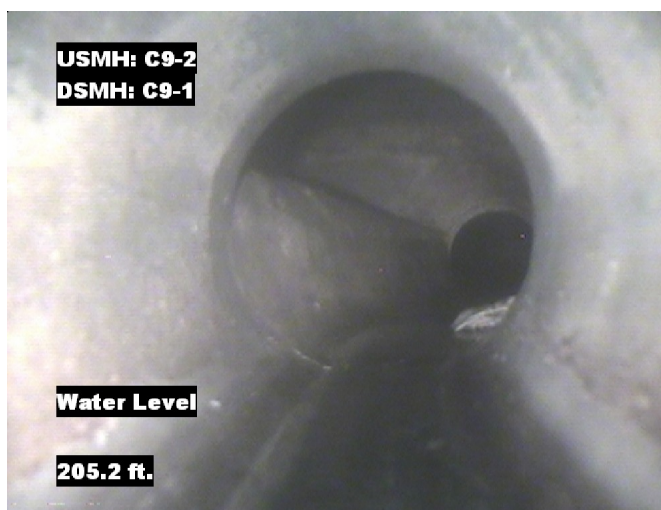
Distance: 205.2 ft. Grade: 0
Condition: Water Level
Remarks: N/A

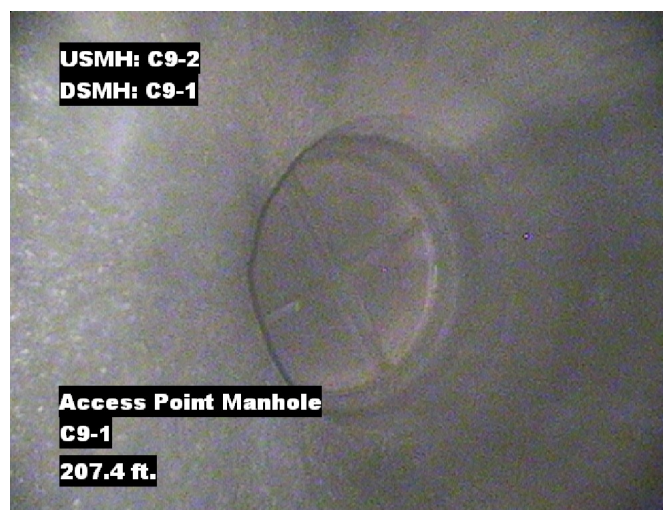
Distance: 207.4 ft. Grade: 0
Condition: Access Point Manhole
Remarks: C9-1
