Defect Listing

Pipe Segment Refere... D-13_D-12	City Oliver Springs	Street Highway #61 & #62	Material Fibreglass Reinforc...	Location C... Woods	Sewer Use Sanitary
Upstream MH D-13	Total Length 207.9	Year Laid	Shape Circular	Location Details	
DS Manhole D-12	Length surveyed 207.9	Year Renewed	Height 10	Width 10	Pipe Joint... N/A

Image Report 4/Page

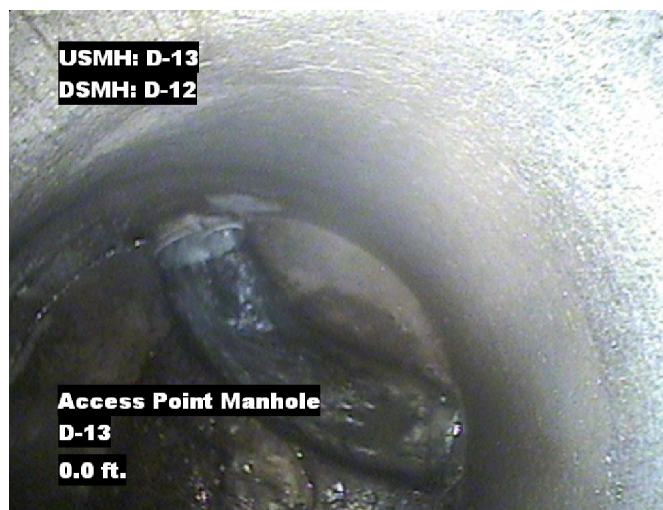
Distance: 0.0 ft. Grade: 0
Condition: Access Point Manhole
Remarks: D-13

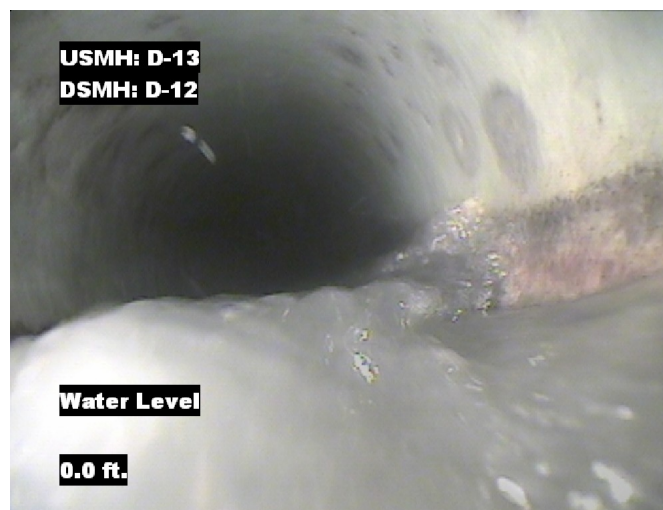
Distance: 0.0 ft. Grade: 0
Condition: Water Level
Remarks: N/A

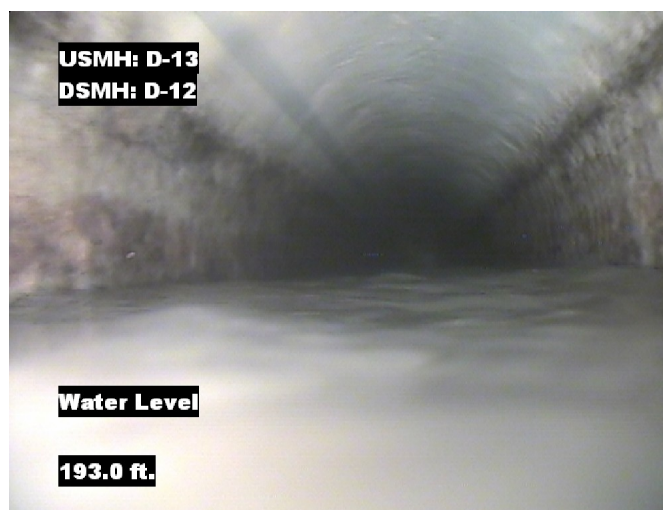
Distance: 192.8 ft. Grade: 0
Condition: Water Level
Remarks: N/A

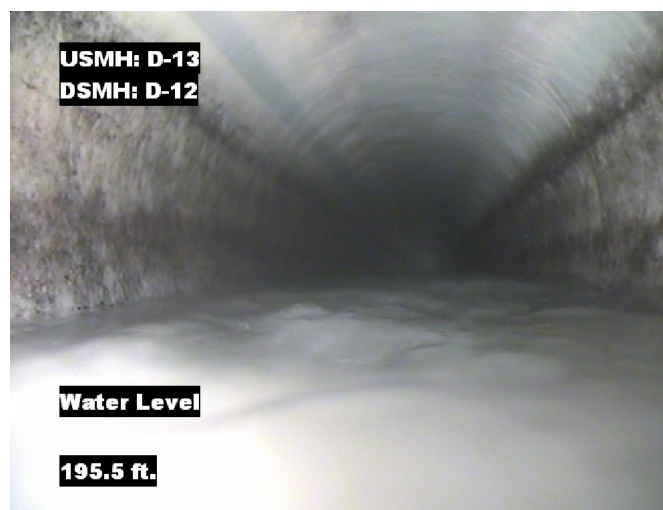
Distance: 195.5 ft. Grade: 0
Condition: Water Level
Remarks: N/A

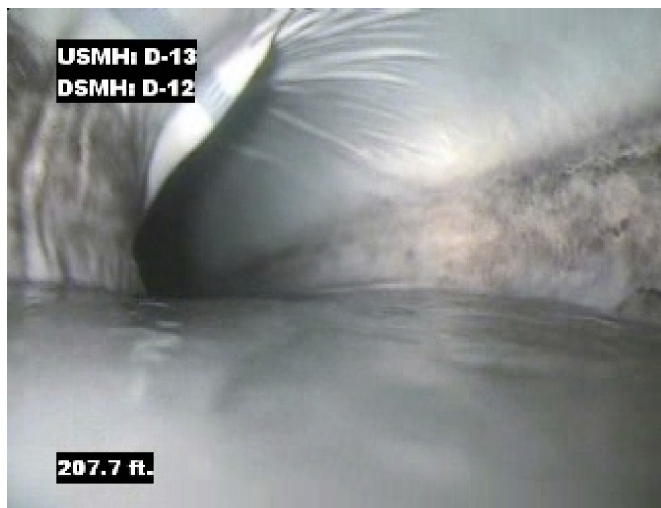
Distance: 207.7 ft. Grade: 3
Condition: Lining Failure Blistered
Remarks: N/A

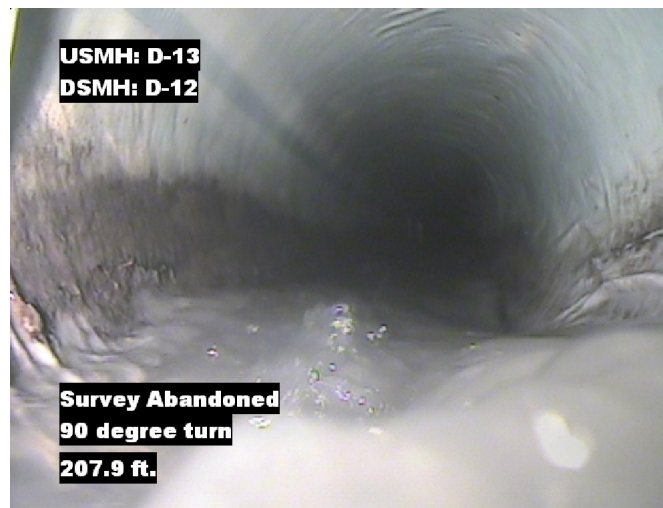
Distance: 207.9 ft. Grade: 0
Condition: Survey Abandoned
Remarks: 90 degree turn
