## Defect Listing

Pipe Segment Refere... <b>D-14_D-13</b>	City <b>Oliver Springs</b>	Street <b>Haven RD</b>	Material <b>Fibreglass Reinf...</b>	Location C... <b>Yard</b>	Sewer Use <b>Sanitary</b>
Upstream MH <b>D-14</b>	Total Length <b>194.6</b>	Year Laid	Shape <b>Circular</b>	Location Details	
DS Manhole <b>D-13</b>	Length surveyed <b>194.6</b>	Year Renewed	Height <b>10</b>	Width <b>10</b>	Pipe Joint... <b>N/A</b>

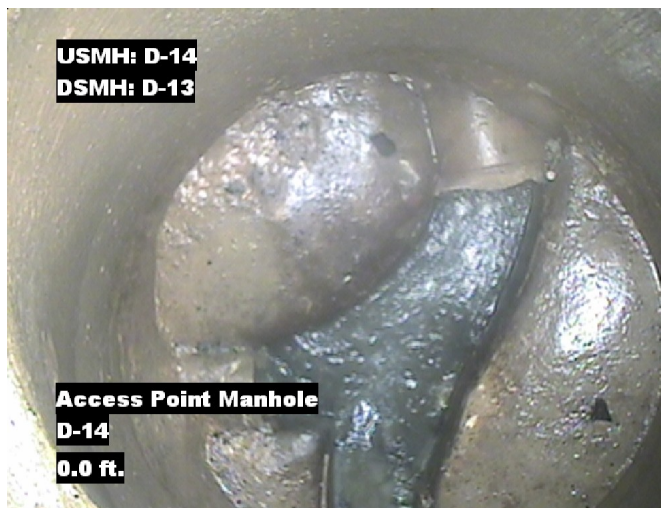
Distance: 0.0 ft. Grade: 0  
Condition: Access Point Manhole  
Remarks: D-14

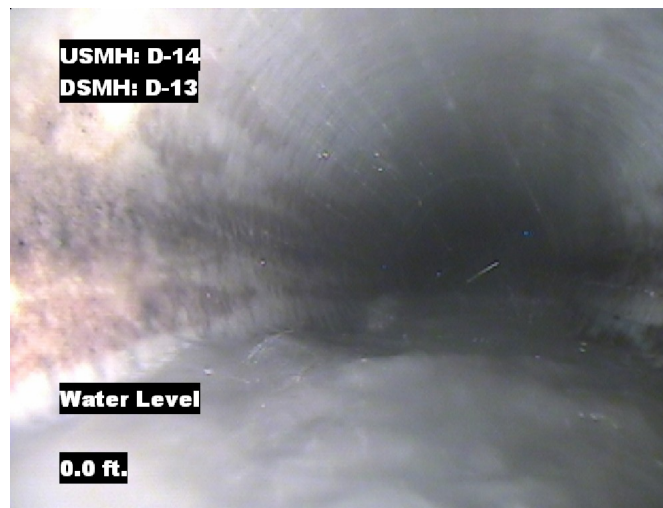
Distance: 0.0 ft. Grade: 0  
Condition: Water Level  
Remarks: N/A

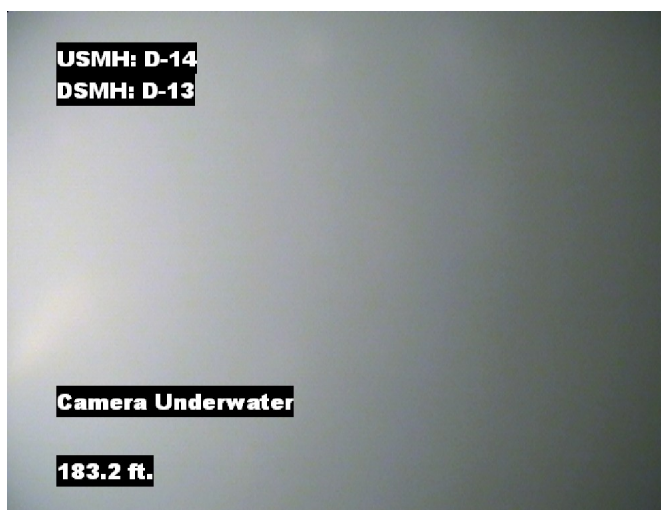
Distance: 183.2 ft. Grade: 4  
Condition: Camera Underwater  
Remarks: N/A

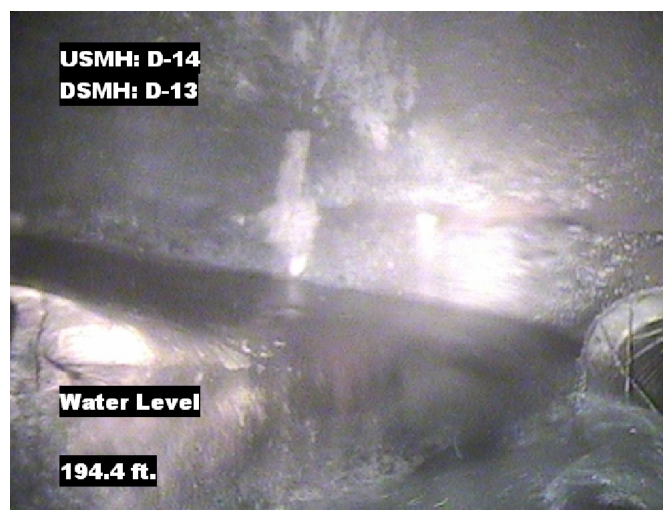
Distance: 194.4 ft. Grade: 0  
Condition: Water Level  
Remarks: N/A

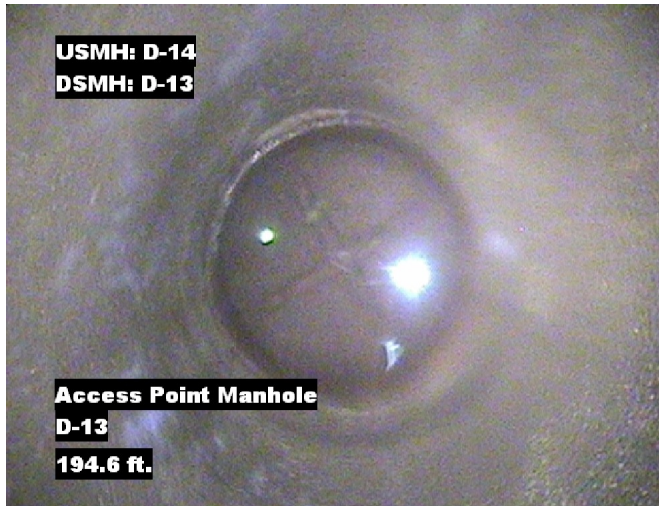
Distance: 194.6 ft. Grade: 0  
Condition: Access Point Manhole  
Remarks: D-13
