Defect Listing

Pipe Segment Refere...	City	Street	Material	Location C...	Sewer Use
D-15_D-14	Oliver Springs	Midway Dr	Fibreglass Reinforc...	Yard	Sanitary
Upstream MH	Total Length	Year Laid	Shape	Location Details	
D-15	351.1		Circular		
DS Manhole	Length surveyed	Year Renewed	Height	Width	Pipe Joint...
D-14	351.1		10	10	N/A

SPR	N/A	MPR	N/A	PO Number	Customer
SPRI	N/A	MPRI	N/A	4397-03	GRW
QSR	N/A	QMR	N/A	Work Order	Purpose
				4397-02	Pre-Rehabilitation Survey
OPR	Surveyed By	Direction	Date	Media label	
N/A	Barry Rogers	Downstream	20150707		
OPRI	Certificate Number	Pre-Cleaning	Time	Weather	
N/A	U-1012-16405	Jetting	08:08	Dry	
Date Cleaned			End Time	Additional Info	
20150707			08:27

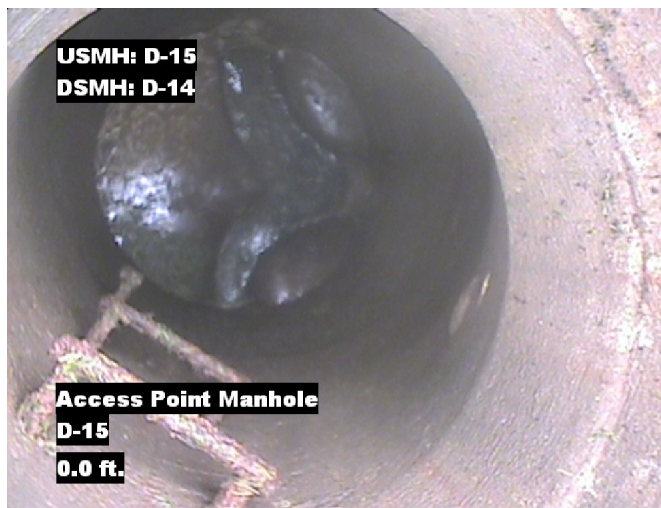
Distance: 0.0 ft. Grade: 0
Condition: Access Point Manhole
Remarks: D-15

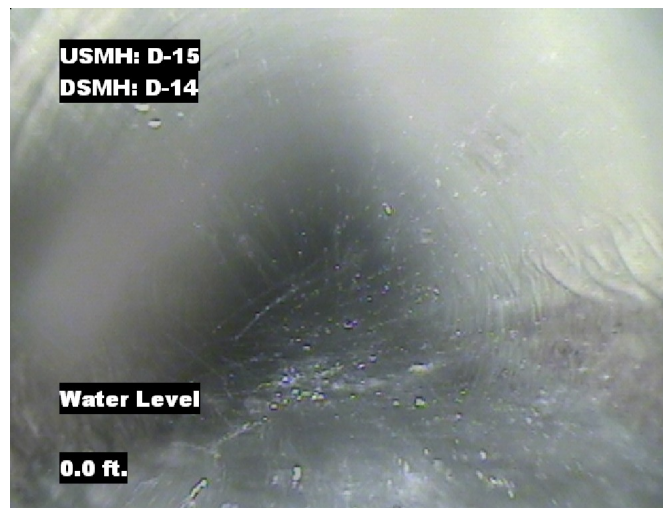
Distance: 0.0 ft. Grade: 0
Condition: Water Level
Remarks: N/A

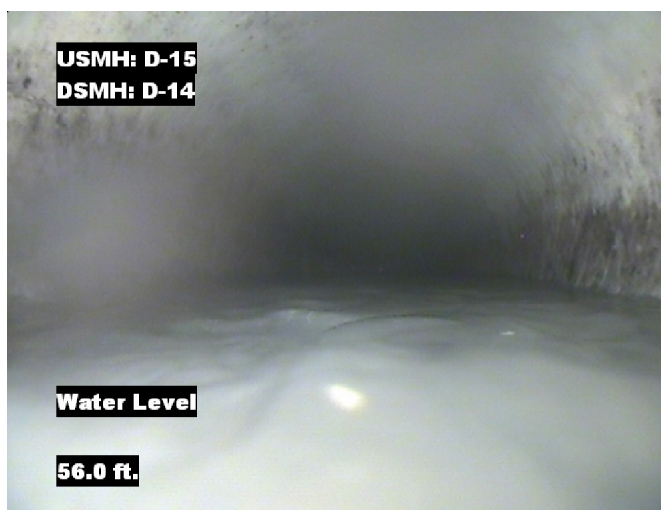
Distance: 56.0 ft. Grade: 0
Condition: Water Level
Remarks: N/A

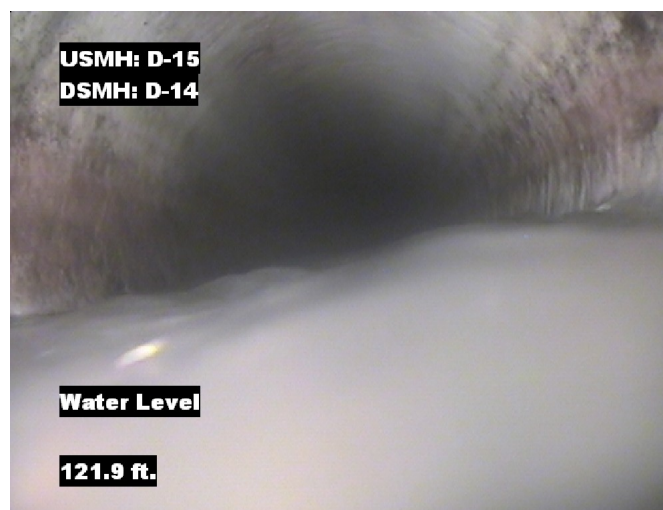
Distance: 121.9 ft. Grade: 0
Condition: Water Level
Remarks: N/A

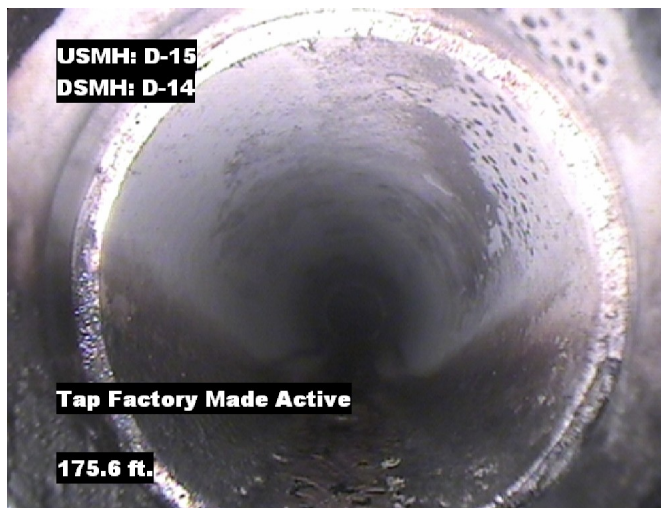
Distance: 175.6 ft. Grade: 0
Condition: Tap Factory Made Active
Remarks: N/A

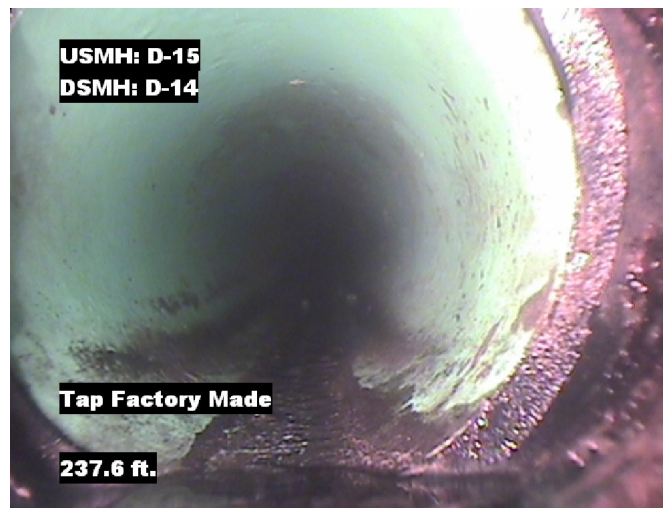
Distance: 237.6 ft. Grade: 0
Condition: Tap Factory Made
Remarks: N/A

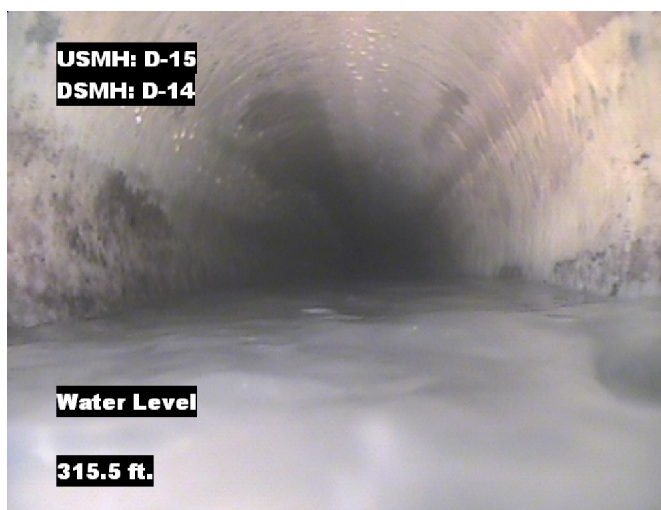
Distance: 315.5 ft. Grade: 0
Condition: Water Level
Remarks: N/A

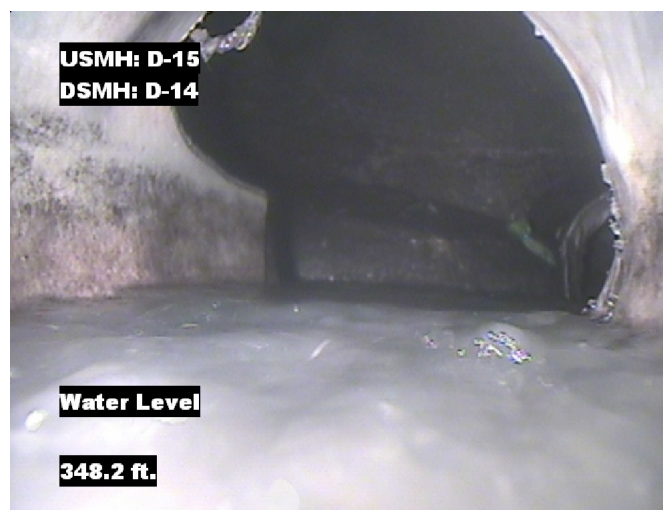
Distance: 348.2 ft. Grade: 0
Condition: Water Level
Remarks: N/A

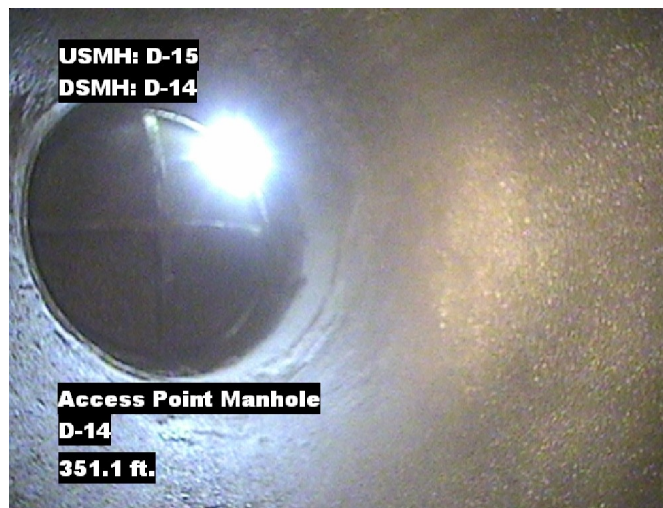
Distance: 351.1 ft. Grade: 0
Condition: Access Point Manhole
Remarks: D-14
