Defect Listing

Pipe Segment Refere...	City	Street	Material	Location C...	Sewer Use
D-16_D-15	Oliver Springs	Midway Dr	Fibreglass Reinforc...	Light High...	Sanitary
Upstream MH	Total Length	Year Laid	Shape	Location Details	
D-16	263		Circular		
DS Manhole	Length surveyed	Year Renewed	Height	Width	Pipe Joint...
D-15	263		10	10	N/A

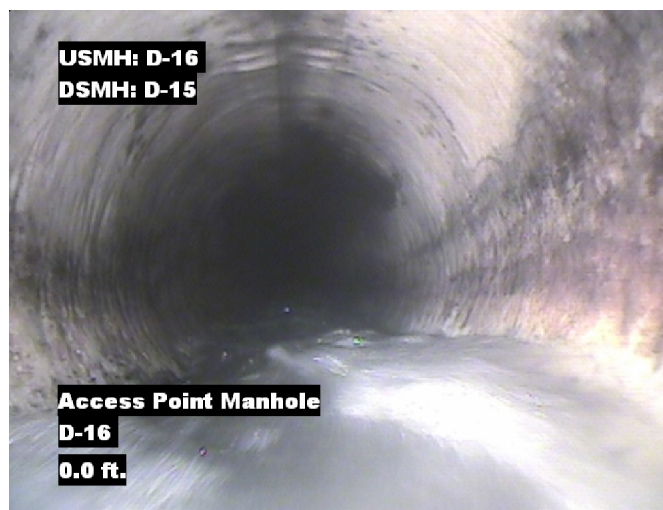
Distance: 0.0 ft. Grade: 0
Condition: Access Point Manhole
Remarks: D-16

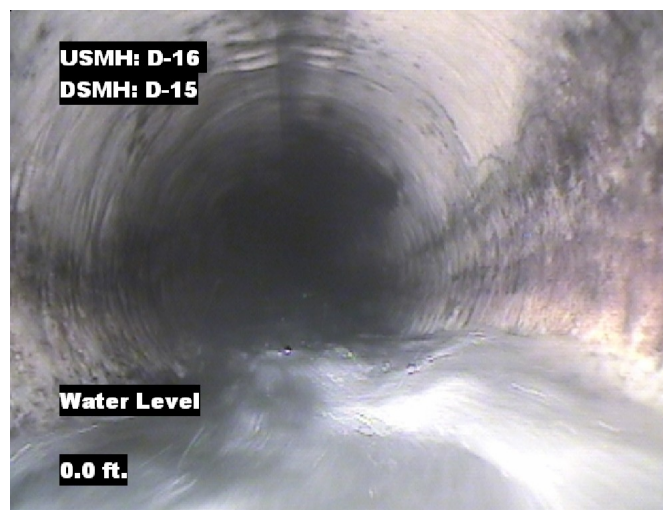
Distance: 0.0 ft. Grade: 0
Condition: Water Level
Remarks: N/A

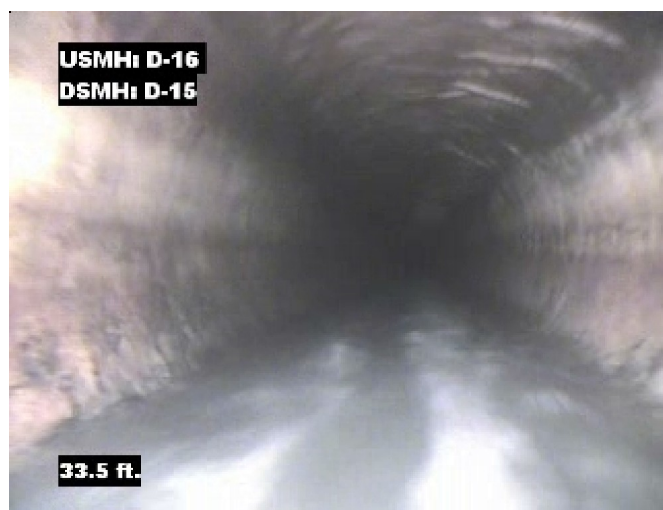
Distance: 33.5 ft. Grade: 3
Condition: Lining Failure Wrinkled
Remarks: cont. defect

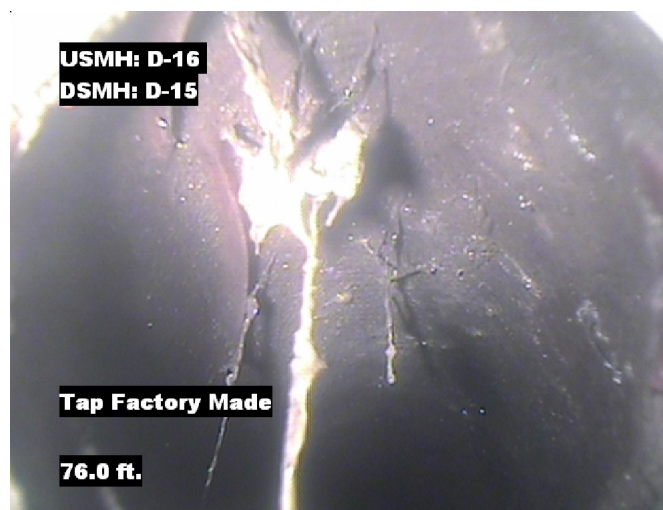
Distance: 76.0 ft. Grade: 0
Condition: Tap Factory Made
Remarks: N/A

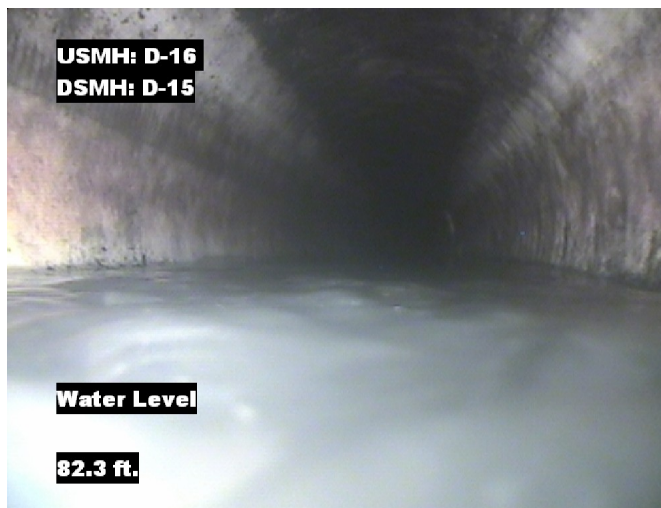
Distance: 82.3 ft. Grade: 0
Condition: Water Level
Remarks: N/A

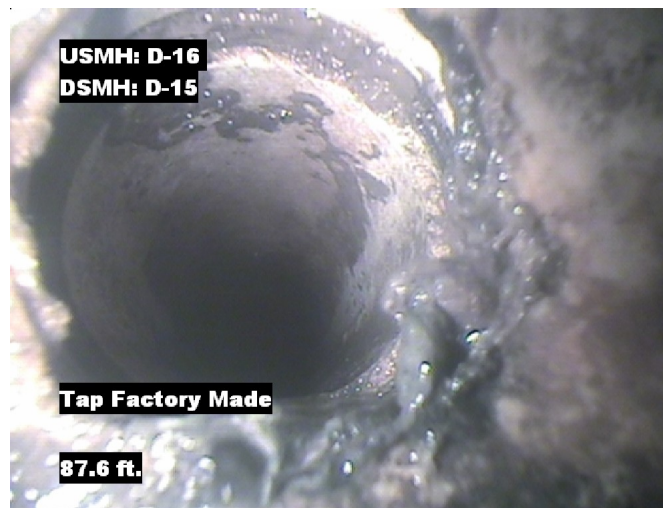
Distance: 87.6 ft. Grade: 0
Condition: Tap Factory Made
Remarks: N/A

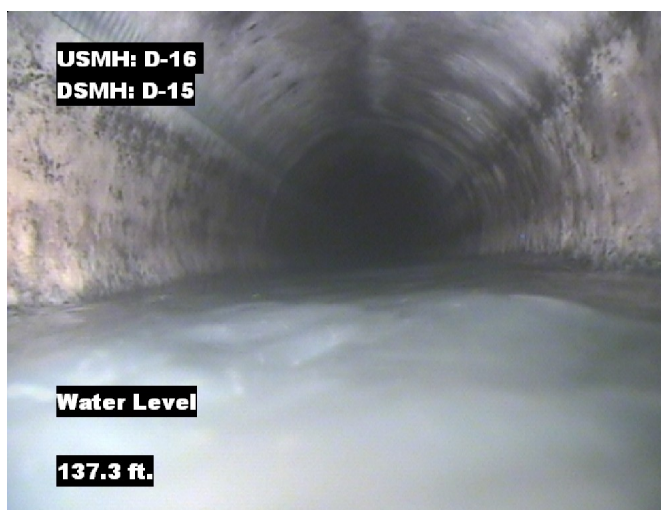
Distance: 137.3 ft. Grade: 0
Condition: Water Level
Remarks: N/A

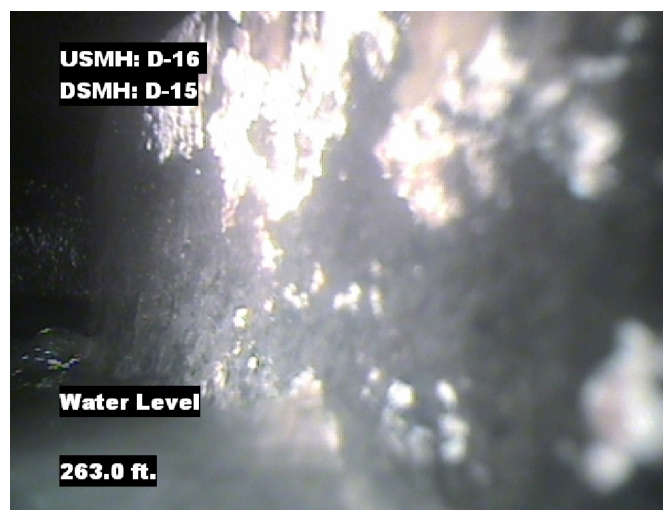
Distance: 263.0 ft. Grade: 0
Condition: Water Level
Remarks: N/A

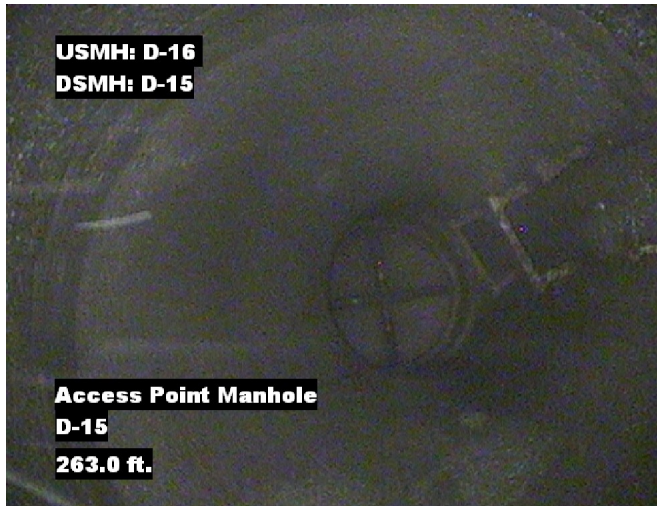
Distance: 263.0 ft. Grade: 0
Condition: Access Point Manhole
Remarks: D-15
