## Defect Listing

Pipe Segment Refere... <b>D-17_D-17-1</b>	City <b>Oliver Springs</b>	Street <b>Airport Rd</b>	Material <b>Concrete Pipe (non-...</b>	Location C... <b>Light High...</b>	Sewer Use <b>Sanitary</b>
Upstream MH <b>D-17</b>	Total Length <b>237.9</b>	Year Laid	Shape <b>Circular</b>	Location Details	
DS Manhole <b>D-17-1</b>	Length surveyed <b>237.9</b>	Year Renewed	Height <b>8</b>	Width <b>8</b>	Pipe Joint... <b>4</b>

SPR <b>N/A</b>	MPR <b>10</b>	PO Number <b>4397-03</b>	Customer <b>GRW</b>
SPRI <b>N/A</b>	MPRI <b>2</b>	Work Order <b>4397-02</b>	Purpose <b>Pre-Rehabilitation Survey</b>
QSR <b>N/A</b>	QMR <b>2500</b>		
OPR <b>10</b>	Surveyed By <b>Barry Rogers</b>	Direction <b>Downstream</b>	Date <b>20150701</b>
OPRI <b>2</b>	Certificate Number <b>U-1012-16405</b>	Pre-Cleaning <b>Jetting</b>	Time <b>12:31</b>
	Date Cleaned <b>20150701</b>	End Time <b>12:40</b>	Weather <b>Saturated</b>
			Media label
			Additional Info

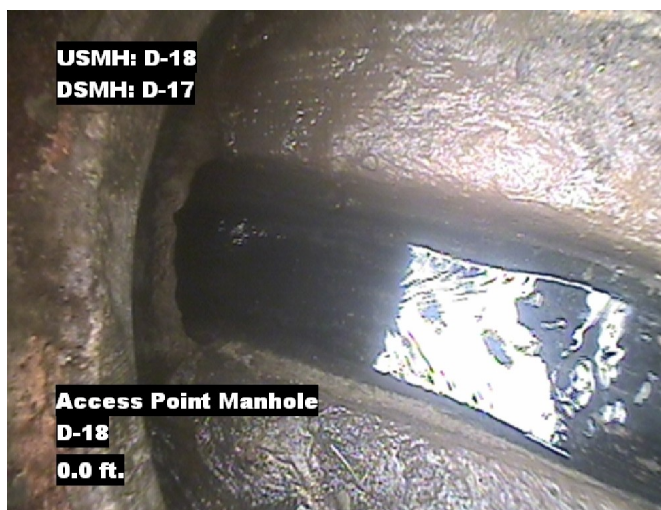
Distance: 0.0 ft. Grade: 0  
Condition: Access Point Manhole  
Remarks: D-17

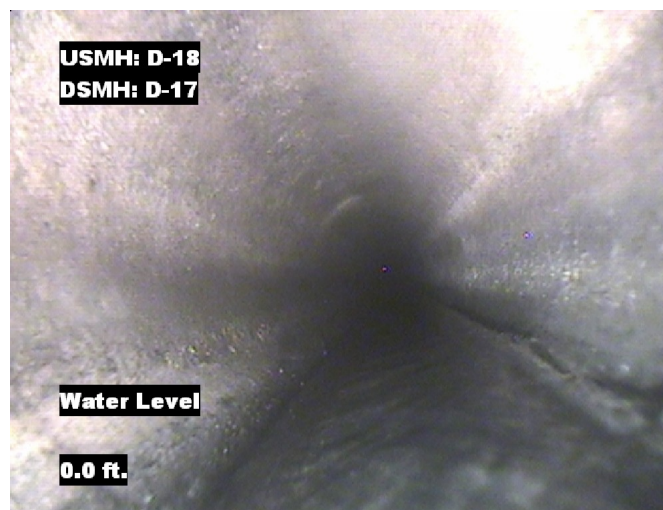
Distance: 0.0 ft. Grade: 0  
Condition: Water Level  
Remarks: N/A

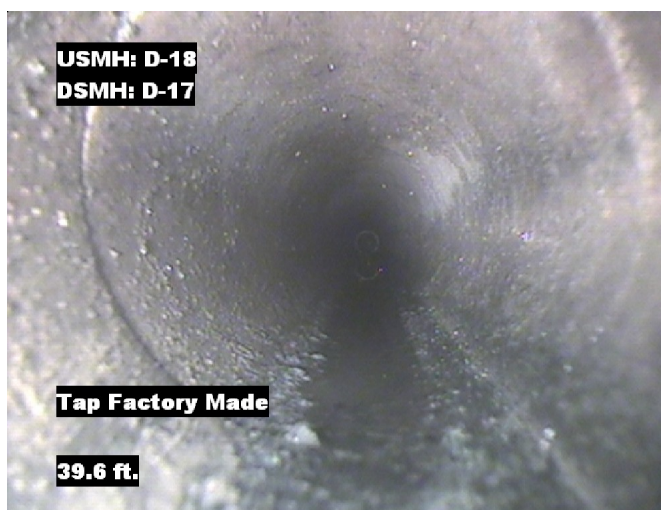
Distance: 39.6 ft. Grade: 0  
Condition: Tap Factory Made  
Remarks: N/A

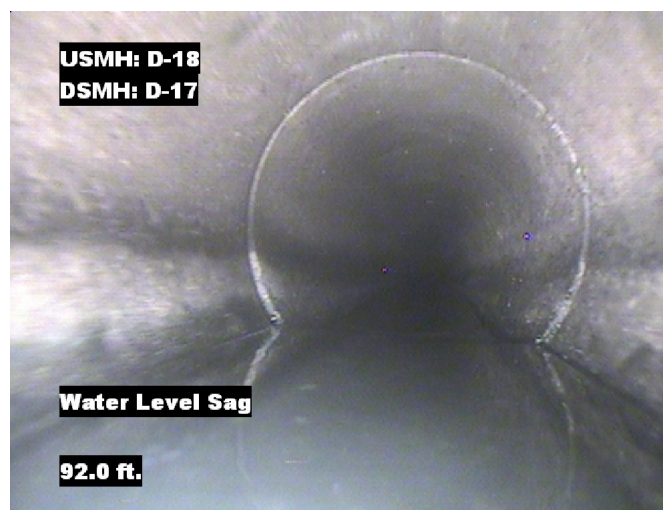
Distance: 92.0 ft. Grade: 2  
Condition: Water Level Sag  
Remarks: N/A

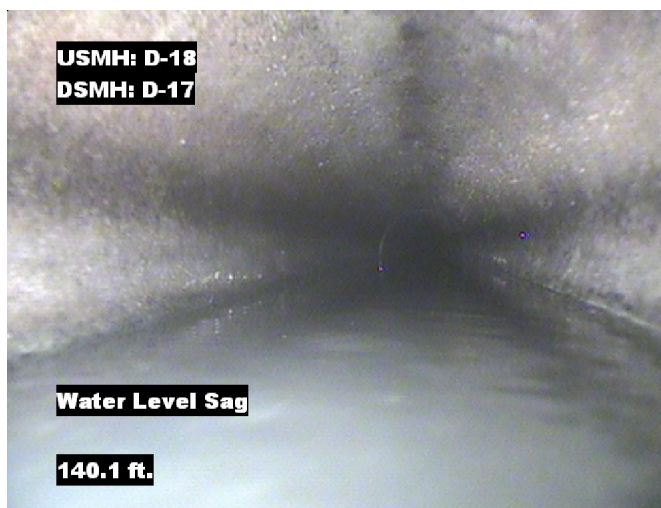
Distance: 140.1 ft. Grade: 2  
Condition: Water Level Sag  
Remarks: N/A

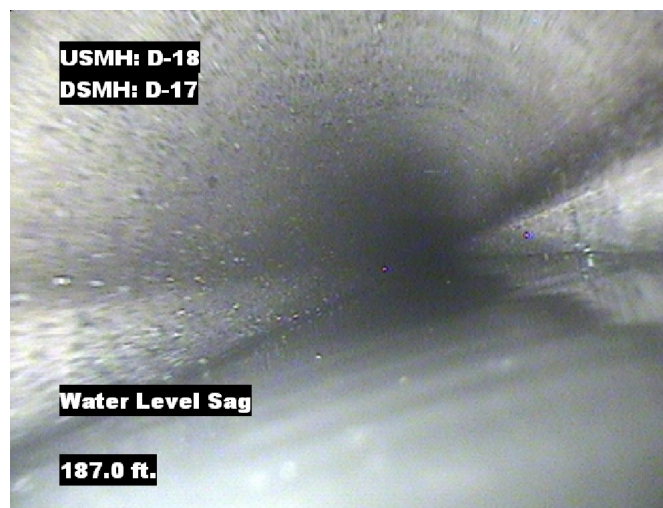
Distance: 186.8 ft. Grade: 2  
Condition: Water Level Sag  
Remarks: N/A

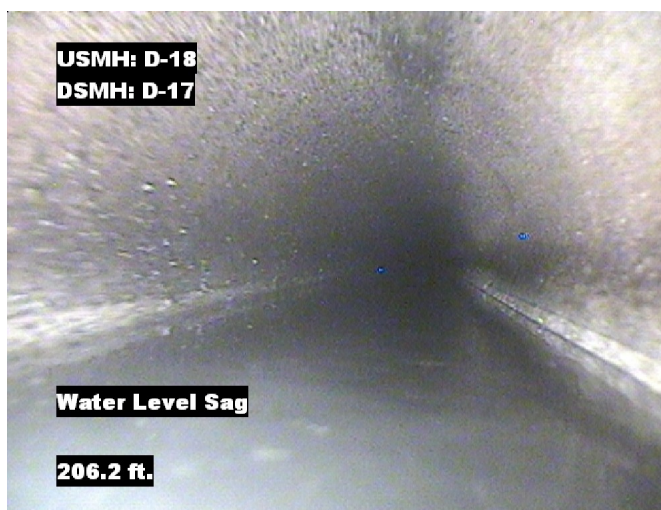
Distance: 206.1 ft. Grade: 2  
Condition: Water Level Sag  
Remarks: N/A

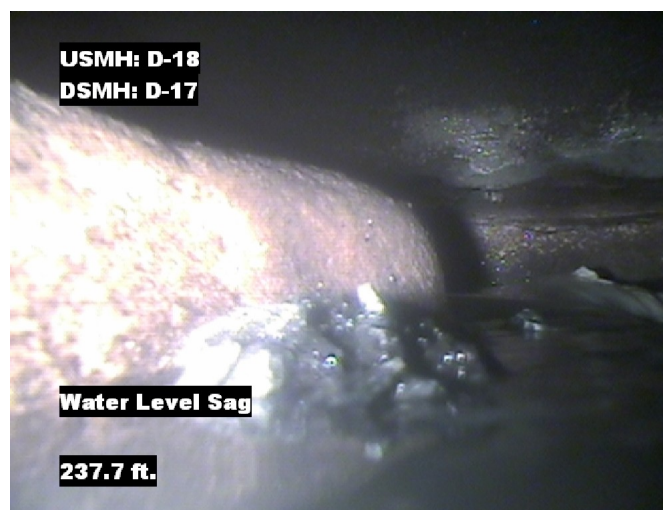
Distance: 237.7 ft. Grade: 2  
Condition: Water Level Sag  
Remarks: N/A

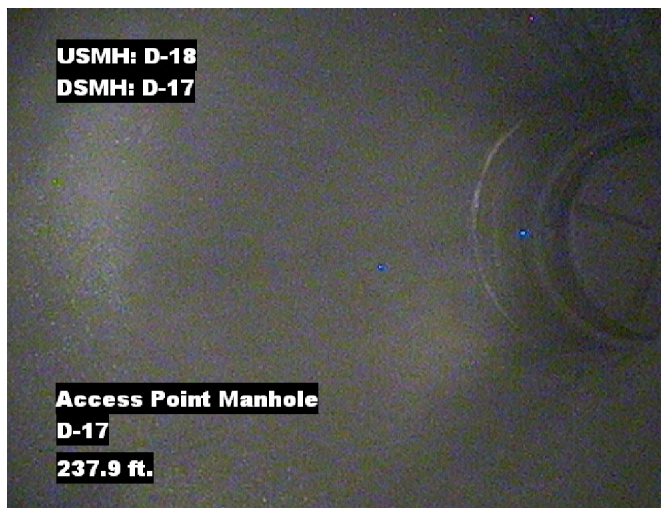
Distance: 237.9 ft.      Grade: 0  
Condition: Access Point Manhole  
Remarks: D17-1
