## Defect Listing

Pipe Segment Refere...	City	Street	Material	Location C...	Sewer Use
D-18_D-17	Oliver Springs	ClowersLN	Concrete Pipe (non-...	Yard	Sanitary
Upstream MH	Total Length	Year Laid	Shape	Location Details	
D-18	230.4		Circular		
DS Manhole	Length surveyed	Year Renewed	Height	Width	Pipe Joint...
D-17	230.4		8	8	4

SPR	N/A	MPR	8	PO Number	Customer
SPRI	N/A	MPRI	2	4397-03	GRW
QSR	N/A	QMR	2400	Work Order	Purpose
				4397-02	Pre-Rehabilitation Survey
OPR	Surveyed By	Direction	Date	Media label	
8	Barry_Rogers	Downstream	20150625		
OPRI	Certificate Number	Pre-Cleaning	Time	Weather	
2	U-1012-16405	Jetting	14:03	Dry	
Date Cleaned			End Time	Additional Info	
20150625			14:13

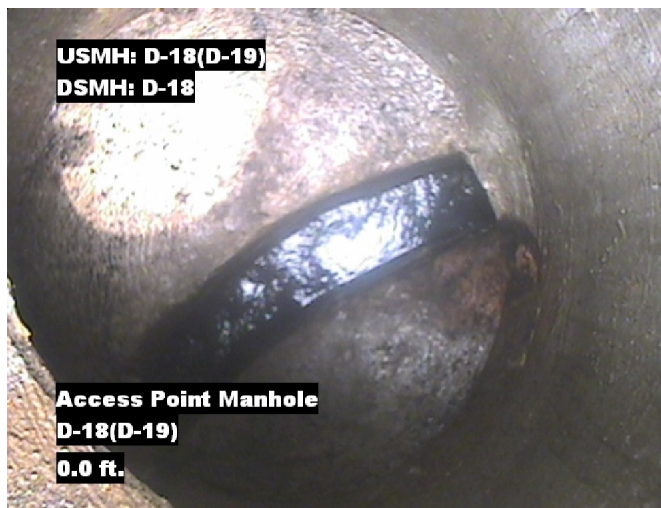
Distance: 0.0 ft. Grade: 0  
Condition: Access Point Manhole  
Remarks: D-18

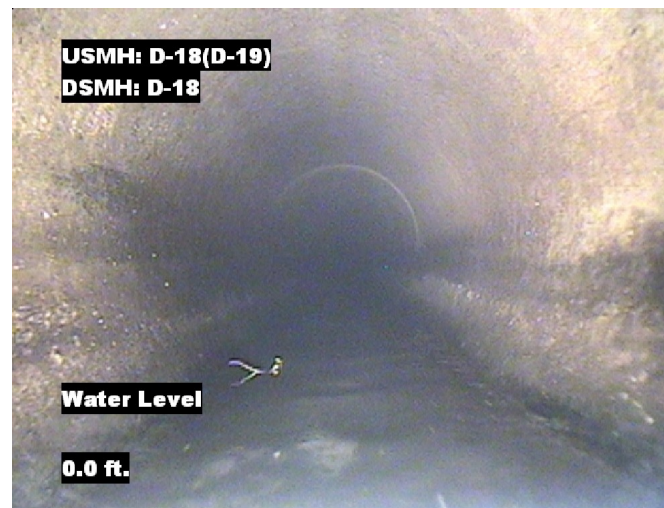
Distance: 0.0 ft. Grade: 0  
Condition: Water Level  
Remarks: N/A

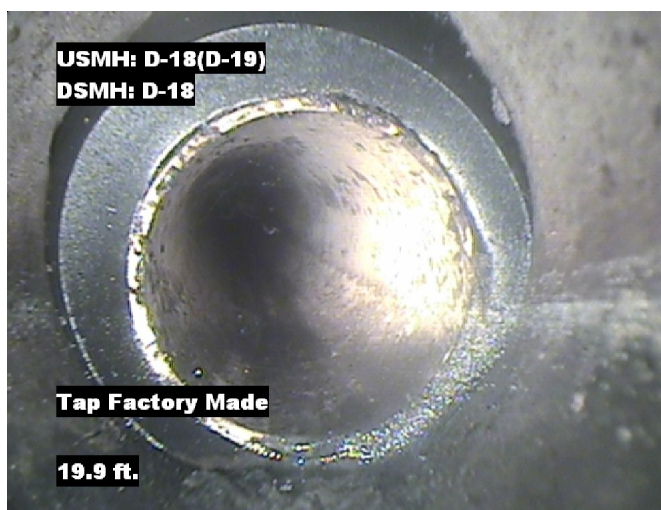
Distance: 19.9 ft. Grade: 0  
Condition: Tap Factory Made  
Remarks: N/A

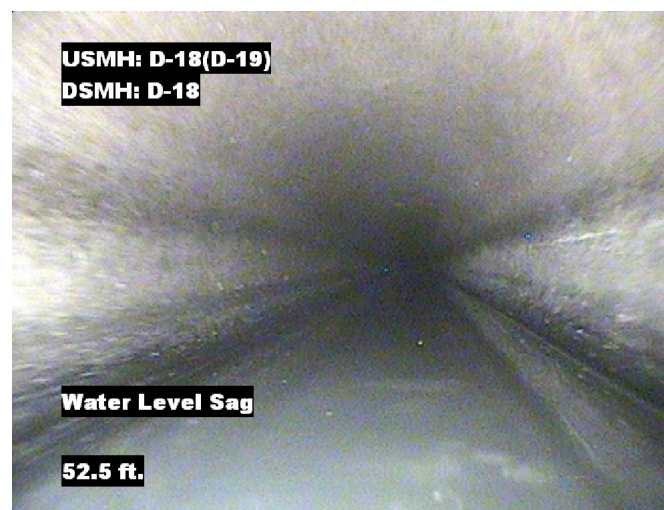
Distance: 52.4 ft. Grade: 2  
Condition: Water Level Sag  
Remarks: N/A

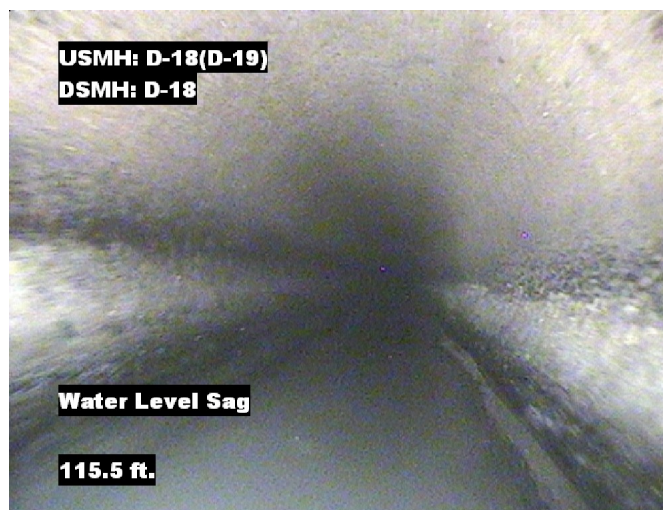
Distance: 115.4 ft. Grade: 2  
Condition: Water Level Sag  
Remarks: N/A

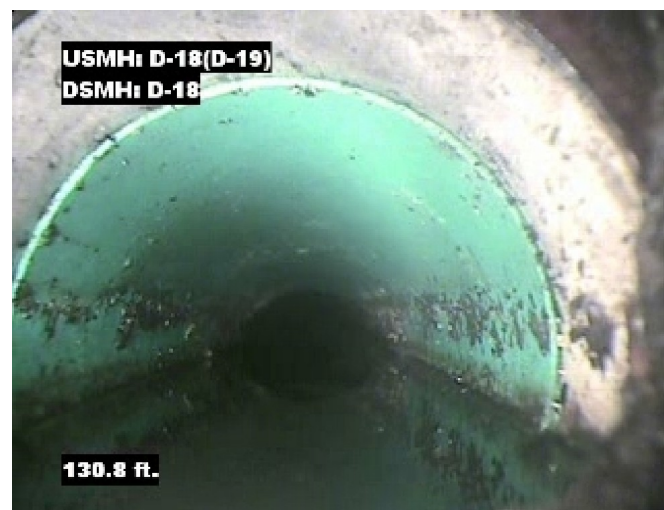
Distance: 130.8 ft. Grade: 2  
Condition: Tap Factory Made Defective  
Remarks: offset connection

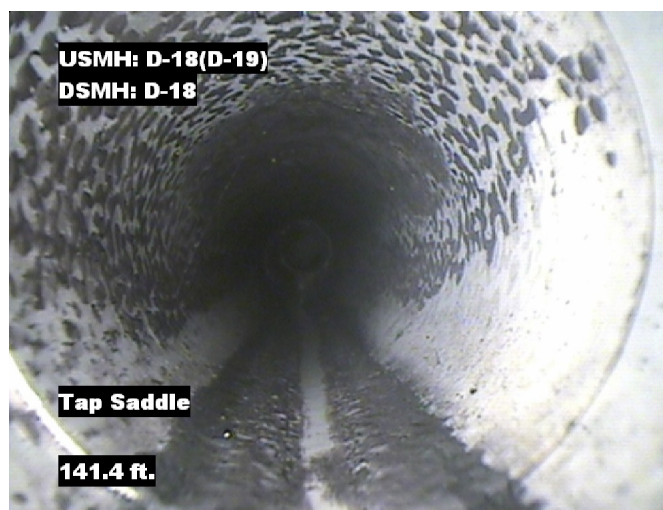
Distance: 141.4 ft. Grade: 0  
Condition: Tap Saddle  
Remarks: N/A

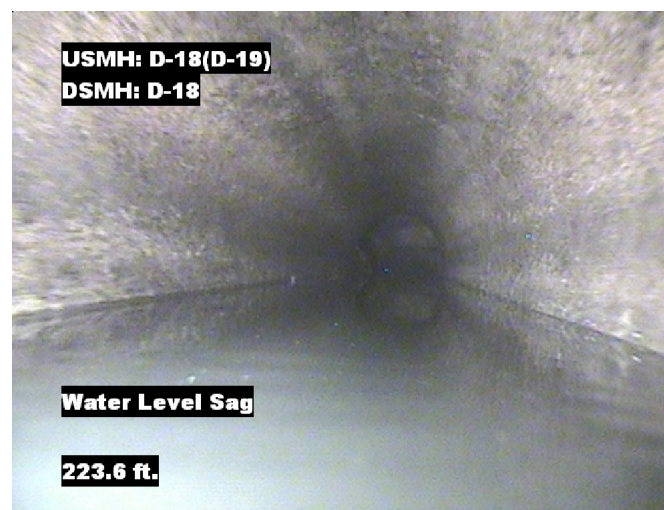
Distance: 223.5 ft. Grade: 2  
Condition: Water Level Sag  
Remarks: N/A

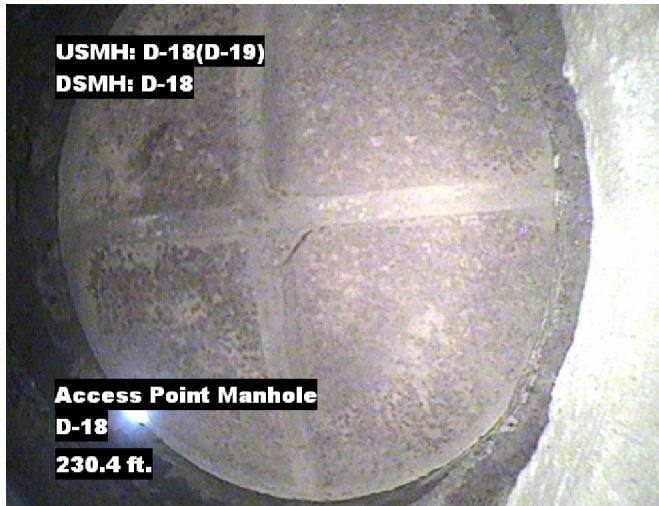
Distance: 230.4 ft. Grade: 0  
Condition: Access Point Manhole  
Remarks: D-17
