Defect Listing

Pipe Segment Refere...	City	Street	Material	Location C...	Sewer Use
D-19_D-18	Oliver Springs	clowers Ln	Concrete Pipe (non-...	Light High...	Sanitary
Upstream MH	Total Length	Year Laid	Shape	Location Details	
D-19	147.8		Circular		
DS Manhole	Length surveyed	Year Renewed	Height	Width	Pipe Joint...
D-18	147.8		8	8	4

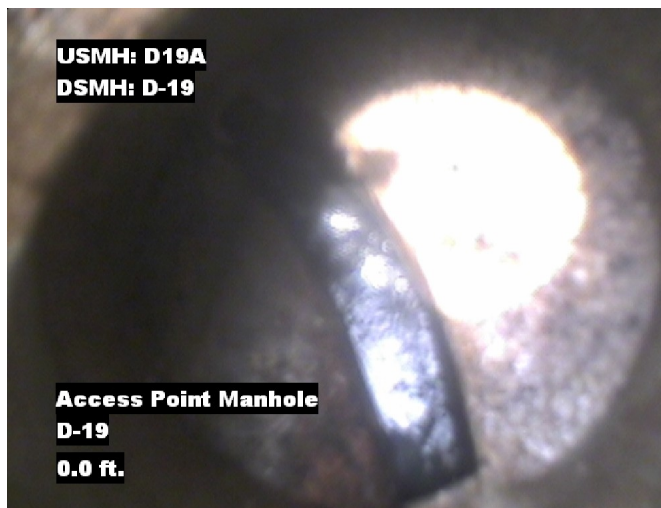
Distance: 0.0 ft. Grade: 0
Condition: Access Point Manhole
Remarks: D-19

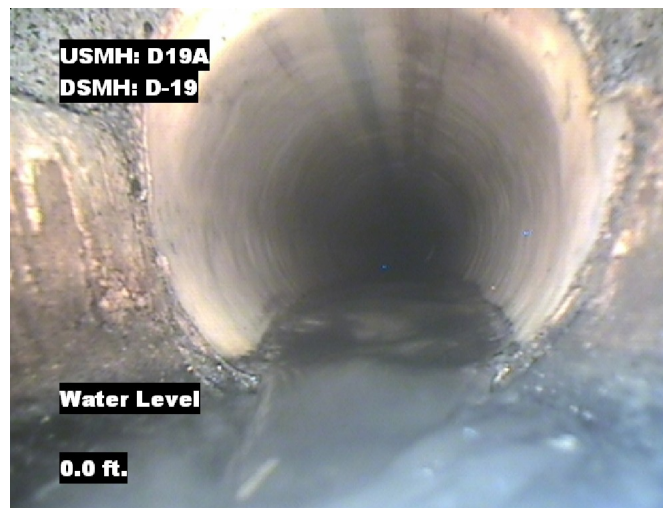
Distance: 0.0 ft. Grade: 0
Condition: Water Level
Remarks: N/A

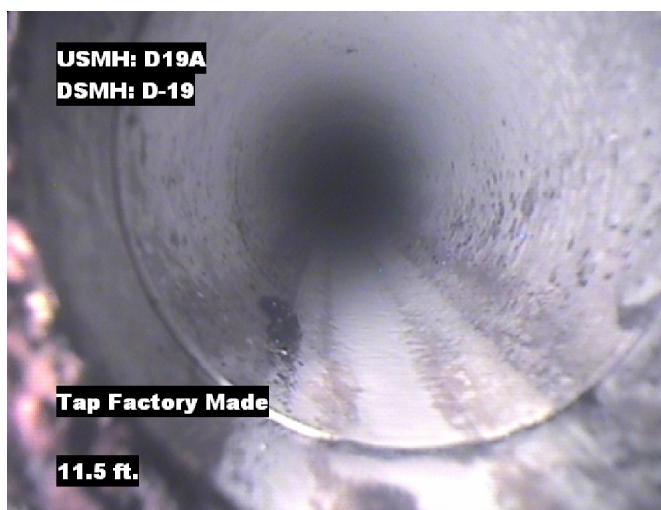
Distance: 11.5 ft. Grade: 0
Condition: Tap Factory Made
Remarks: N/A

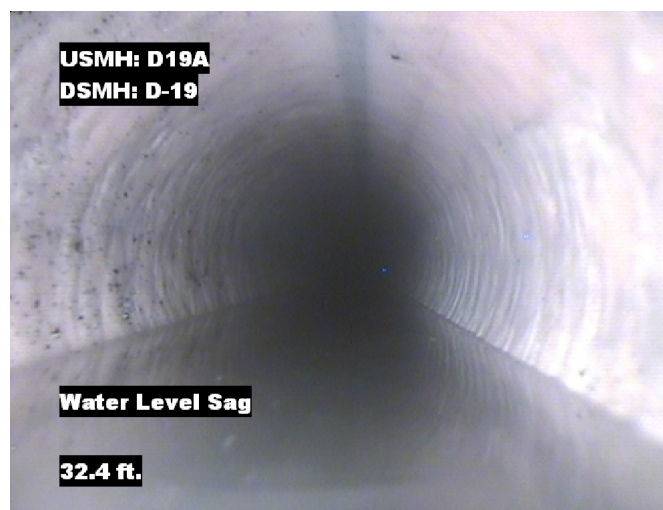
Distance: 32.4 ft. Grade: 2
Condition: Water Level Sag
Remarks: N/A

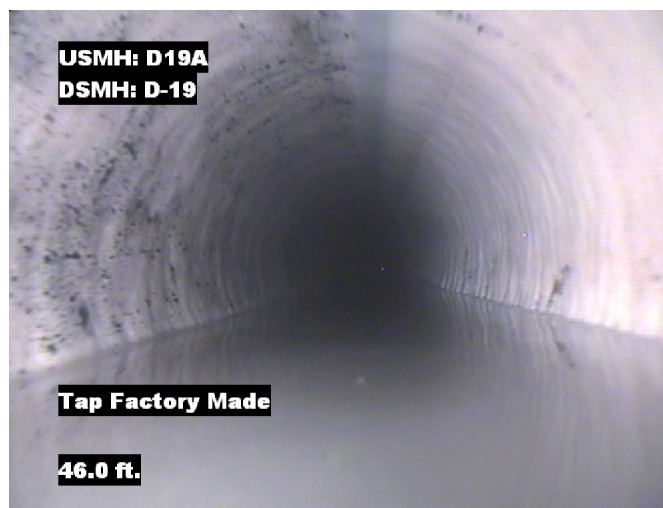
Distance: 45.9 ft. Grade: 0
Condition: Tap Factory Made
Remarks: N/A

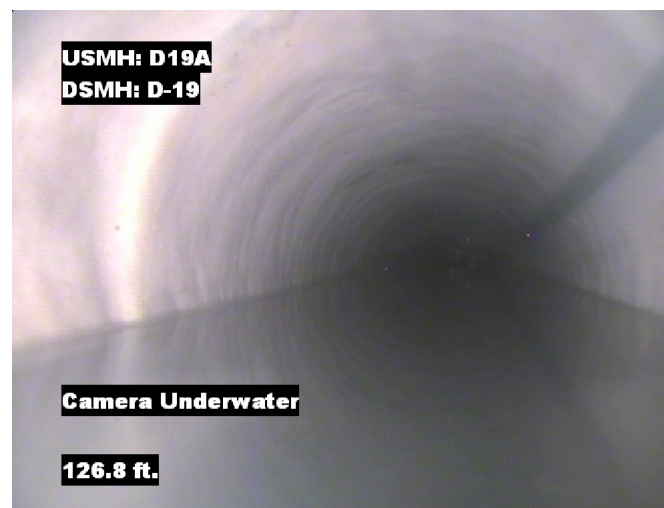
Distance: 126.8 ft. Grade: 4
Condition: Camera Underwater
Remarks: N/A

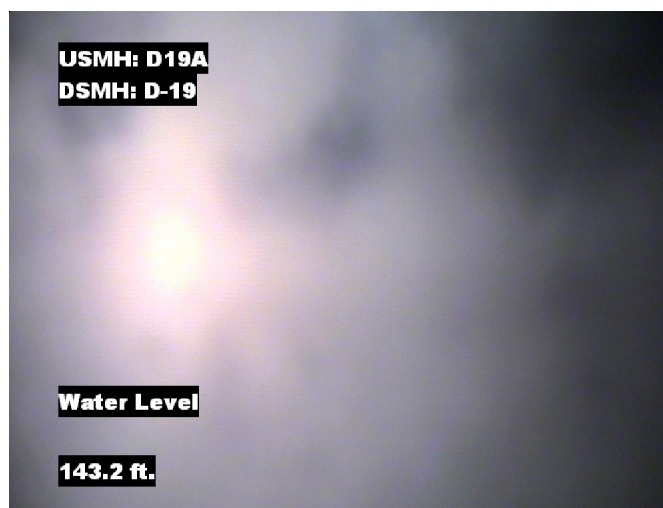
Distance: 143.2 ft. Grade: 0
Condition: Water Level
Remarks: N/A

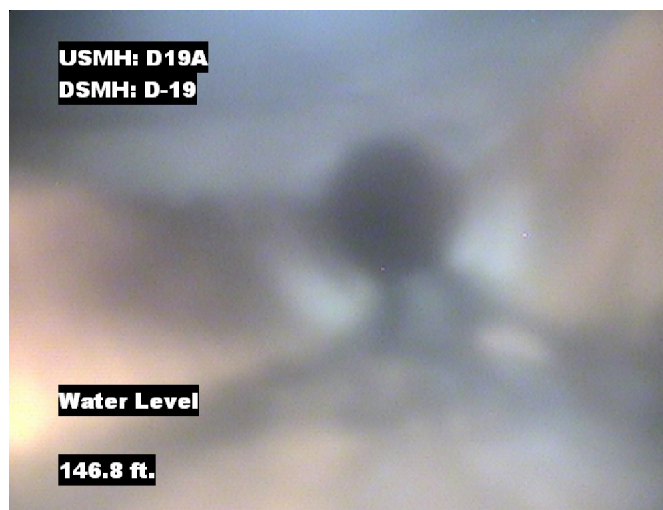
Distance: 146.8 ft. Grade: 0
Condition: Water Level
Remarks: N/A

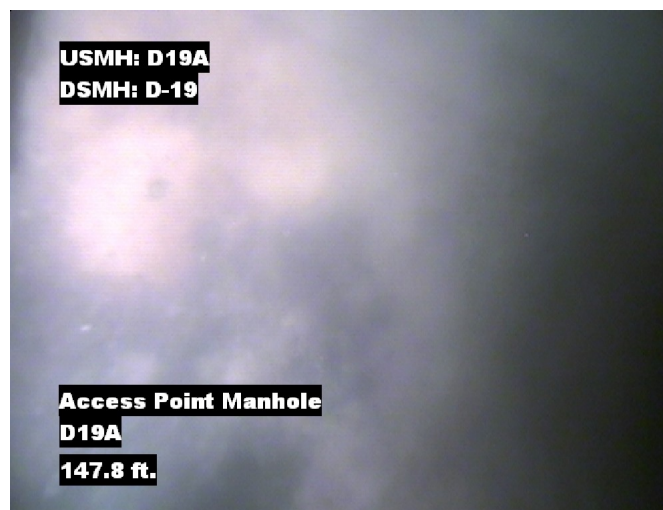
Distance: 147.8 ft. Grade: 0
Condition: Access Point Manhole
Remarks: D19A
