Defect Listing

Pipe Segment Refere		City		Street	Mat	Material		Sewer Use
D-20_D-19		Oliver Springs		Oliver St	Ot	Other		Sanitary
Upstream MH		Total Length		Year Laid	Sh	Shape		Details
D-	D-20		2.1		Circ	ular		
DS Ma	DS Manhole		surveyed	Year Renewed	Year Renewed Height		Pipe Joint	
D-	D-19		2.1		8	8	N/A	
SPR	N/A	MPR	4	PO Number 4397-03		Customer		
0001	-	MBDI						
SPRI	N/A	MPRI	2	Work Order		Pre-F		
QSR	N/A	QMR	2200	4397-02				urvey
Ol	PR	Surveyed By		Direction	Date		Media label	
4	4	Barry_Rogers		Downstream	20150625			
OF	PRI	Certificate Number		Pre-Cleaning	Time		Weather	
:	2		2-16405	Jetting	14:45		Dry	
		Date C	leaned		End Time		Additional Info	
		2015	0625		14:49

Image Report 4/Page

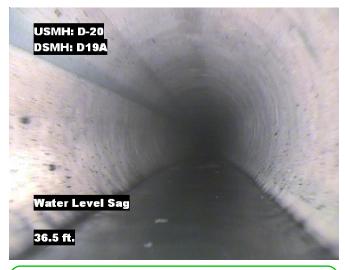
Distance: 0.0 ft. Grade: 0

Condition: Water Level

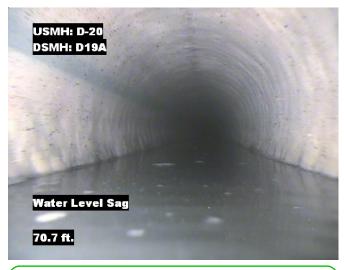
Distance: 36.4 ft. Grade: 2

Condition: Water Level Sag

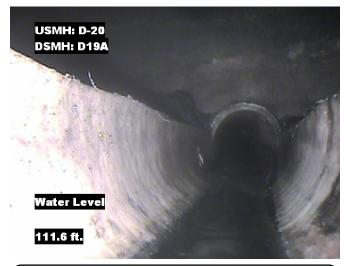
Distance: 111.6 ft. Grade:

Condition: Water Level

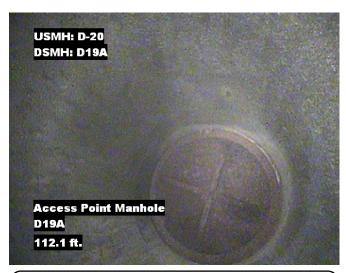
Distance: 112.1 ft. Grade: 0

Condition: Access Point Manhole

Remarks: D-19
