Defect Listing

Pipe Segment Refere... D-21_D-20	City Oliver Springs	Street Oliver	Material Concrete Pipe (non-...	Location C... Light High...	Sewer Use Sanitary
Upstream MH D-21	Total Length 211.3	Year Laid	Shape Circular	Location Details	
DS Manhole D-20	Length surveyed 211.3	Year Renewed	Height 8	Width 8	Pipe Joint... 4

Image Report 4/Page

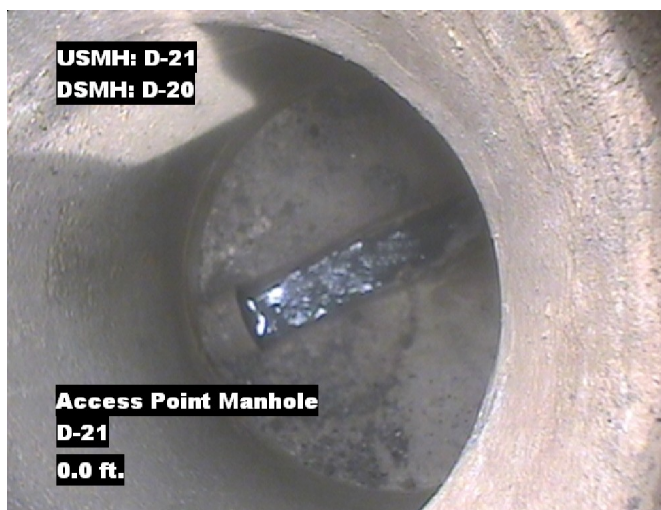
Distance: 0.0 ft. Grade: 0
Condition: Access Point Manhole
Remarks: D-21

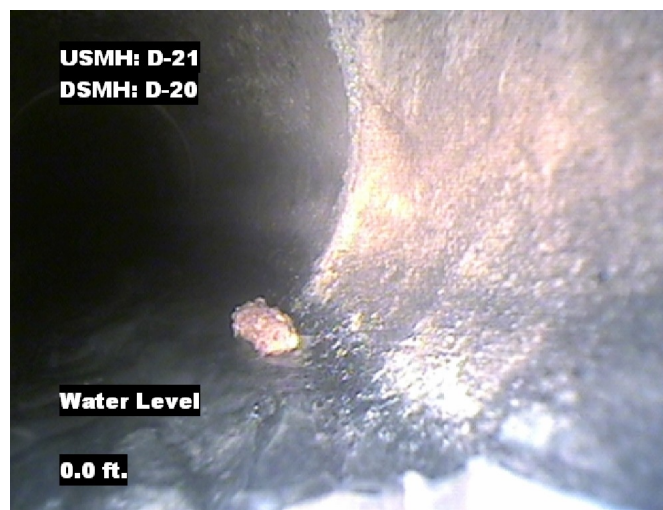
Distance: 0.0 ft. Grade: 0
Condition: Water Level
Remarks: N/A

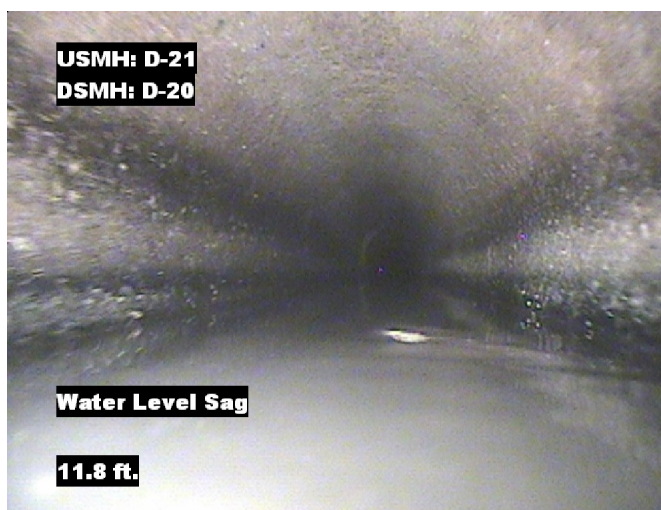
Distance: 11.7 ft. Grade: 2
Condition: Water Level Sag
Remarks: N/A

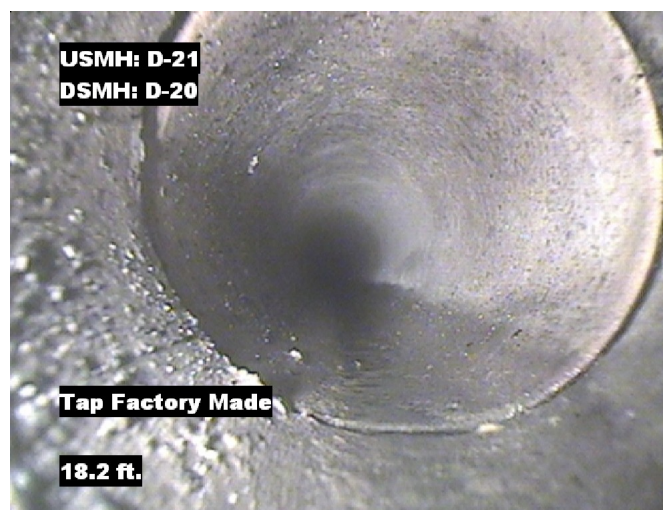
Distance: 18.2 ft. Grade: 0
Condition: Tap Factory Made
Remarks: N/A

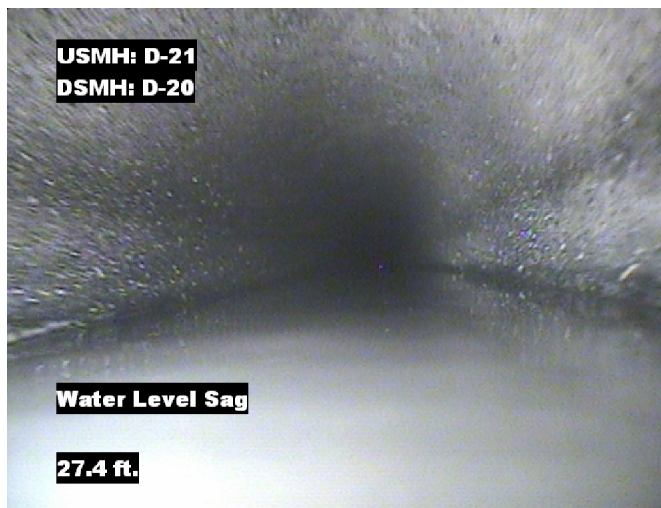
Distance: 27.4 ft. Grade: 2
Condition: Water Level Sag
Remarks: N/A

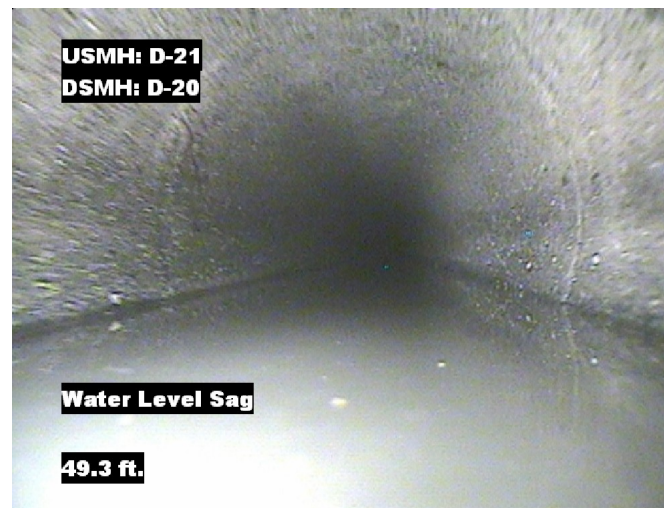
Distance: 49.2 ft. Grade: 2
Condition: Water Level Sag
Remarks: N/A

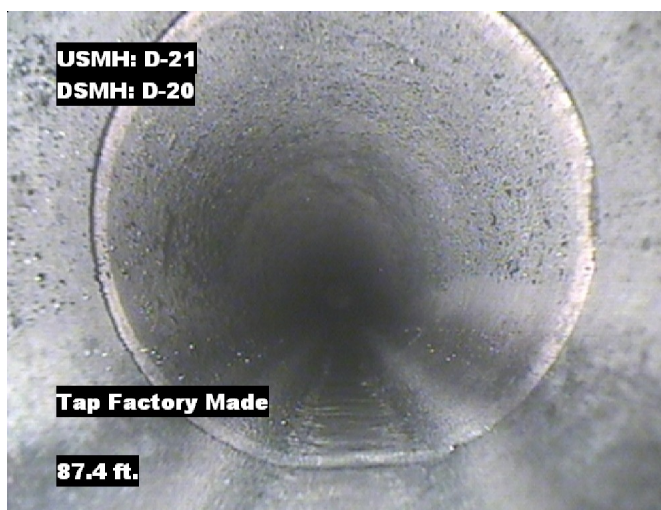
Distance: 87.4 ft. Grade: 0
Condition: Tap Factory Made
Remarks: N/A

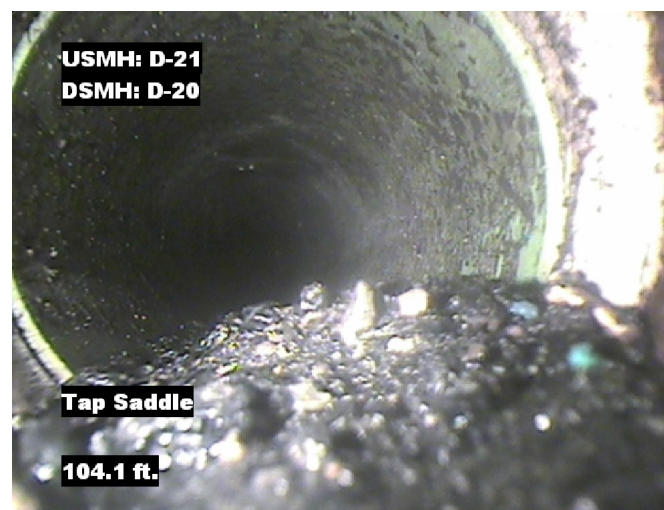
Distance: 104.1 ft. Grade: 0
Condition: Tap Saddle
Remarks: N/A

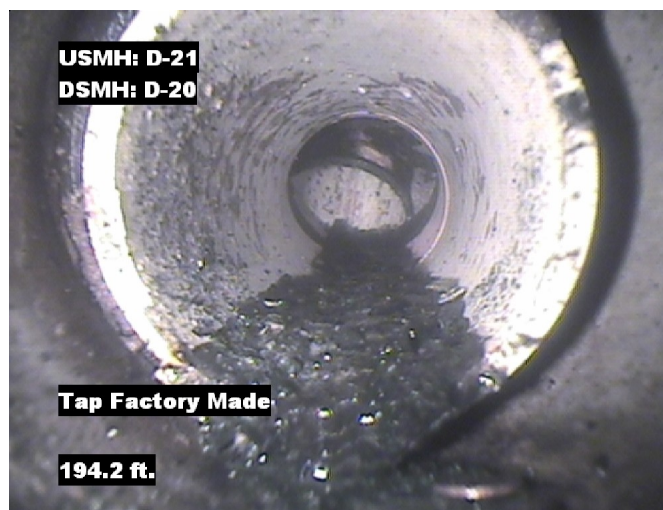
Distance: 194.2 ft. Grade: 0
Condition: Tap Factory Made
Remarks: N/A

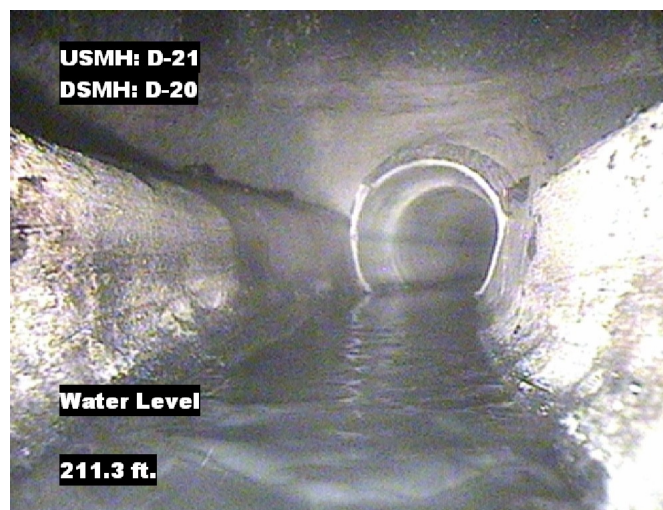
Distance: 211.3 ft. Grade: 0
Condition: Water Level
Remarks: N/A

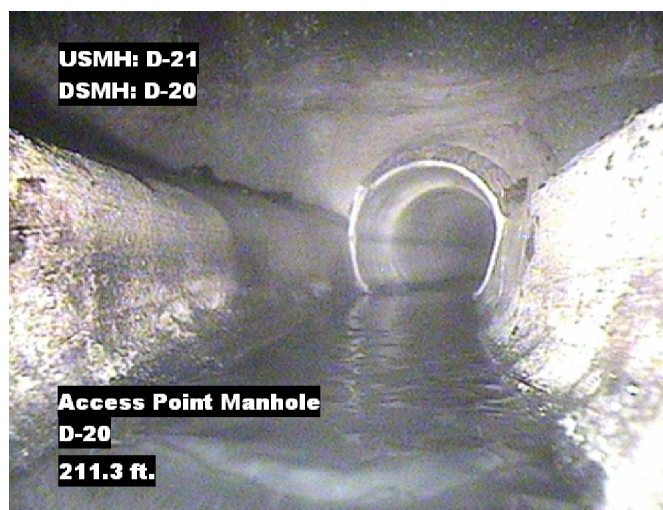
Distance: 211.3 ft. Grade: 0
Condition: Access Point Manhole
Remarks: D-20
