Defect Listing

Pipe Segment Refere...	City	Street	Material	Location C...	Sewer Use
D-22_D-21	Oliver Springs	Oliver Dr	Concrete Pipe (non-...	Light High...	Sanitary
Upstream MH	Total Length	Year Laid	Shape	Location Details	
D-22	213.4		Circular		
DS Manhole	Length surveyed	Year Renewed	Height	Width	Pipe Joint...
D-21	213.4		8	8	4

SPR	N/A	MPR	10	PO Number	Customer
SPRI	N/A	MPRI	2.5	4397-03	GRW
QSR	N/A	QMR	4123	Work Order	Purpose
				4397-02	Pre-Rehabilitation Survey
OPR	Surveyed By	Direction	Date	Media label	
10	Barry_Rogers	Downstream	20150630		
OPRI	Certificate Number	Pre-Cleaning	Time	Weather	
2.5	U-1012-16405	Jetting	06:58	Light Rain	
Date Cleaned			End Time	Additional Info	
20150626			07:10

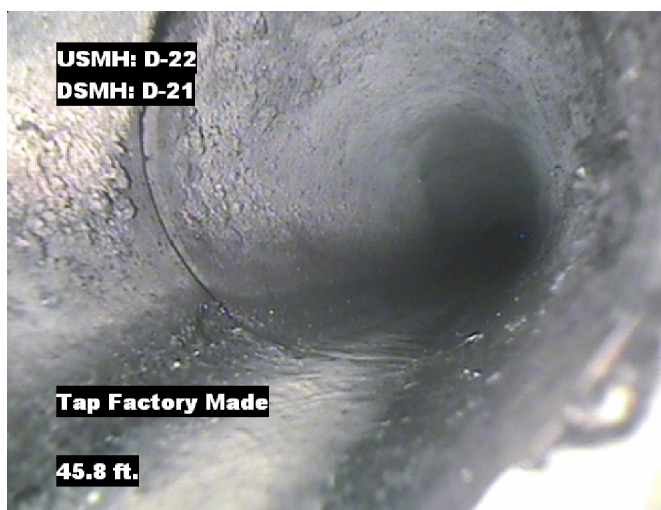
Distance: 45.8 ft. Grade: 0
Condition: Tap Factory Made
Remarks: N/A

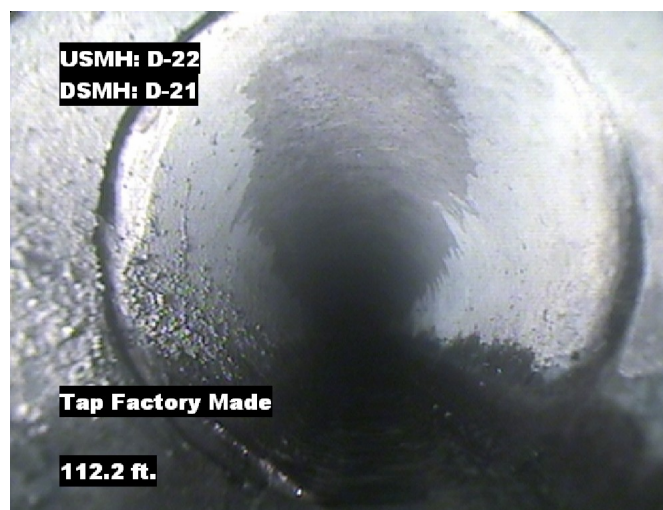
Distance: 112.2 ft. Grade: 0
Condition: Tap Factory Made
Remarks: N/A

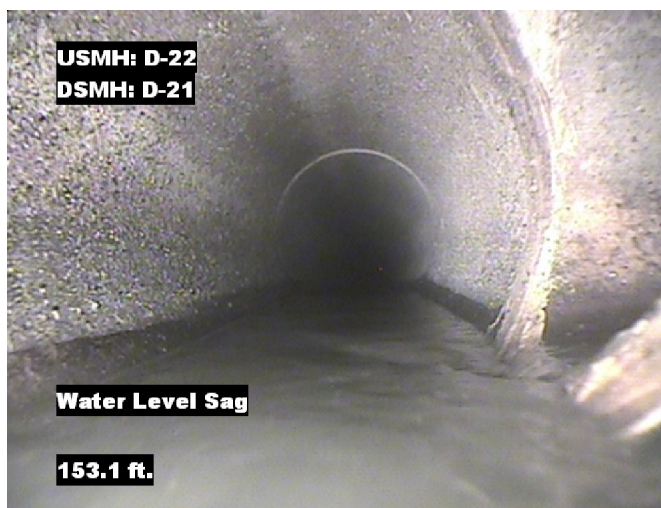
Distance: 153.1 ft. Grade: 2
Condition: Water Level Sag
Remarks: N/A

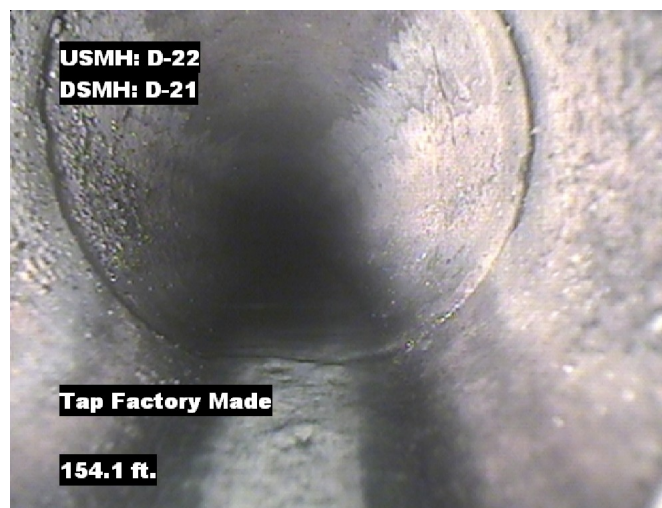
Distance: 154.1 ft. Grade: 0
Condition: Tap Factory Made
Remarks: N/A

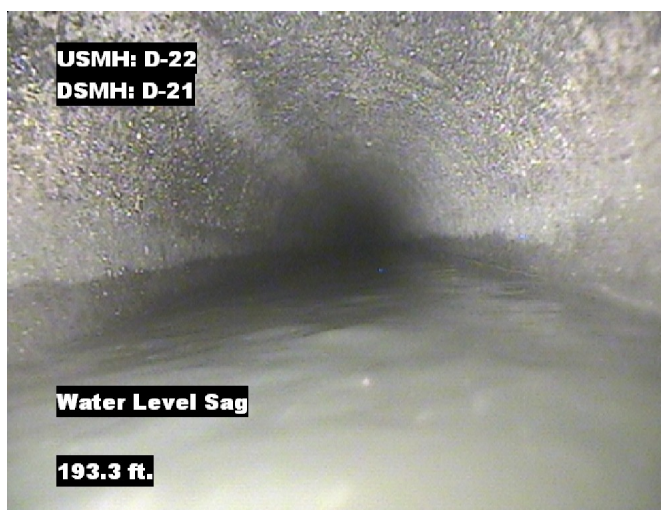
Distance: 193.3 ft. Grade: 2
Condition: Water Level Sag
Remarks: N/A

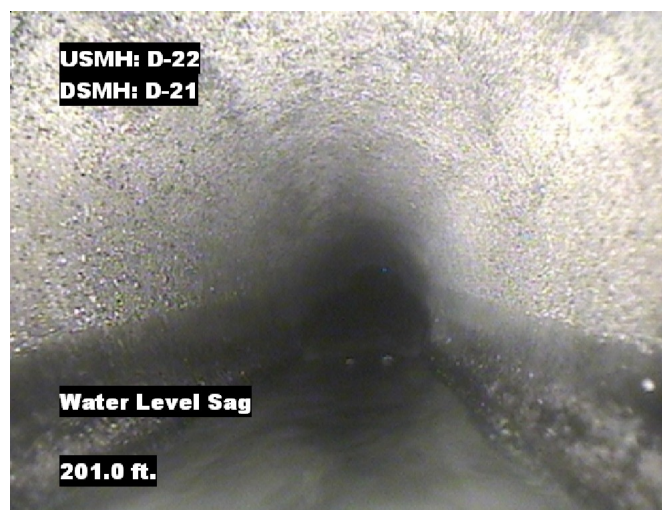
Distance: 201.0 ft. Grade: 2
Condition: Water Level Sag
Remarks: N/A

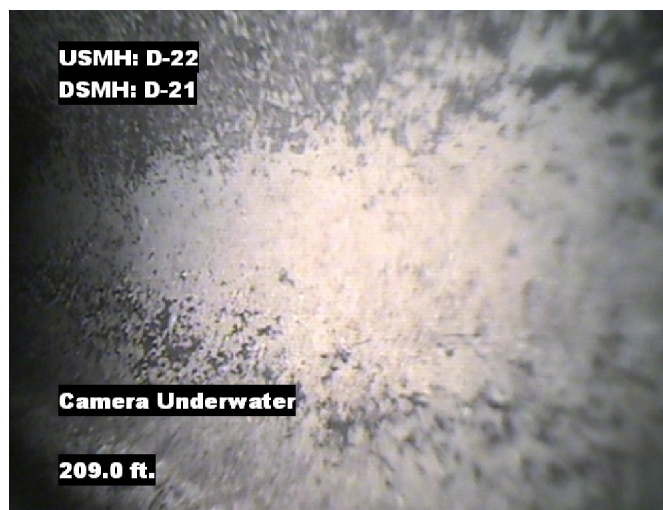
Distance: 209.0 ft. Grade: 4
Condition: Camera Underwater
Remarks: N/A
