## Defect Listing

Pipe Segment Refere...	City	Street	Material	Location C...	Sewer Use
D-23_D-22	Oliver Springs	Oliver DR	Concrete Pipe (non-...	Light High...	Sanitary
Upstream MH	Total Length	Year Laid	Shape	Location Details	
D-23	266.6		Circular		
DS Manhole	Length surveyed	Year Renewed	Height	Width	Pipe Joint...
D-22	266.6		8	8	4

SPR	4	MPR	18	PO Number	Customer
SPRI	2	MPRI	2.6	4397-03	GRW
QSR	3111	QMR	4231	Work Order	Purpose
				4397-02	Pre-Rehabilitation Survey
OPR		Surveyed By	Direction	Date	Media label
22		Barry Rogers	Downstream	20150624	
OPRI		Certificate Number	Pre-Cleaning	Time	Weather
2.4		U-1012-16405	Heavy Cleaning	15:03	Dry
		Date Cleaned		End Time	Additional Info
		20150624		15:24

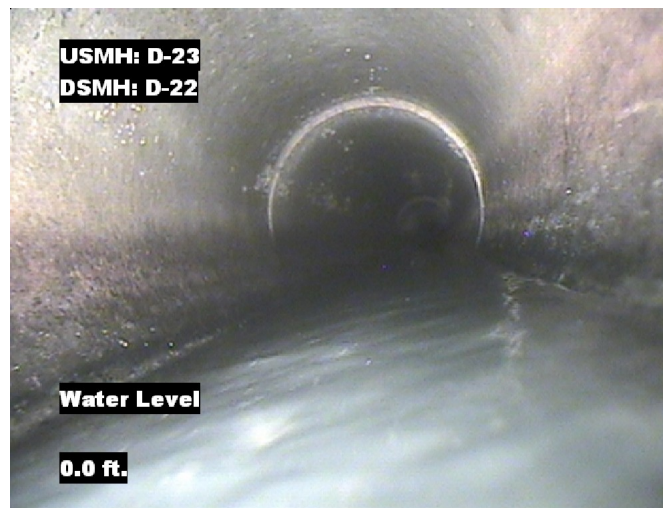
Distance: 0.0 ft. Grade: 0  
Condition: Water Level  
Remarks: N/A

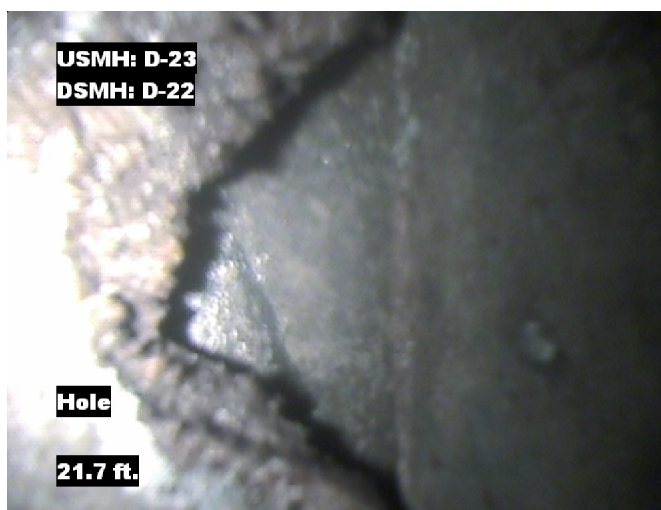
Distance: 21.7 ft. Grade: 3  
Condition: Hole  
Remarks: N/A

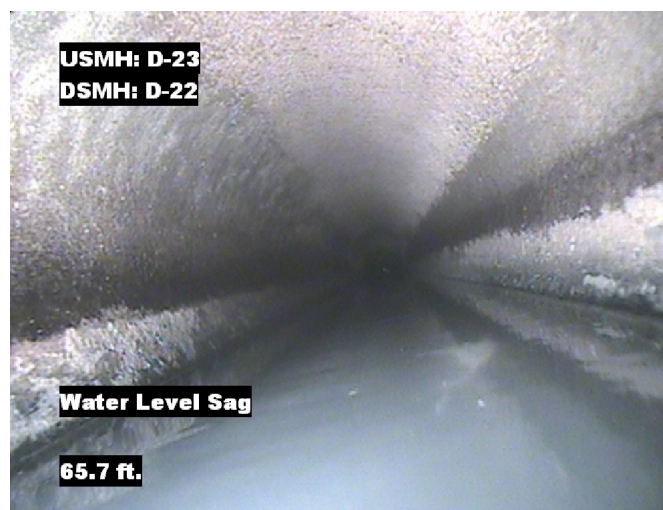
Distance: 65.7 ft. Grade: 2  
Condition: Water Level Sag  
Remarks: N/A

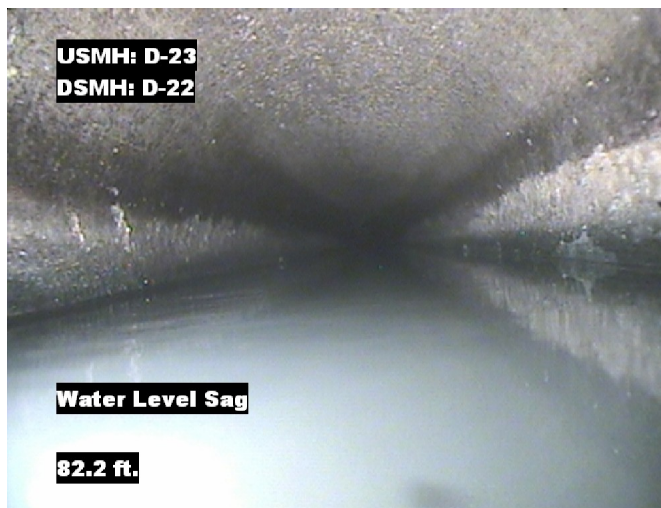
Distance: 82.2 ft. Grade: 3  
Condition: Water Level Sag  
Remarks: N/A

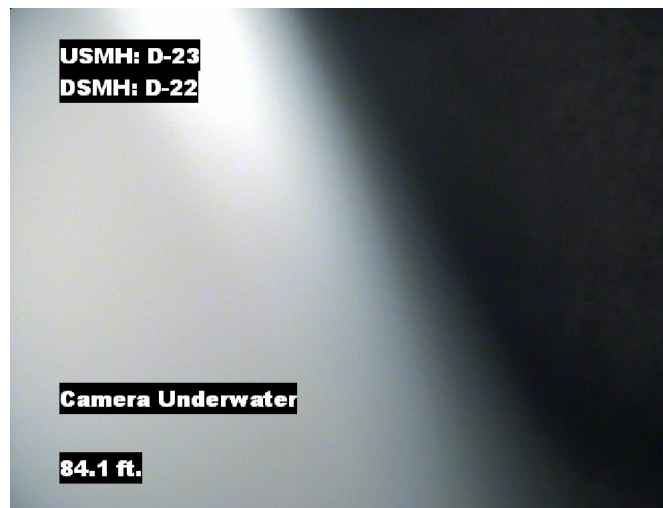
Distance: 84.1 ft. Grade: 4  
Condition: Camera Underwater  
Remarks: N/A

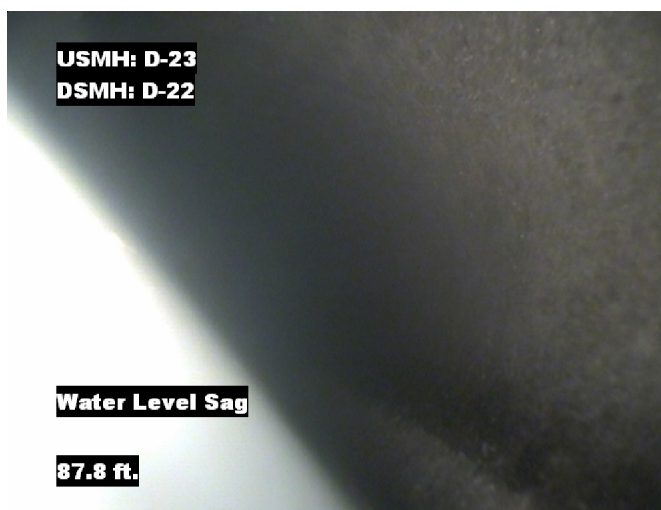
Distance: 87.8 ft. Grade: 4  
Condition: Water Level Sag  
Remarks: N/A

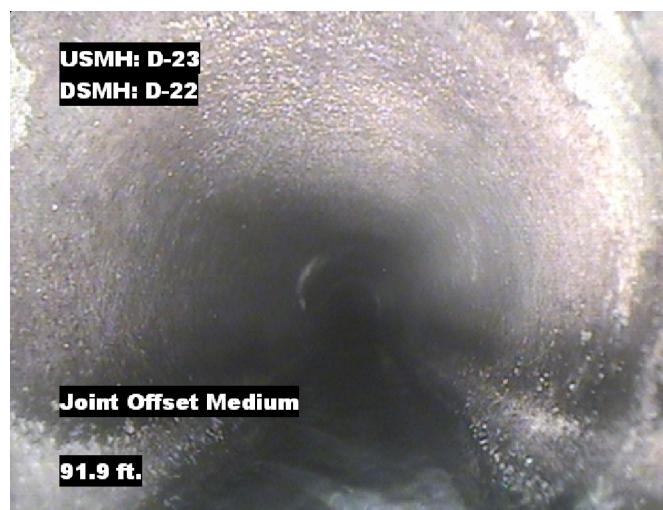
Distance: 91.9 ft. Grade: 1  
Condition: Joint Offset Medium  
Remarks: N/A

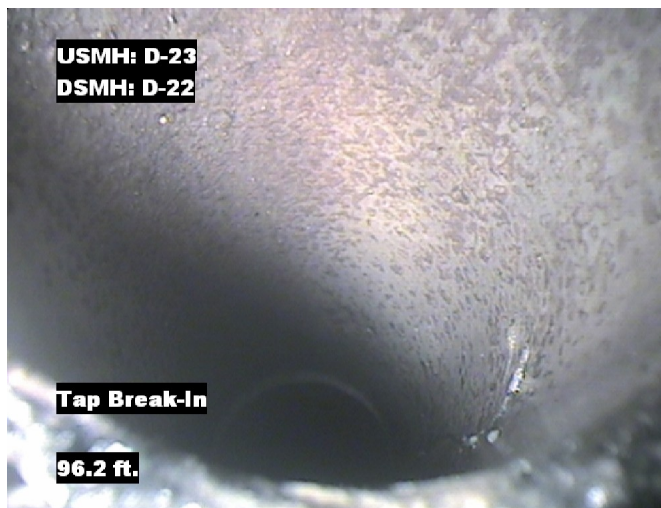
Distance: 96.2 ft. Grade: 0  
Condition: Tap Break-In  
Remarks: N/A

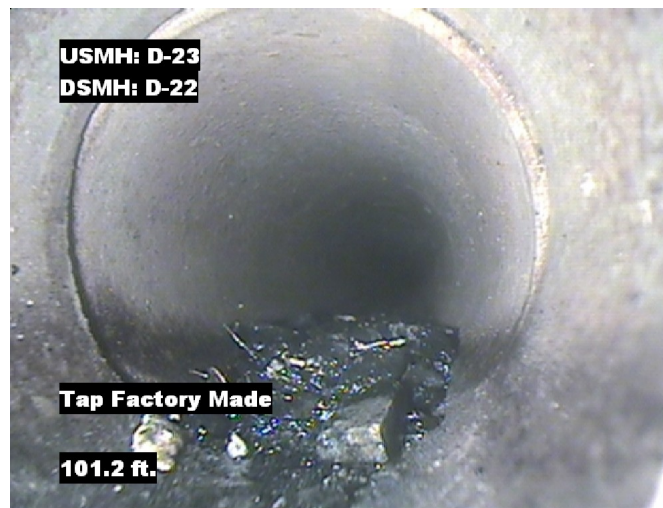
Distance: 101.2 ft. Grade: 0  
Condition: Tap Factory Made  
Remarks: N/A

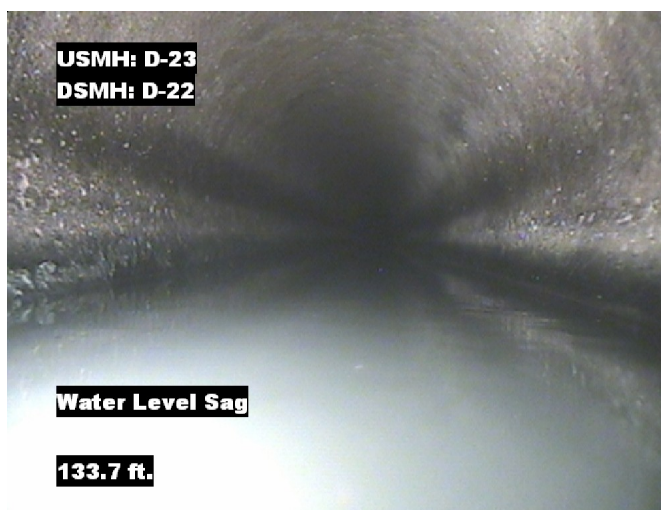
Distance: 133.7 ft. Grade: 2  
Condition: Water Level Sag  
Remarks: N/A

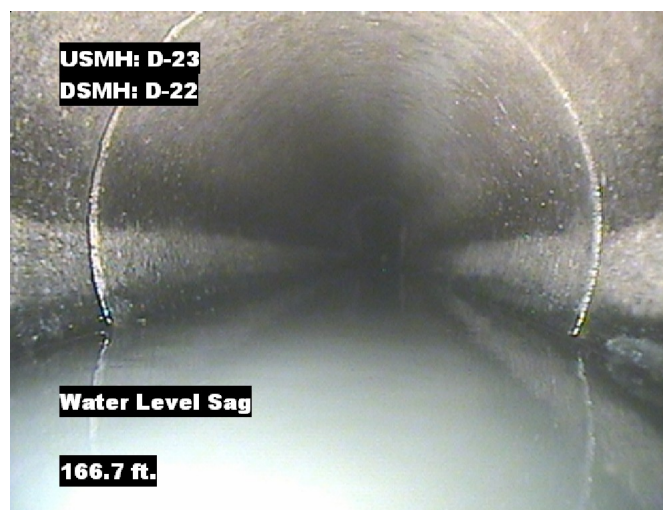
Distance: 166.7 ft. Grade: 2  
Condition: Water Level Sag  
Remarks: N/A

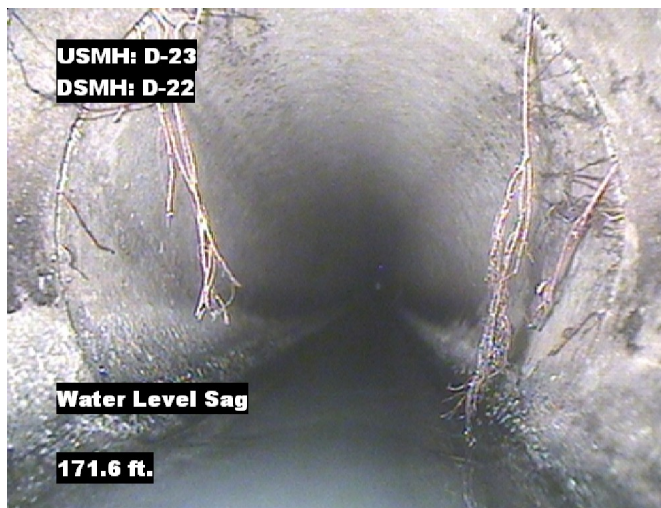
Distance: 171.6 ft. Grade: 2  
Condition: Water Level Sag  
Remarks: N/A

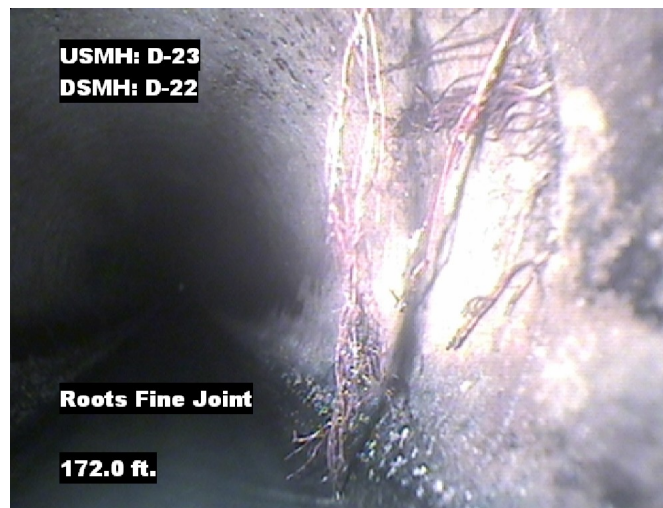
Distance: 172.0 ft. Grade: 1  
Condition: Roots Fine Joint  
Remarks: N/A

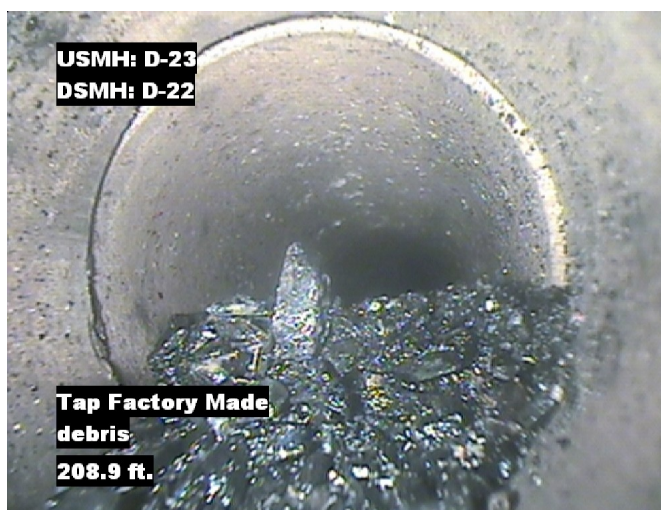
Distance: 208.9 ft. Grade: 0  
Condition: Tap Factory Made  
Remarks: debris

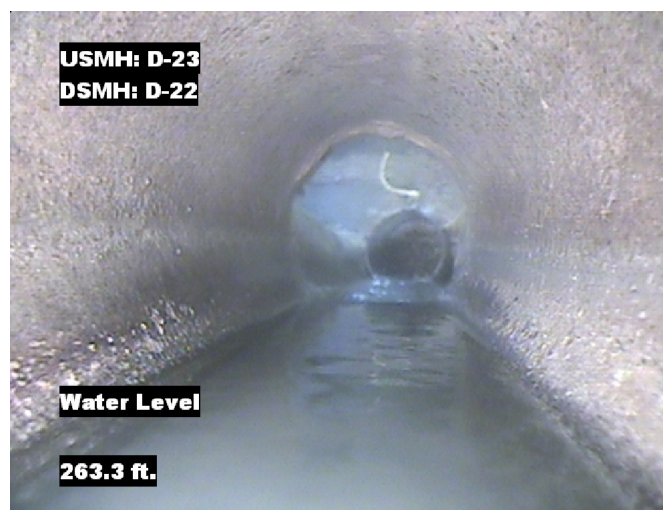
Distance: 263.3 ft. Grade: 0  
Condition: Water Level  
Remarks: N/A
