Defect Listing

Pipe Segment Refere... D-24_D-23	City Oliver Springs	Street Oliver DR	Material Concrete Pipe (non-...	Location C... Light High...	Sewer Use Sanitary
Upstream MH D-24	Total Length 326.1	Year Laid	Shape Circular	Location Details	
DS Manhole D-23	Length surveyed 326.1	Year Renewed	Height 8	Width 8	Pipe Joint... 4

Image Report 4/Page

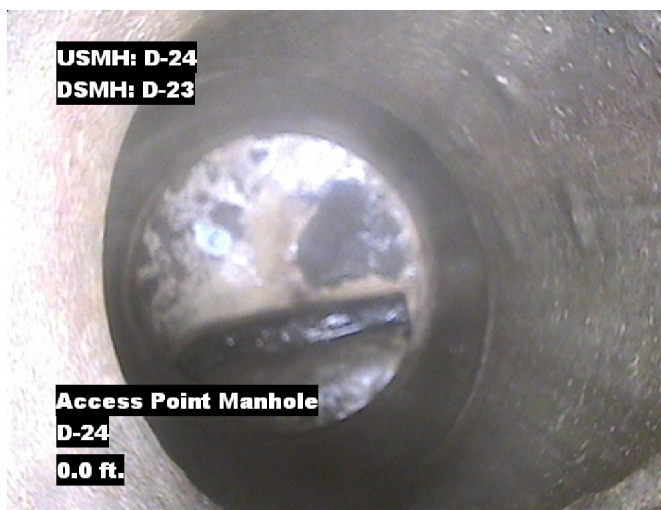
Distance: 0.0 ft. Grade: 0
Condition: Access Point Manhole
Remarks: D-24

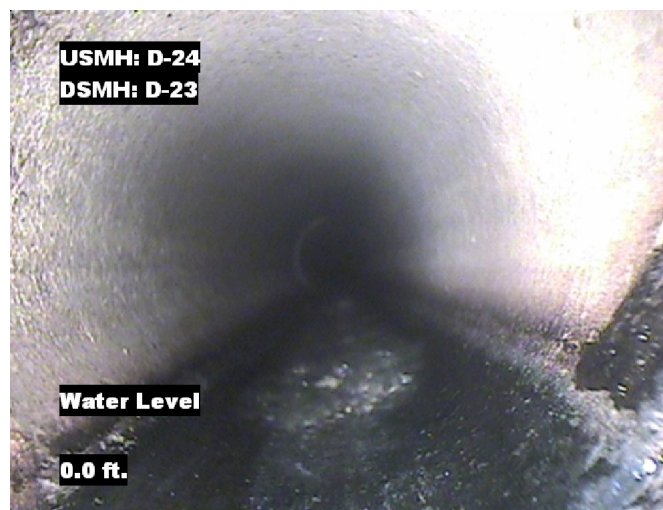
Distance: 0.0 ft. Grade: 0
Condition: Water Level
Remarks: N/A

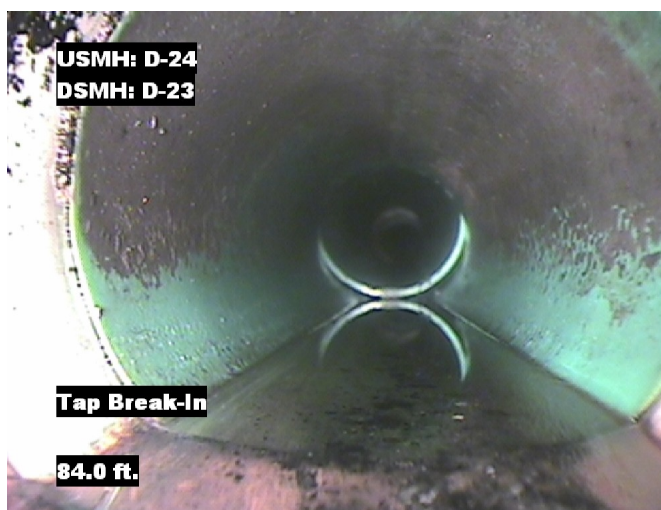
Distance: 84.0 ft. Grade: 0
Condition: Tap Break-In
Remarks: N/A

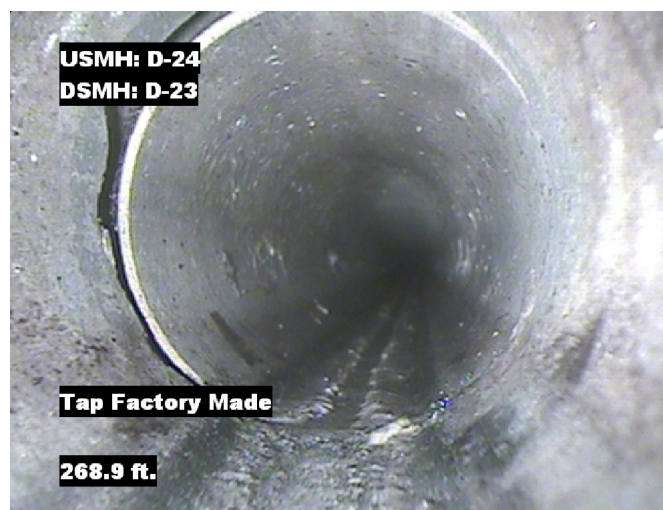
Distance: 268.9 ft. Grade: 0
Condition: Tap Factory Made
Remarks: N/A

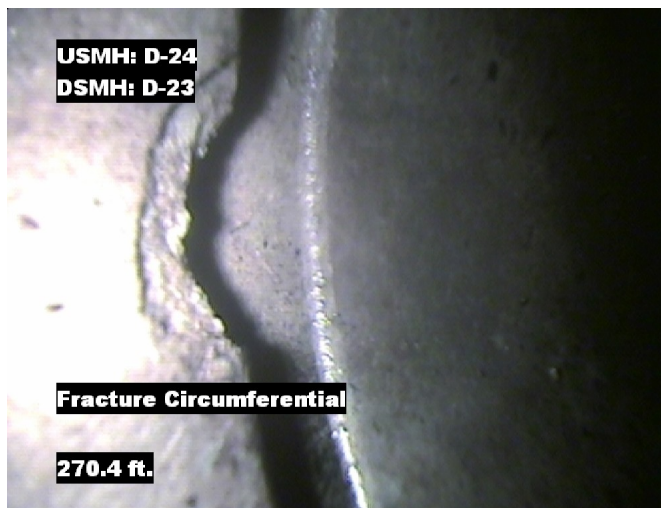
Distance: 270.4 ft. Grade: 2
Condition: Fracture Circumferential
Remarks: N/A

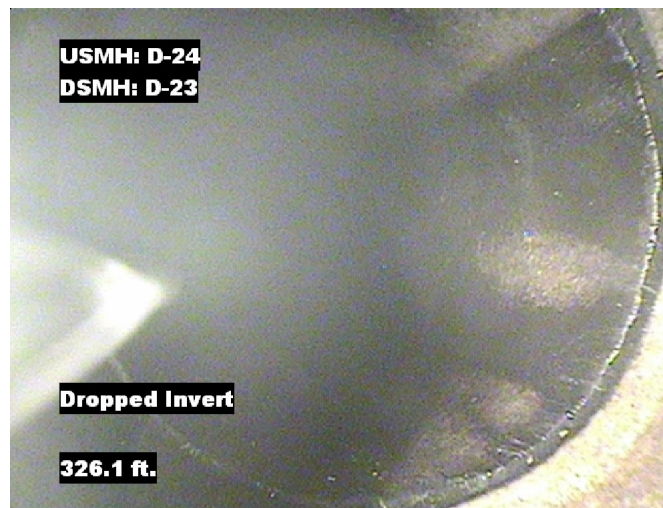
Distance: 326.1 ft. Grade: 5
Condition: Dropped Invert
Remarks: N/A

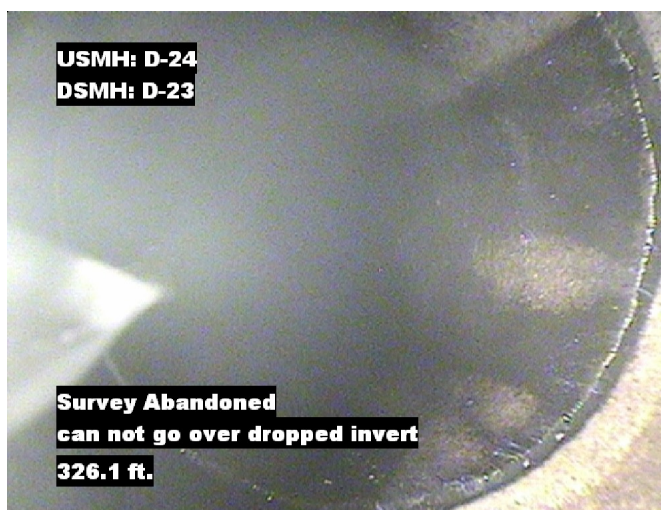
Distance: 326.1 ft. Grade: 0
Condition: Survey Abandoned
Remarks: can not go over dropped invert
