## Defect Listing

Pipe Segment Refere...	City	Street	Material	Location C...	Sewer Use
<b>D-25_D-24</b>	<b>Oliver Springs</b>	<b>Oliver Dr</b>	<b>Concrete Pipe (non-...</b>	<b>Light High...</b>	<b>Sanitary</b>
Upstream MH	Total Length	Year Laid	Shape	Location Details	
<b>D-25</b>	<b>305.4</b>		<b>Circular</b>		
DS Manhole	Length surveyed	Year Renewed	Height	Width	Pipe Joint...
<b>D-24</b>	<b>305.4</b>		<b>8</b>	<b>8</b>	<b>4</b>

SPR	N/A	MPR	2	PO Number	Customer
SPRI	N/A	MPRI	2	<b>4397-03</b>	<b>GRW</b>
QSR	N/A	QMR	2100	Work Order	Purpose
				<b>4397-02</b>	<b>Pre-Rehabilitation Survey</b>
OPR	Surveyed By	Direction	Date	Media label	
<b>2</b>	<b>Barry Rogers</b>	<b>Downstream</b>	<b>20150623</b>		
OPRI	Certificate Number	Pre-Cleaning	Time	Weather	
<b>2</b>	<b>U-1012-16405</b>	<b>Jetting</b>	<b>14:59</b>	<b>Dry</b>	
Date Cleaned			End Time	Additional Info	
<b>20150623</b>			<b>15:09</b>

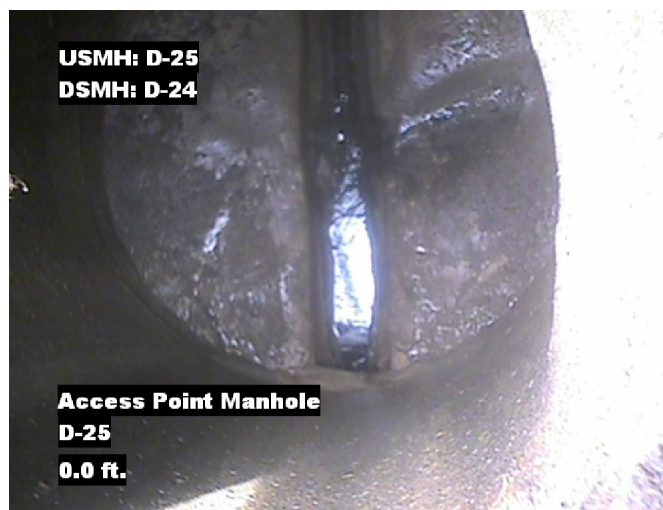
Distance: 0.0 ft. Grade: 0  
Condition: Access Point Manhole  
Remarks: D-25

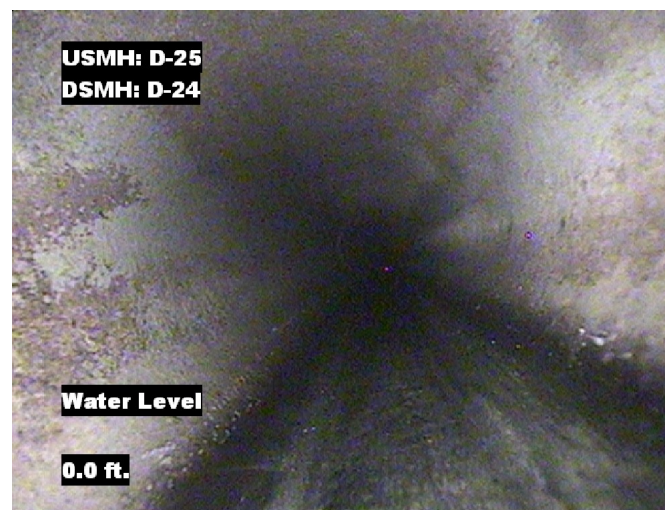
Distance: 0.0 ft. Grade: 0  
Condition: Water Level  
Remarks: N/A

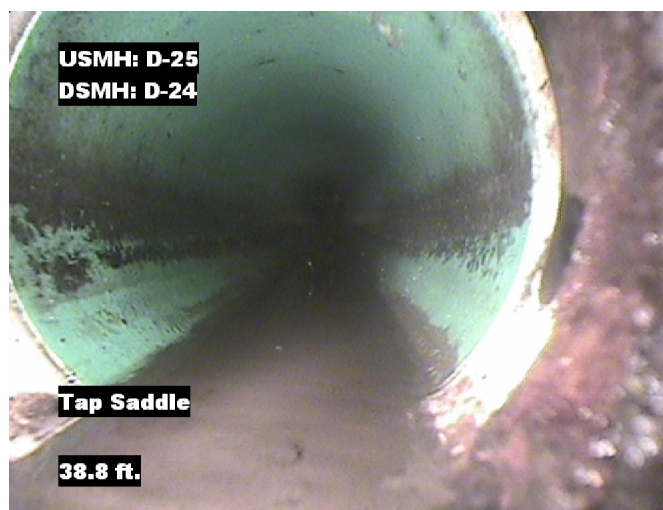
Distance: 38.8 ft. Grade: 0  
Condition: Tap Saddle  
Remarks: N/A

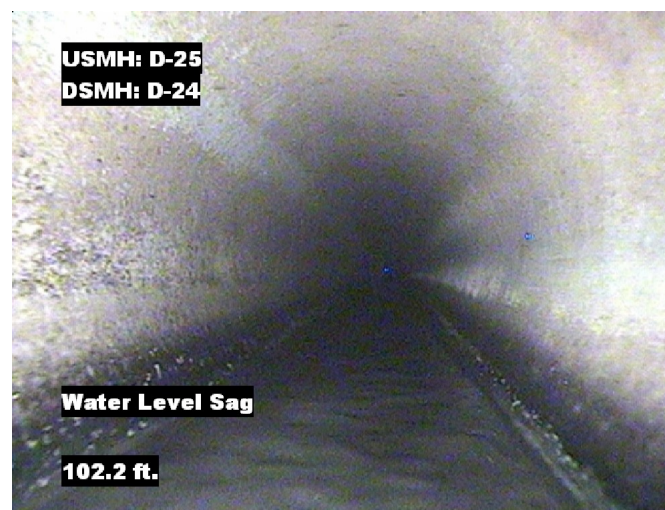
Distance: 102.2 ft. Grade: 2  
Condition: Water Level Sag  
Remarks: N/A

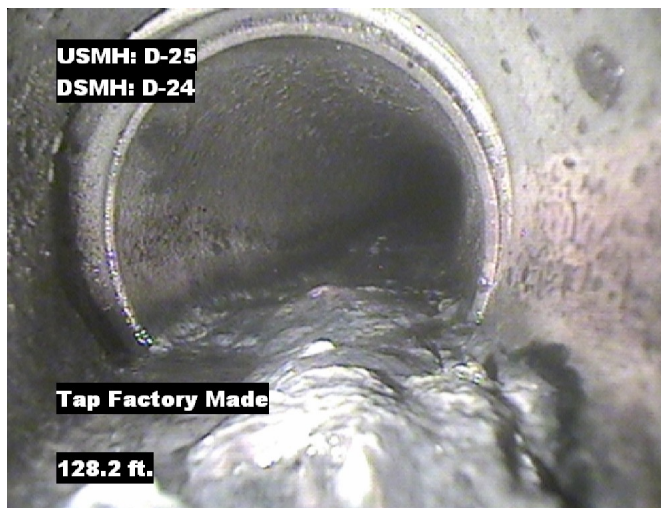
Distance: 128.2 ft. Grade: 0  
Condition: Tap Factory Made  
Remarks: N/A

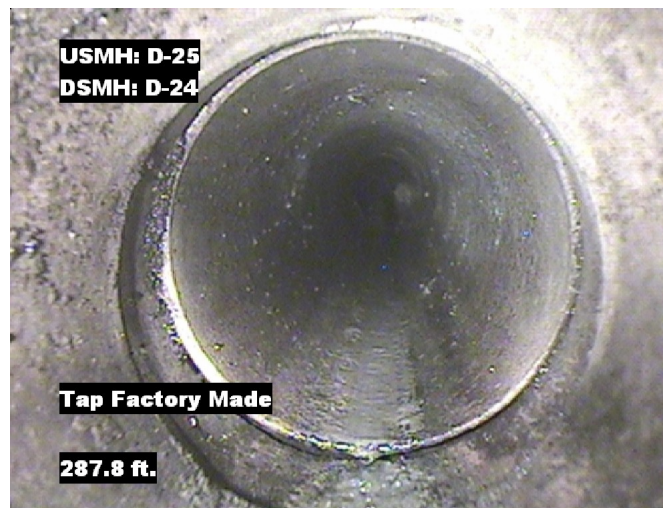
Distance: 287.8 ft. Grade: 0  
Condition: Tap Factory Made  
Remarks: N/A

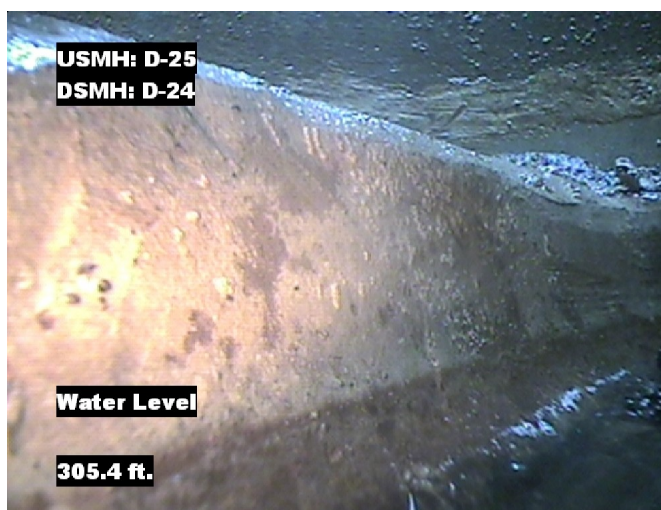
Distance: 305.4 ft. Grade: 0  
Condition: Water Level  
Remarks: N/A

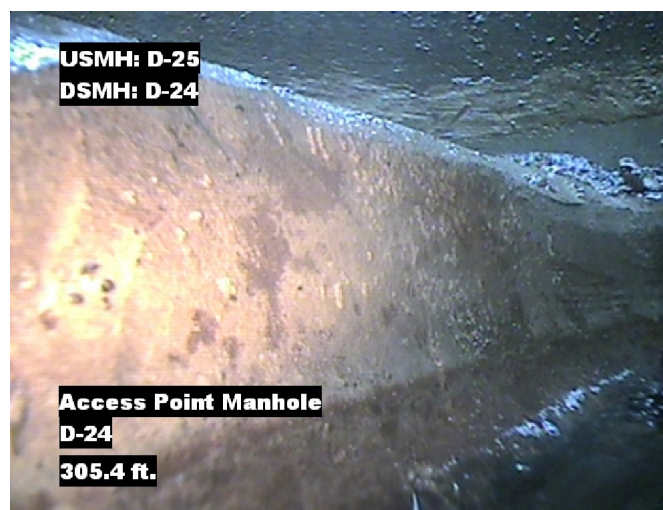
Distance: 305.4 ft. Grade: 0  
Condition: Access Point Manhole  
Remarks: D-24
