## Defect Listing

Pipe Segment Refere... <b>D-26_D-25</b>	City <b>Oliver Springs</b>	Street <b>Oliver Dr</b>	Material <b>Concrete Pipe (non-...</b>	Location C... <b>Light High...</b>	Sewer Use <b>Sanitary</b>
Upstream MH <b>D-26</b>	Total Length <b>84.6</b>	Year Laid	Shape <b>Circular</b>	Location Details	
DS Manhole <b>D-25</b>	Length surveyed <b>84.6</b>	Year Renewed	Height <b>8</b>	Width <b>8</b>	Pipe Joint... <b>4</b>

SPR <b>N/A</b>	MPR <b>2</b>	PO Number <b>4397-03</b>	Customer <b>GRW</b>
SPRI <b>N/A</b>	MPRI <b>2</b>	Work Order <b>4397-02</b>	Purpose <b>Pre-Rehabilitation Survey</b>
QSR <b>N/A</b>	QMR <b>2100</b>		
OPR <b>2</b>	Surveyed By <b>Barry Rogers</b>	Direction <b>Downstream</b>	Date <b>20150623</b>
OPRI <b>2</b>	Certificate Number <b>U-1012-16405</b>	Pre-Cleaning <b>Jetting</b>	Time <b>14:26</b>
	Date Cleaned <b>20150623</b>	End Time <b>14:33</b>	Weather <b>Dry</b>
			Media label
			Additional Info

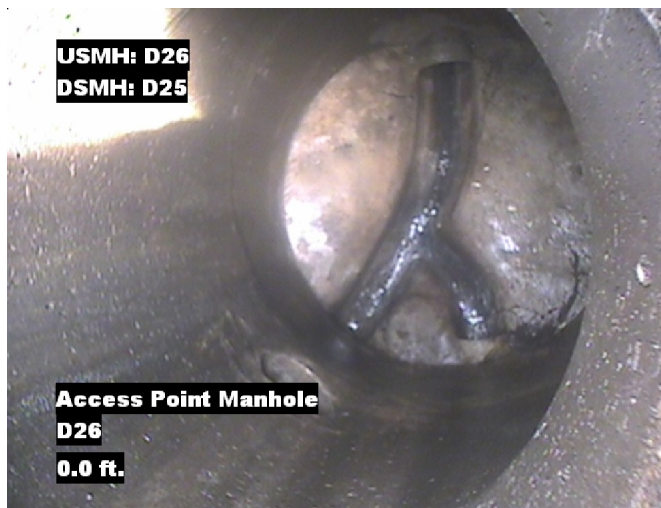
Distance: 0.0 ft. Grade: 0  
Condition: Access Point Manhole  
Remarks: D-26

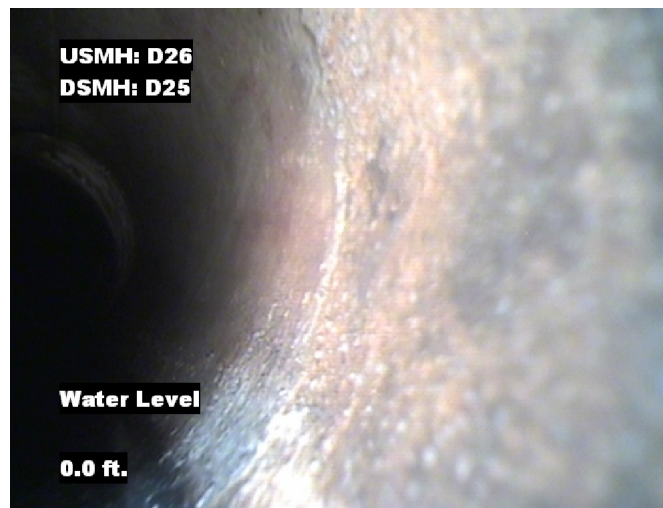
Distance: 0.0 ft. Grade: 0  
Condition: Water Level  
Remarks: N/A

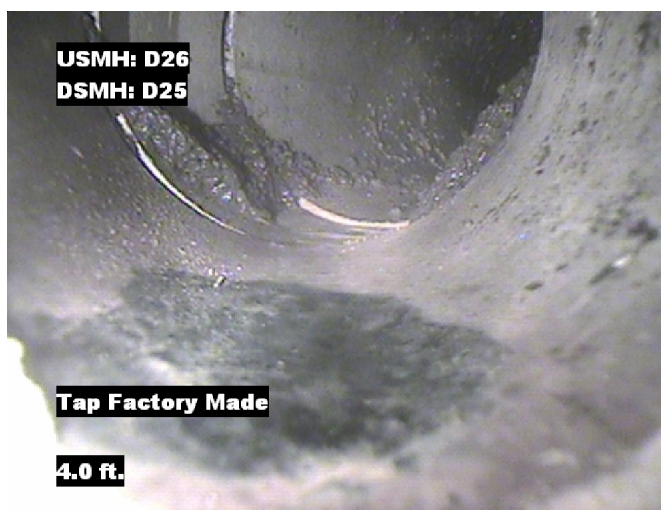
Distance: 4.0 ft. Grade: 0  
Condition: Tap Factory Made  
Remarks: N/A

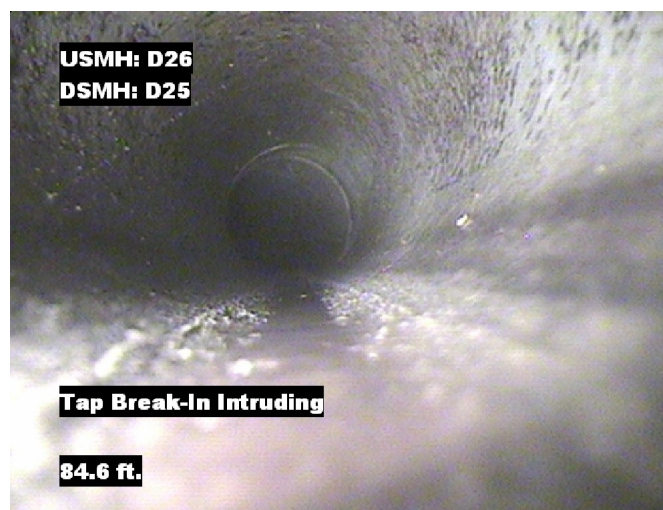
Distance: 84.6 ft. Grade: 2  
Condition: Tap Break-In Intruding  
Remarks: N/A

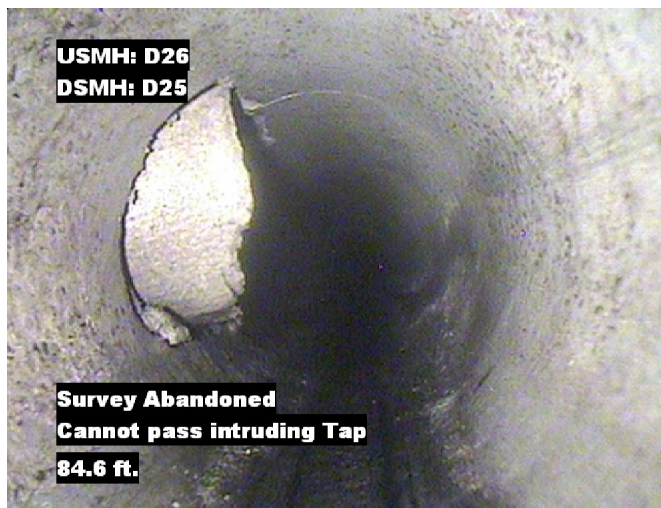
Distance: 84.6 ft. Grade: 0  
Condition: Survey Abandoned  
Remarks: Cannot pass intruding Tap
