## Defect Listing

Pipe Segment Refere... <b>D-27_D-26</b>	City <b>Oliver Springs</b>	Street <b>Oliver DR</b>	Material <b>Concrete Pipe (non-...</b>	Location C... <b>Light High...</b>	Sewer Use <b>Sanitary</b>
Upstream MH <b>D-27</b>	Total Length <b>326.2</b>	Year Laid	Shape <b>Circular</b>	Location Details <b>Oliver DR 411</b>	
DS Manhole <b>D-26</b>	Length surveyed <b>159.8</b>	Year Renewed	Height <b>8</b>	Width <b>8</b>	Pipe Joint... <b>4</b>

SPR <b>N/A</b>	MPR <b>2</b>	PO Number <b>4397-03</b>	Customer <b>GRW</b>
SPRI <b>N/A</b>	MPRI <b>2</b>	Work Order <b>4397-02</b>	Purpose <b>Pre-Rehabilitation Survey</b>
QSR <b>N/A</b>	QMR <b>2100</b>		
OPR <b>2</b>	Surveyed By <b>Barry Rogers</b>	Direction <b>Upstream</b>	Date <b>20150623</b>
OPRI <b>2</b>	Certificate Number <b>U-1012-16405</b>	Pre-Cleaning <b>Jetting</b>	Time <b>14:39</b>
	Date Cleaned <b>20150623</b>	End Time <b>14:46</b>	Weather <b>Dry</b>
			Additional Info

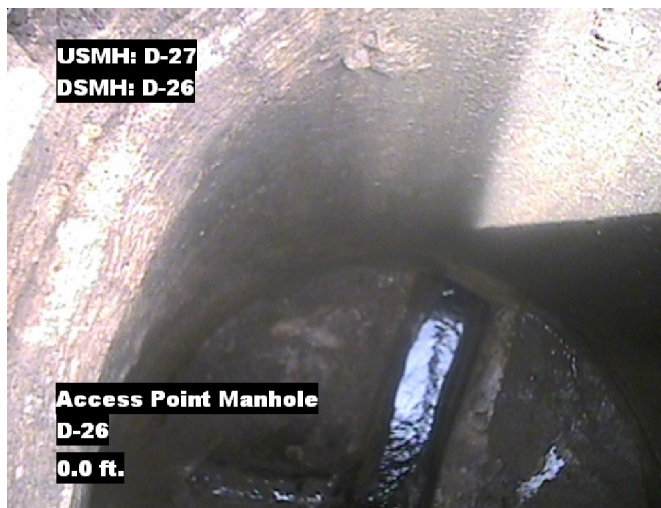
Distance: 0.0 ft. Grade: 0  
Condition: Access Point Manhole  
Remarks: D-26

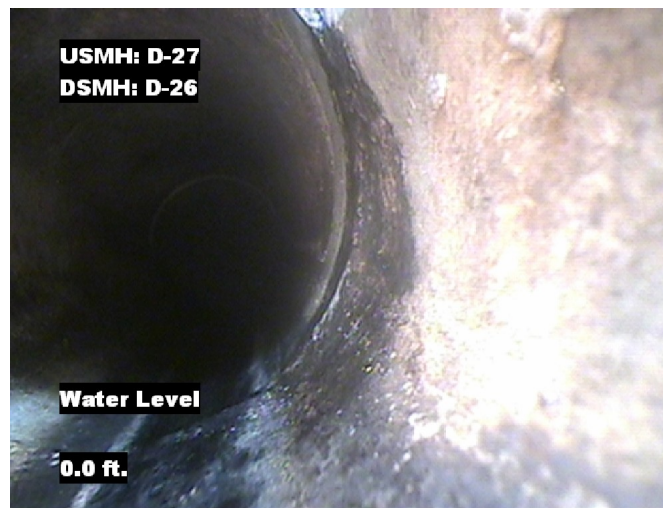
Distance: 0.0 ft. Grade: 0  
Condition: Water Level  
Remarks: N/A

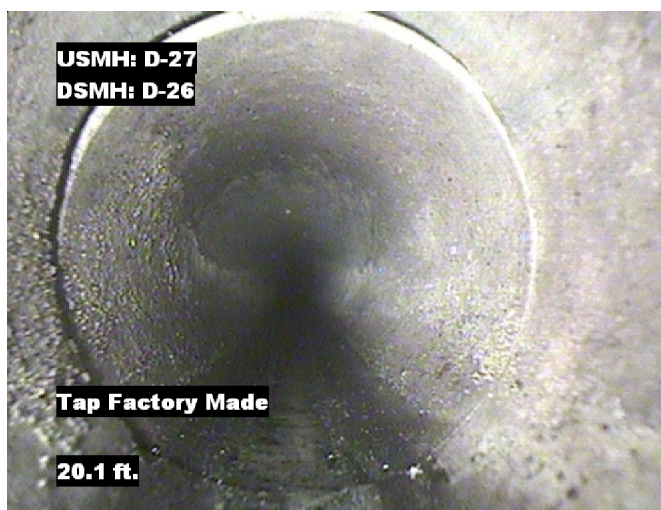
Distance: 20.1 ft. Grade: 0  
Condition: Tap Factory Made  
Remarks: N/A

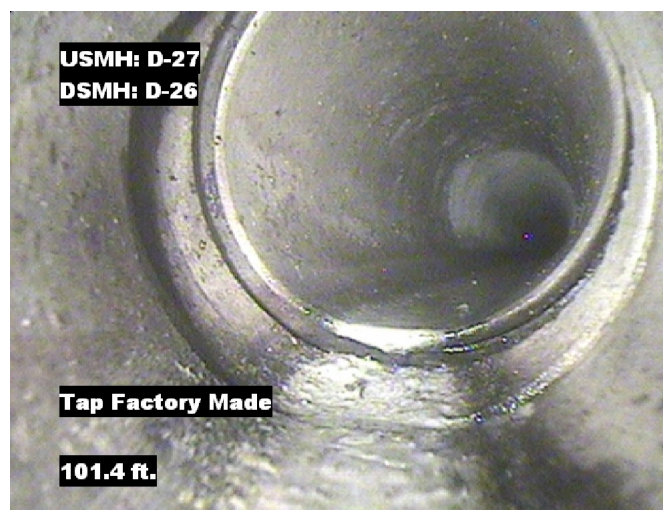
Distance: 101.4 ft. Grade: 0  
Condition: Tap Factory Made  
Remarks: N/A

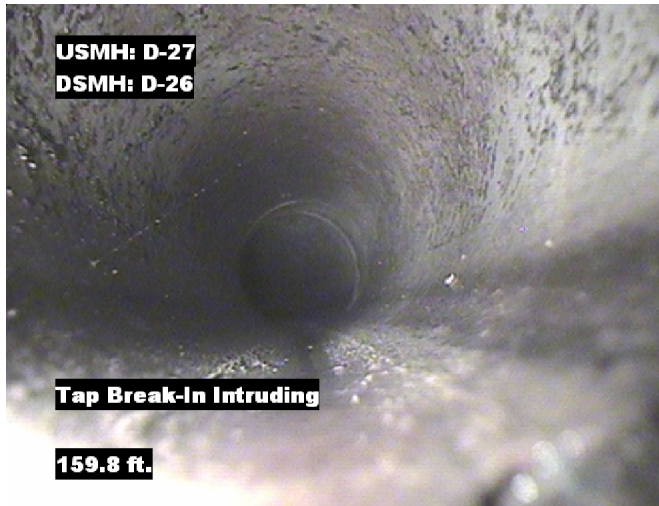
Distance: 159.8 ft. Grade: 2  
Condition: Tap Break-In Intruding  
Remarks: N/A

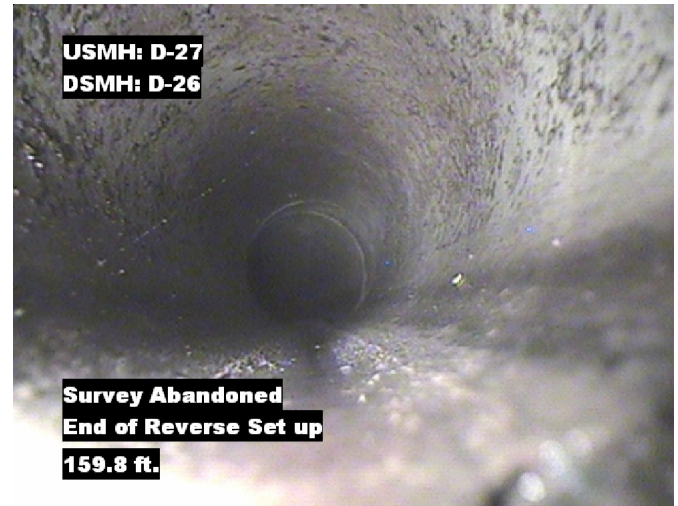
Distance: 159.8 ft. Grade: 0  
Condition: Survey Abandoned  
Remarks: End of Reverse Set up
