## Defect Listing

Pipe Segment Refere... <b>D1-1_D-12</b>	City <b>Oliver Springs</b>	Street <b>Hwy 62</b>	Material <b>Concrete Pipe (non-...</b>	Location C... <b>Easement/R...</b>	Sewer Use <b>Sanitary</b>
Upstream MH <b>D1-1</b>	Total Length <b>133.4</b>	Year Laid	Shape <b>Circular</b>	Location Details	
DS Manhole <b>D-12</b>	Length surveyed <b>133.4</b>	Year Renewed	Height <b>8</b>	Width <b>8</b>	Pipe Joint... <b>4</b>

SPR <b>N/A</b>	MPR <b>7</b>	PO Number <b>4397-03</b>	Customer <b>GRW</b>
SPRI <b>N/A</b>	MPRI <b>3.5</b>	Work Order <b>4397-02</b>	Purpose <b>Pre-Rehabilitation Survey</b>
QSR <b>N/A</b>	QMR <b>4131</b>		
OPR <b>7</b>	Surveyed By <b>Barry Rogers</b>	Direction <b>Downstream</b>	Date <b>20150709</b>
OPRI <b>3.5</b>	Certificate Number <b>U-1012-16405</b>	Pre-Cleaning <b>Jetting</b>	Time <b>08:41</b>
	Date Cleaned <b>20150709</b>	End Time <b>09:01</b>	Weather <b>Damp</b>
			Media label
			Additional Info

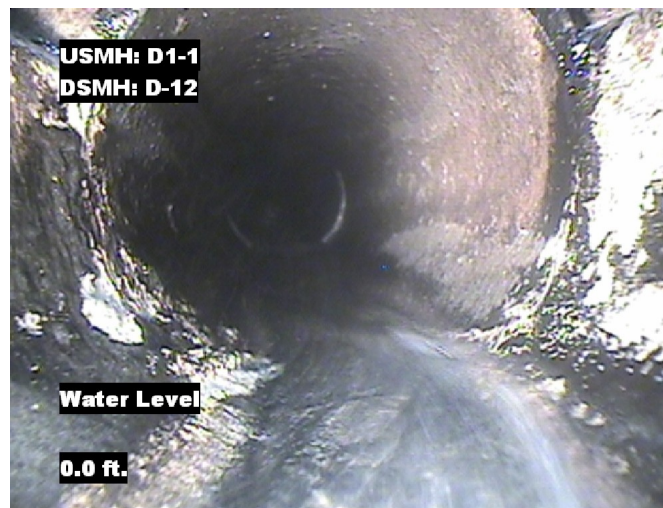
Distance: 0.0 ft. Grade: 0  
Condition: Water Level  
Remarks: N/A

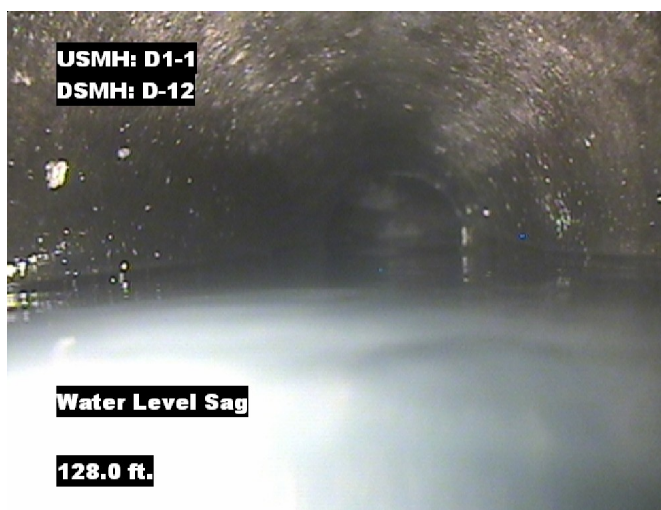
Distance: 128.0 ft. Grade: 3  
Condition: Water Level Sag  
Remarks: N/A

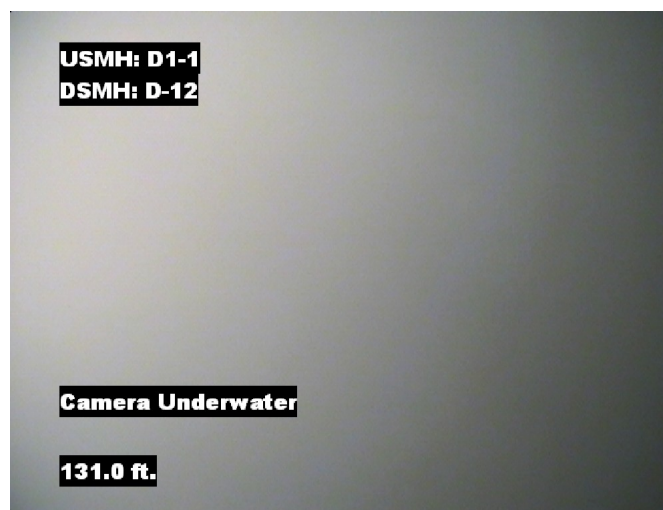
Distance: 131.0 ft. Grade: 4  
Condition: Camera Underwater  
Remarks: N/A

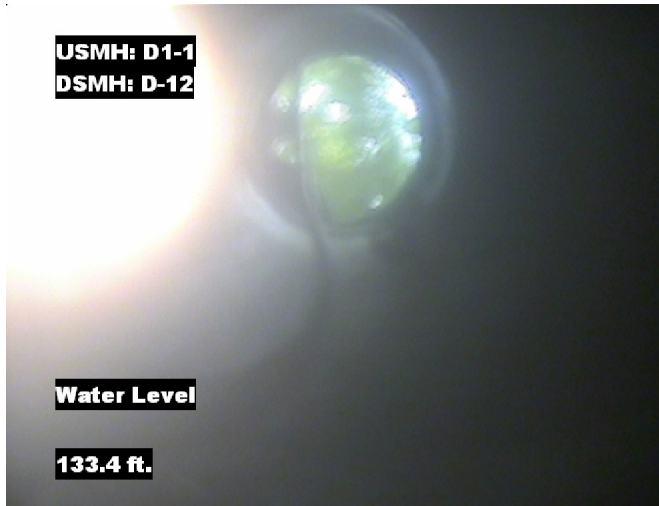
Distance: 133.4 ft. Grade: 0  
Condition: Water Level  
Remarks: N/A
