## Defect Listing

Pipe Segment Refere...	City	Street	Material	Location C...	Sewer Use
<b>D1-2_D1-1</b>	<b>Oliver Springs</b>	<b>Hwy 62</b>	<b>Concrete Pipe (non-...</b>	<b>Light High...</b>	<b>Sanitary</b>
Upstream MH	Total Length	Year Laid	Shape	Location Details	
<b>D1-2</b>	<b>236</b>		<b>Circular</b>		
DS Manhole	Length surveyed	Year Renewed	Height	Width	Pipe Joint...
<b>D1-1</b>	<b>236</b>		<b>8</b>	<b>8</b>	<b>4</b>

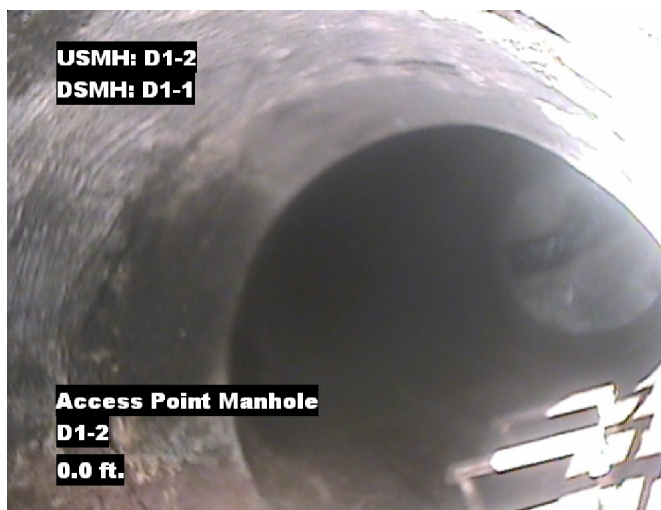
Distance: 0.0 ft. Grade: 0  
Condition: Access Point Manhole  
Remarks: D1-2

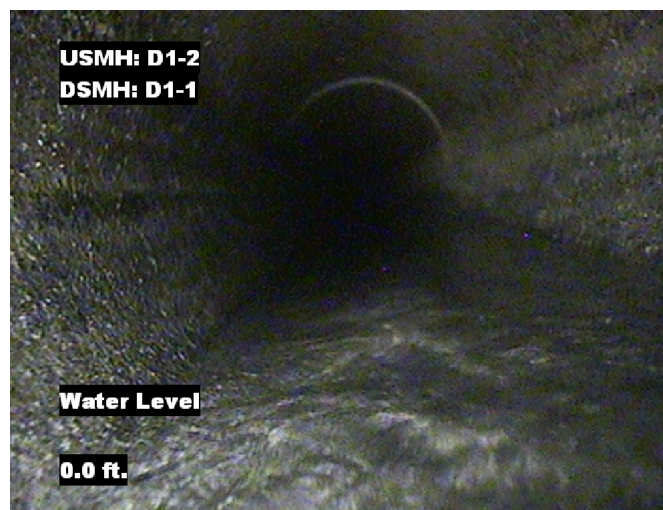
Distance: 0.0 ft. Grade: 0  
Condition: Water Level  
Remarks: N/A

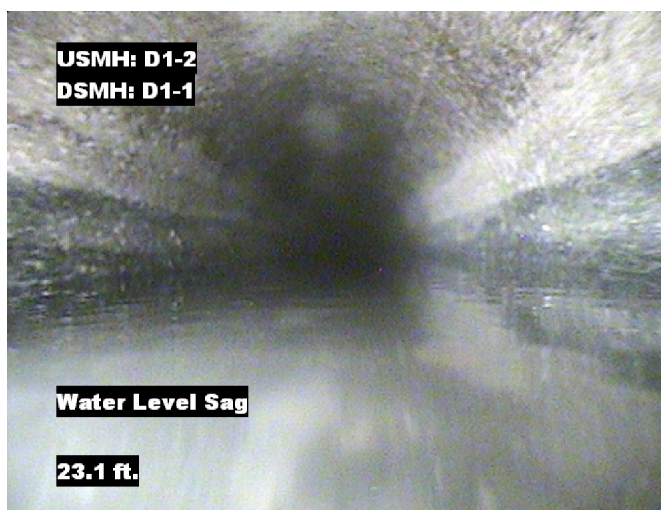
Distance: 23.1 ft. Grade: 2  
Condition: Water Level Sag  
Remarks: N/A

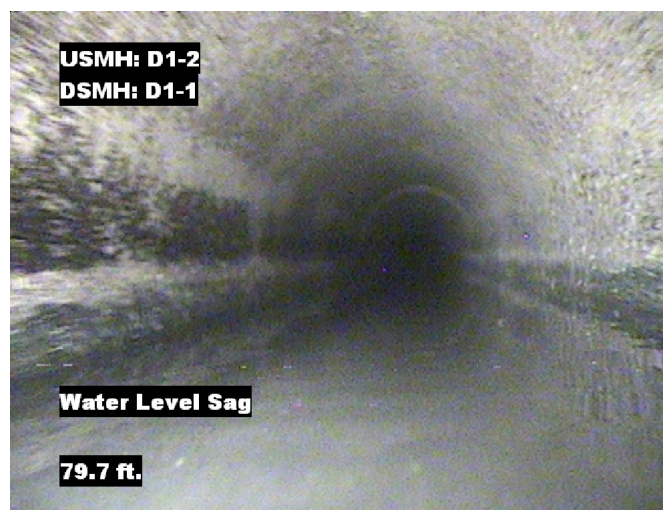
Distance: 79.6 ft. Grade: 2  
Condition: Water Level Sag  
Remarks: N/A

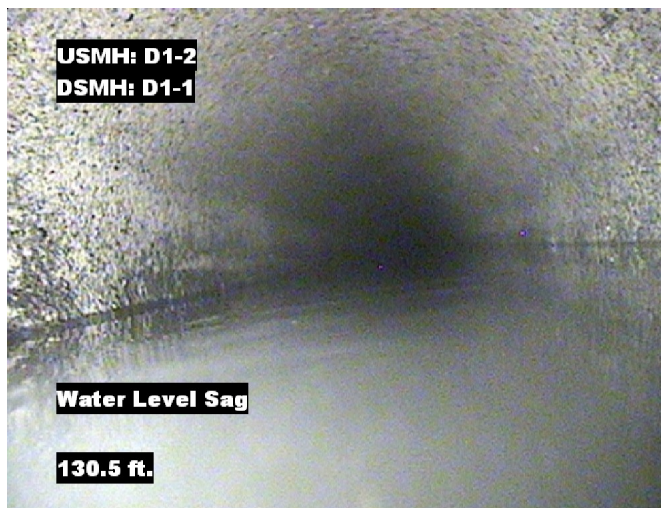
Distance: 130.5 ft. Grade: 3  
Condition: Water Level Sag  
Remarks: N/A

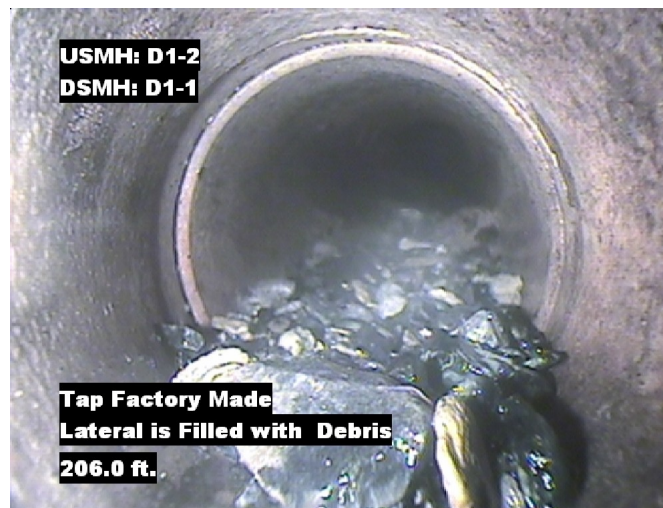
Distance: 206.0 ft. Grade: 0  
Condition: Tap Factory Made  
Remarks: Lateral is Filled with Debris

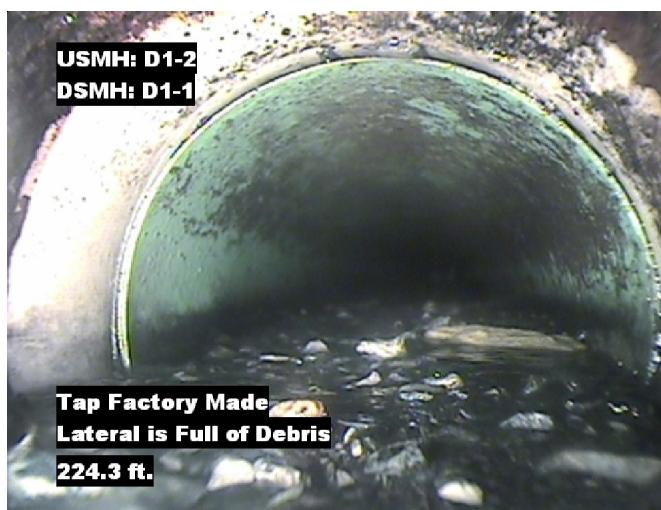
Distance: 224.3 ft. Grade: 0  
Condition: Tap Factory Made  
Remarks: Lateral is Full of Debris

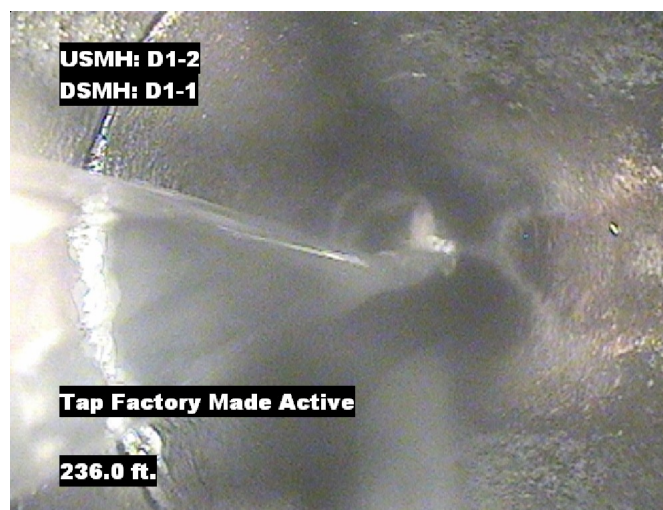
Distance: 236.0 ft. Grade: 0  
Condition: Tap Factory Made Active  
Remarks: N/A

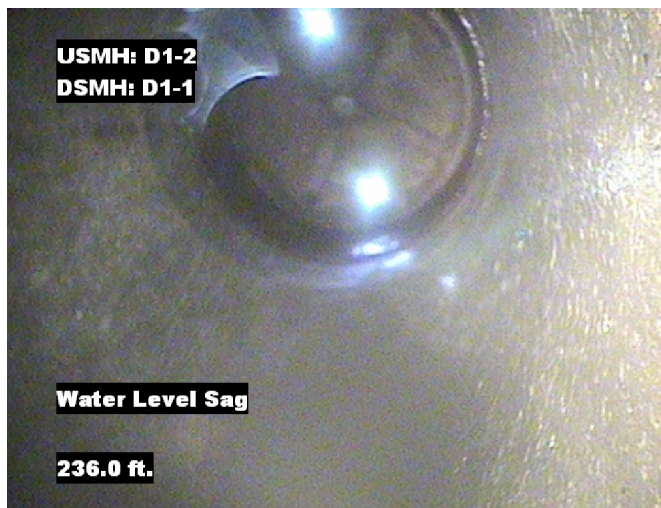
Distance: 236.0 ft. Grade: 3  
Condition: Water Level Sag  
Remarks: N/A

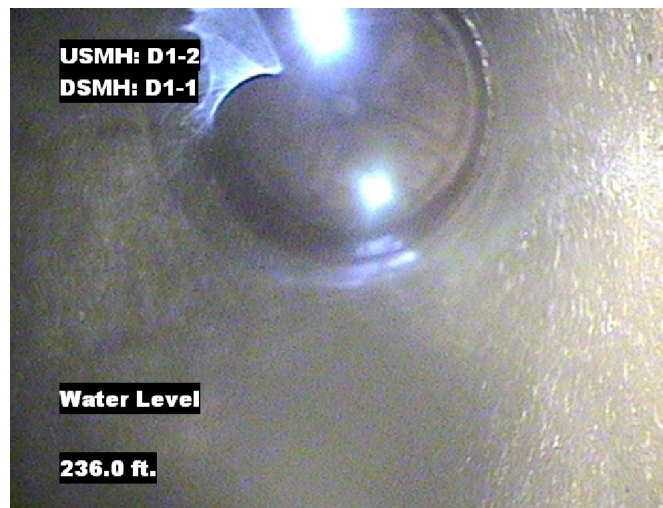
Distance: 236.0 ft. Grade: 0  
Condition: Water Level  
Remarks: N/A

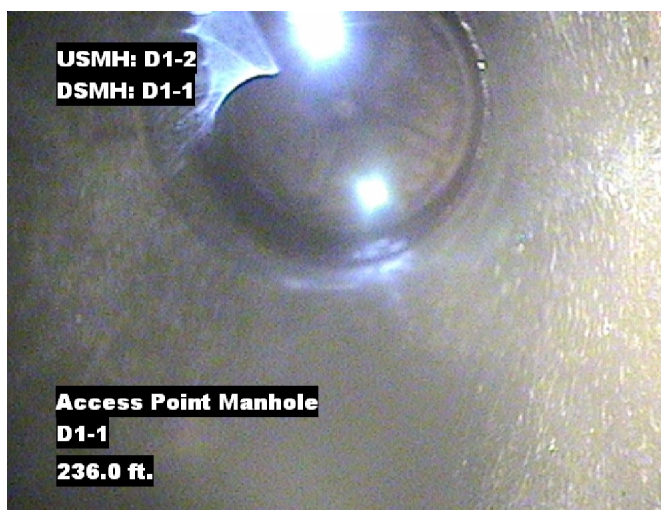
Distance: 236.0 ft. Grade: 0  
Condition: Access Point Manhole  
Remarks: D1-1
