Defect Listing

Pipe Segment Refere... D1-3_D1-2	City Oliver Springs	Street Bennett RD	Material PolyVinyl Chloride	Location C... Light High...	Sewer Use Sanitary
Upstream MH D1-3	Total Length 261.7	Year Laid	Shape Circular	Location Details	
DS Manhole D1-2	Length surveyed 261.7	Year Renewed	Height 8	Width 8	Pipe Joint... 13

Image Report 4/Page

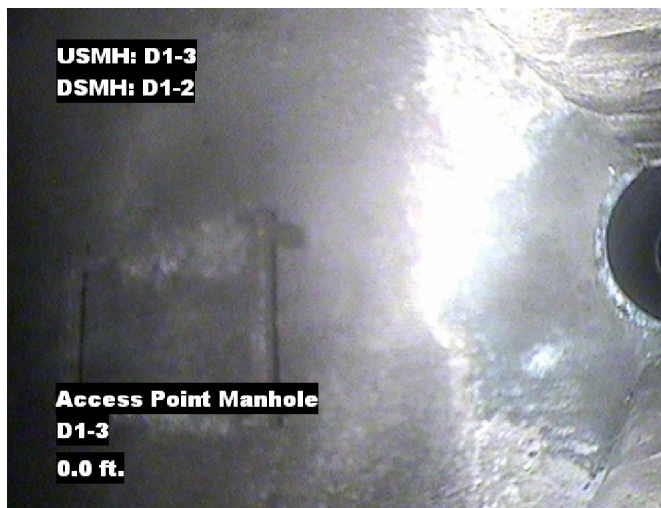
Distance: 0.0 ft. Grade: 0
Condition: Access Point Manhole
Remarks: D1-3

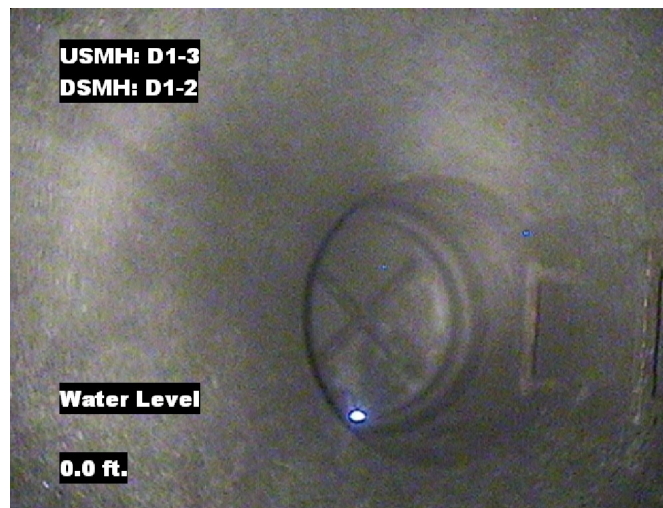
Distance: 0.0 ft. Grade: 0
Condition: Water Level
Remarks: N/A

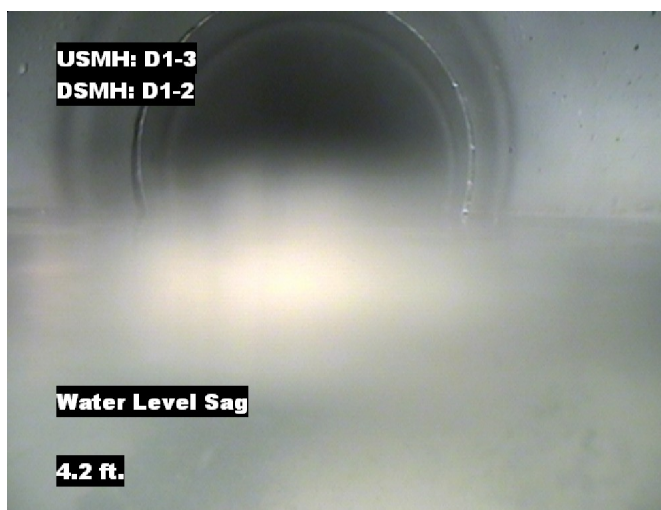
Distance: 4.2 ft. Grade: 3
Condition: Water Level Sag
Remarks: N/A

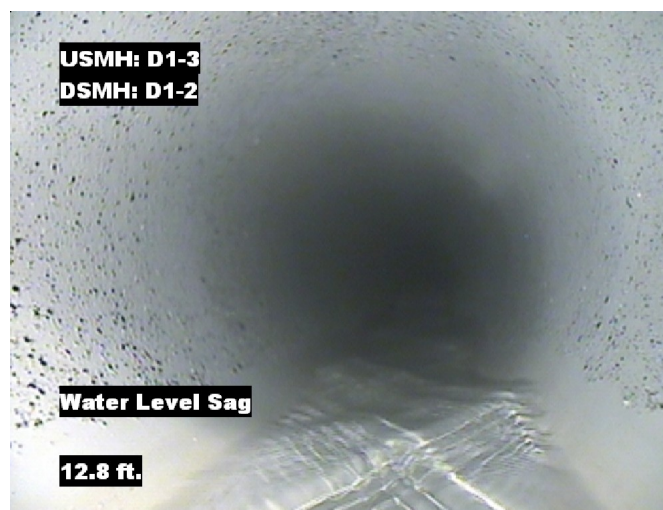
Distance: 12.8 ft. Grade: 3
Condition: Water Level Sag
Remarks: N/A

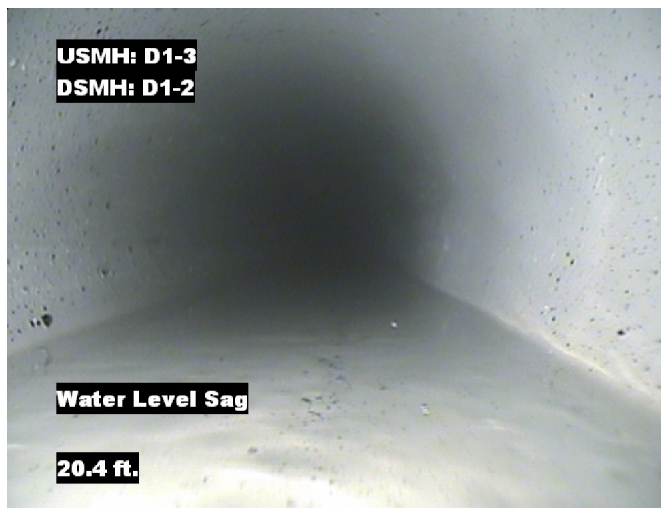
Distance: 20.4 ft. Grade: 2
Condition: Water Level Sag
Remarks: N/A

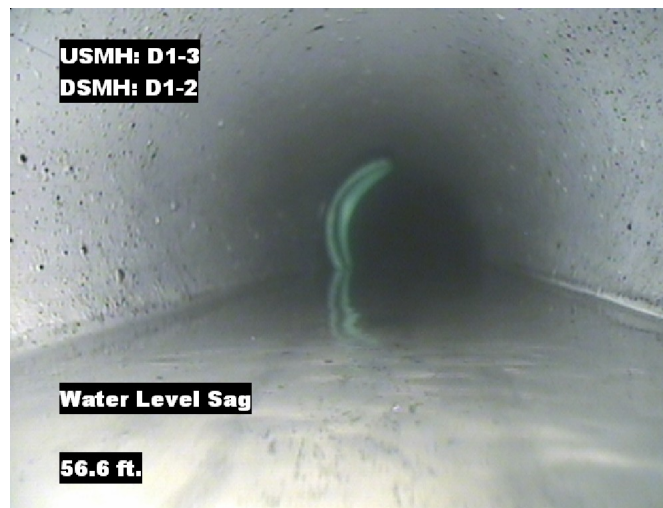
Distance: 56.6 ft. Grade: 2
Condition: Water Level Sag
Remarks: N/A

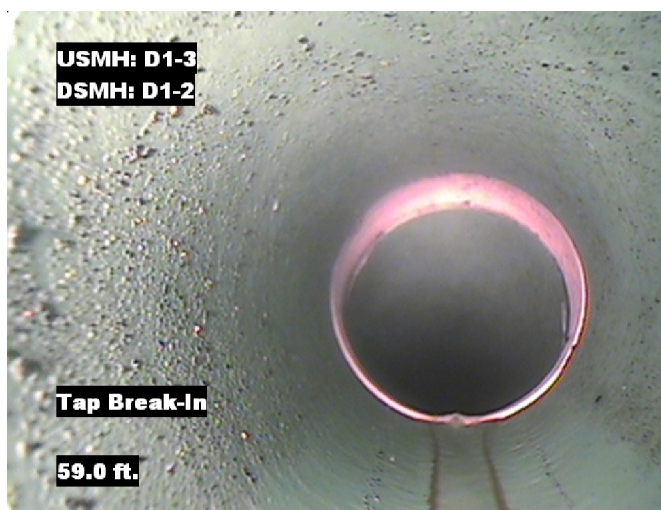
Distance: 59.0 ft. Grade: 0
Condition: Tap Break-In
Remarks: N/A

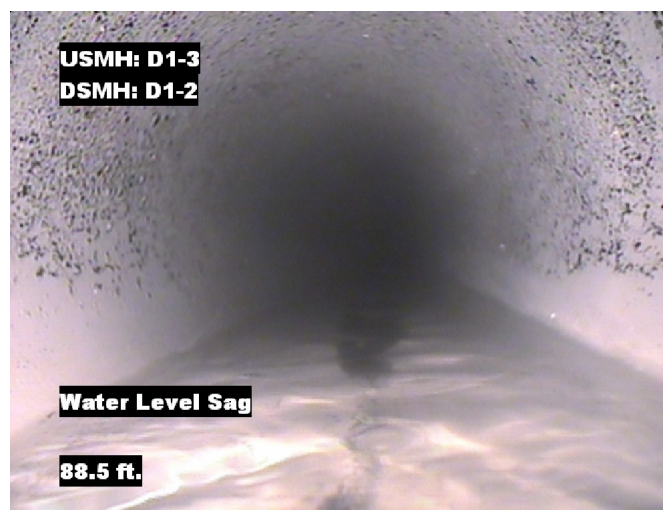
Distance: 88.5 ft. Grade: 2
Condition: Water Level Sag
Remarks: N/A

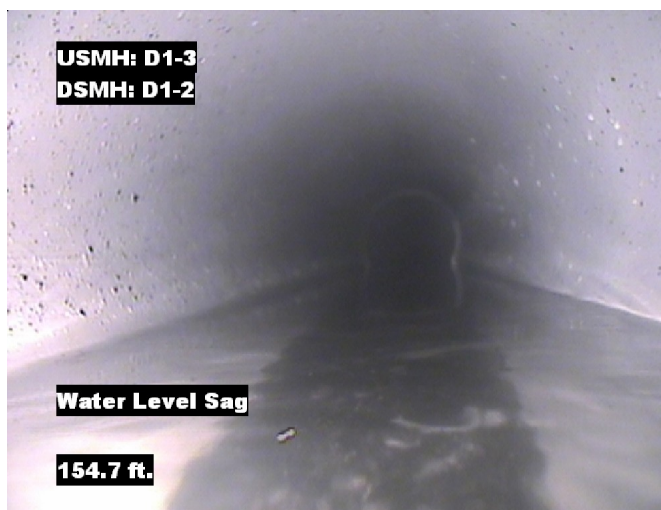
Distance: 154.7 ft. Grade: 2
Condition: Water Level Sag
Remarks: N/A

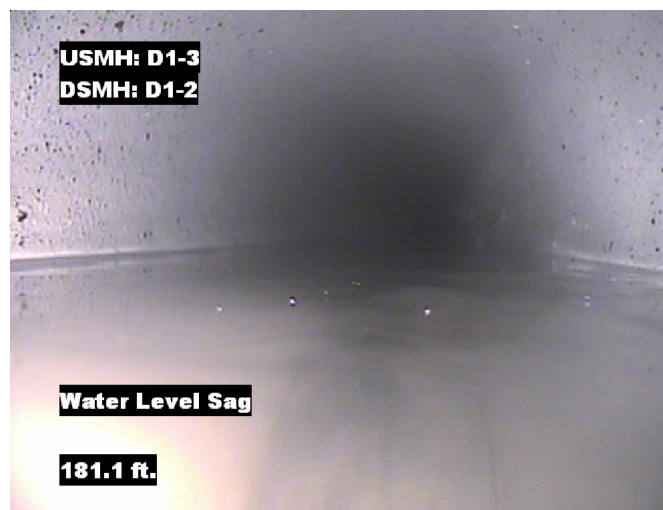
Distance: 181.1 ft. Grade: 2
Condition: Water Level Sag
Remarks: N/A

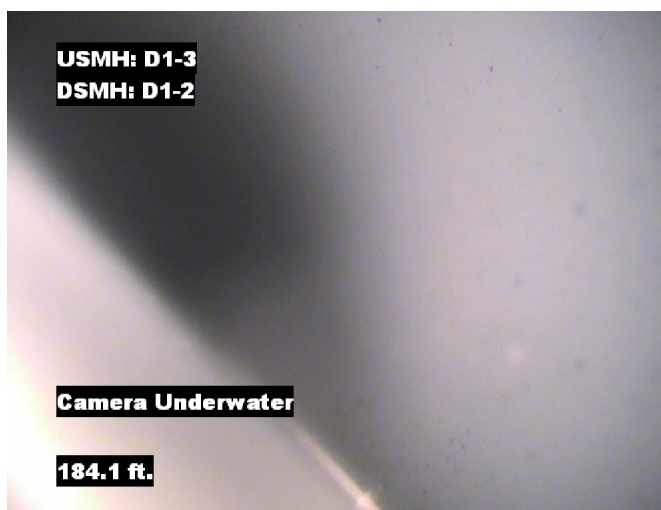
Distance: 184.1 ft. Grade: 4
Condition: Camera Underwater
Remarks: N/A

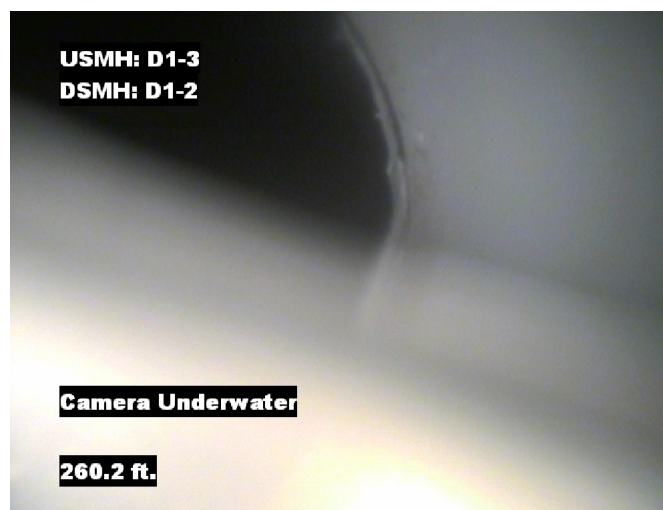
Distance: 260.2 ft. Grade: 4
Condition: Camera Underwater
Remarks: N/A

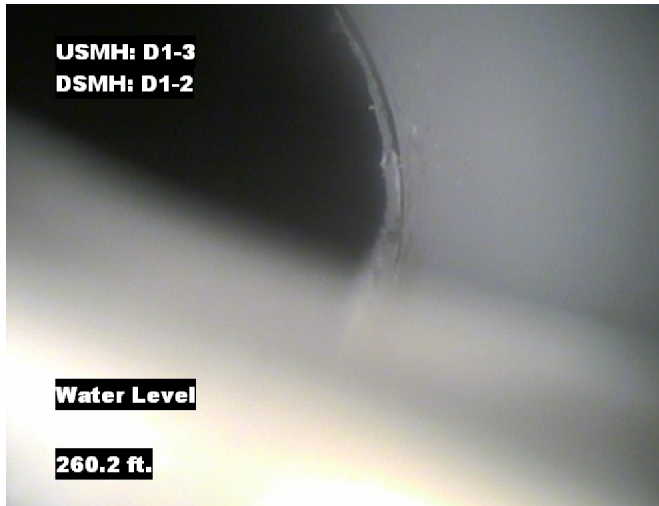
Distance: 260.2 ft. Grade: 0
Condition: Water Level
Remarks: N/A

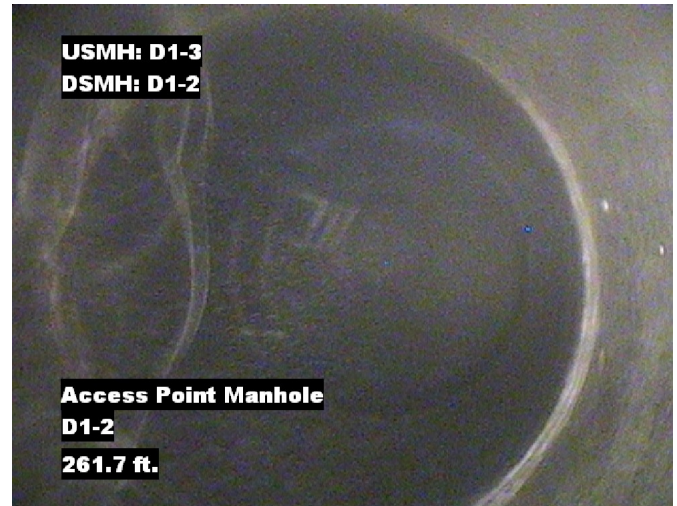
Distance: 261.7 ft. Grade: 0
Condition: Access Point Manhole
Remarks: D1-2
