## Defect Listing

Pipe Segment Refere... <b>D1-4_D1-3</b>	City <b>Oliver Springs</b>	Street <b>Bennett Rd</b>	Material <b>Concrete Pipe (non-...</b>	Location C... <b>Light High...</b>	Sewer Use <b>Sanitary</b>
Upstream MH <b>D1-4</b>	Total Length <b>198</b>	Year Laid	Shape <b>Circular</b>	Location Details	
DS Manhole <b>D1-3</b>	Length surveyed <b>198</b>	Year Renewed	Height <b>8</b>	Width <b>8</b>	Pipe Joint... <b>4</b>

SPR <b>N/A</b>	MPR <b>N/A</b>	PO Number <b>4397-03</b>		Customer <b>GRW</b>	
SPRI <b>N/A</b>	MPRI <b>N/A</b>	Work Order <b>4397-02</b>		Purpose <b>Pre-Rehabilitation Survey</b>	
QSR <b>N/A</b>	QMR <b>N/A</b>				
OPR <b>N/A</b>	Surveyed By <b>Barry Rogers</b>	Direction <b>Downstream</b>	Date <b>20150709</b>	Media label	
OPRI <b>N/A</b>	Certificate Number <b>U-1012-16405</b>	Pre-Cleaning <b>Jetting</b>	Time <b>07:05</b>	Weather <b>Damp</b>	
Date Cleaned <b>20150709</b>			End Time <b>07:12</b>	Additional Info

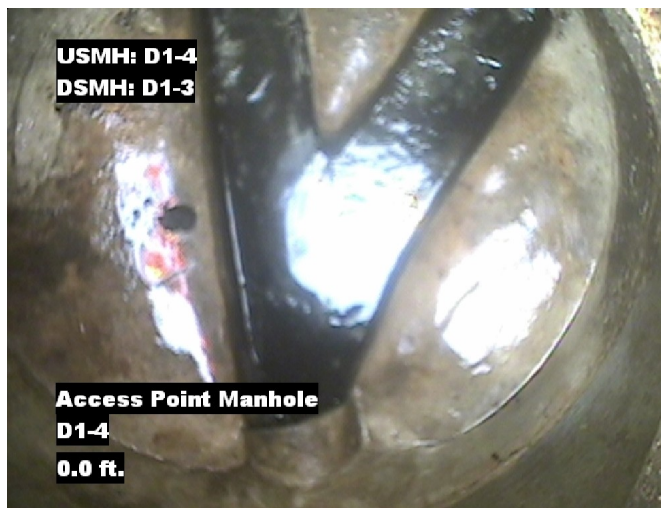
Distance: 0.0 ft. Grade: 0  
Condition: Access Point Manhole  
Remarks: D1-4

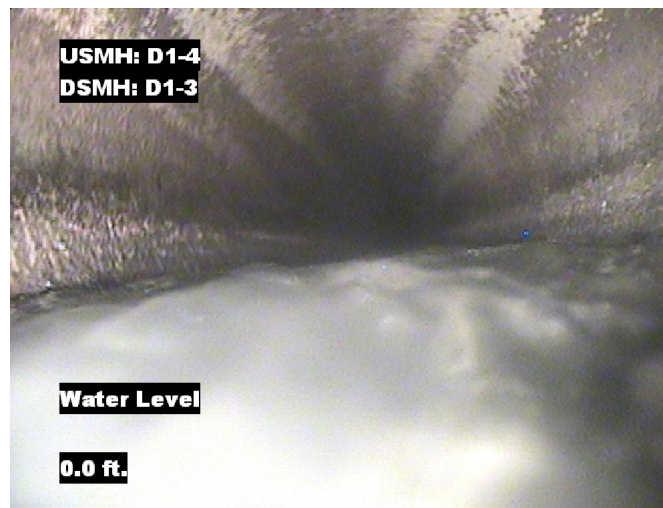
Distance: 0.0 ft. Grade: 0  
Condition: Water Level  
Remarks: N/A

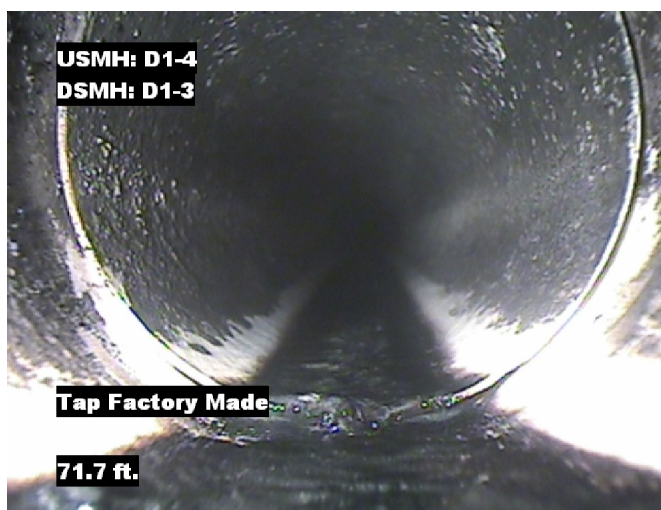
Distance: 71.7 ft. Grade: 0  
Condition: Tap Factory Made  
Remarks: N/A

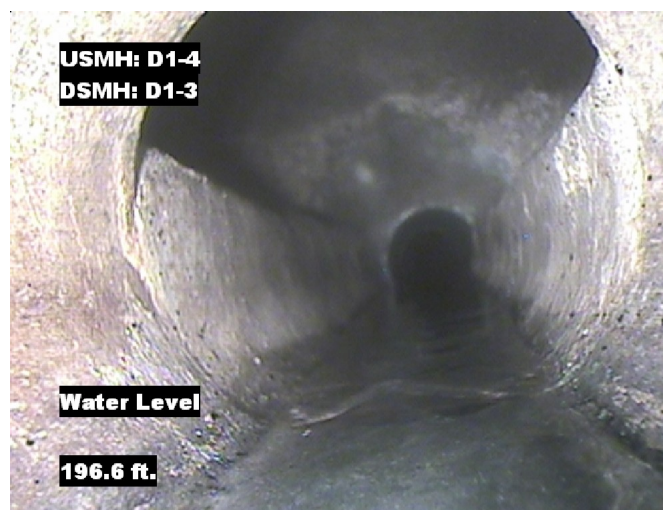
Distance: 196.6 ft. Grade: 0  
Condition: Water Level  
Remarks: N/A

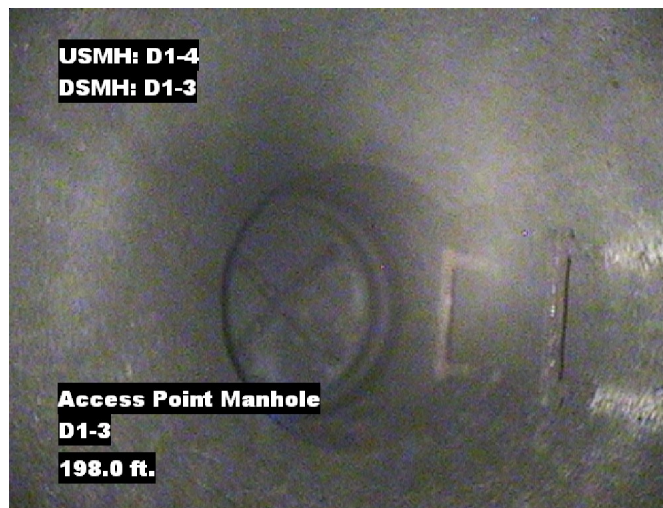
Distance: 198.0 ft. Grade: 0  
Condition: Access Point Manhole  
Remarks: D1-3
