# **Defect Listing**

Pipe Segment Refere		City		Street	Mat	erial	Location C	Sewer Use	
D1-5_D1-4		Oliver Springs		Bennett RD	Concrete F	Pipe (non	Light High	Sanitary	
Upstream MH Total Length		_ength	Year Laid	Sh	ape	ape Location Deta			
D1-5		371.1			Circ	cular			
DS Ma	DS Manhole Len		surveyed	Year Renewed	Height	Width	Pipe Joint		
D1-4		371.1			8	8	4		
SPR	N/A	MPR	10	PO Number Customer		Number			
0001	NI/A	MDDI		4397-03			GRW		
SPRI	N/A	MPRI	3.3	Work Order					
QSR	N/A	QMR	4132	4397-02	Pre-F		Rehabilitation Survey		
OF	PR	Surve	yed By	Direction	Date		Media label		
1	0	Barry_Rogers		Downstream	20150708				
OP	RI	Certificate Number		Pre-Cleaning	Time		Weather		
3.3 U-		U-1012	2-16405	<b>Heavy Cleaning</b>	14:43		Damp		
Date Cleaned						End Time		Additional Info	
		2015	15:11

### **Image Report 4/Page**

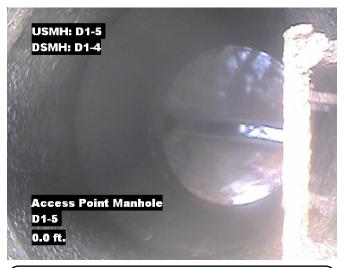
Distance: 0.0 ft. Grade: 0

Condition: Access Point Manhole

Remarks: D1-5

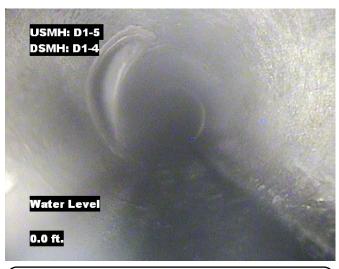
Distance: 0.0 ft. Grade: 0

Condition: Water Level

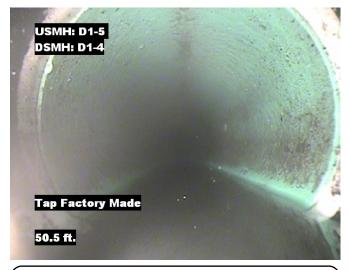
Distance: 50.5 ft. Grade: 0

Condition: Tap Factory Made

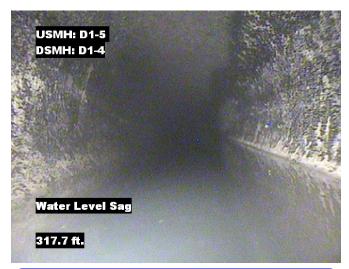
Distance: 317,7 ft. Grade: 3

Condition: Water Level Sag

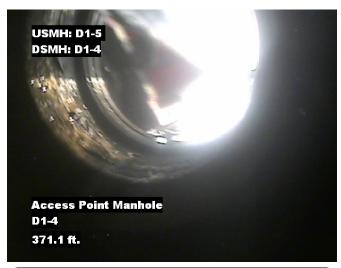
Distance: 371.1 ft. Grade: 0

Condition: Access Point Manhole

Remarks: D1-4
