Defect Listing

Pipe Segment Refere... D1-6_D1-5	City Oliver Springs	Street Bennett RD	Material Concrete Pipe (non-...	Location C... Light High...	Sewer Use Sanitary
Upstream MH D1-6	Total Length 209.8	Year Laid	Shape Circular	Location Details	
DS Manhole D1-5	Length surveyed 209.8	Year Renewed	Height 8	Width 8	Pipe Joint... 4

SPR N/A	MPR 12	PO Number 4397-03	Customer GRW
SPRI N/A	MPRI 2	Work Order 4397-02	Purpose Pre-Rehabilitation Survey
QSR N/A	QMR 4123		
OPR 12	Surveyed By Barry Rogers	Direction Downstream	Date 20150708
OPRI 2	Certificate Number U-1012-16405	Pre-Cleaning Heavy Cleaning	Time 13:58
	Date Cleaned 20150708	End Time 14:11	Weather Damp
			Media label Used Root Saw

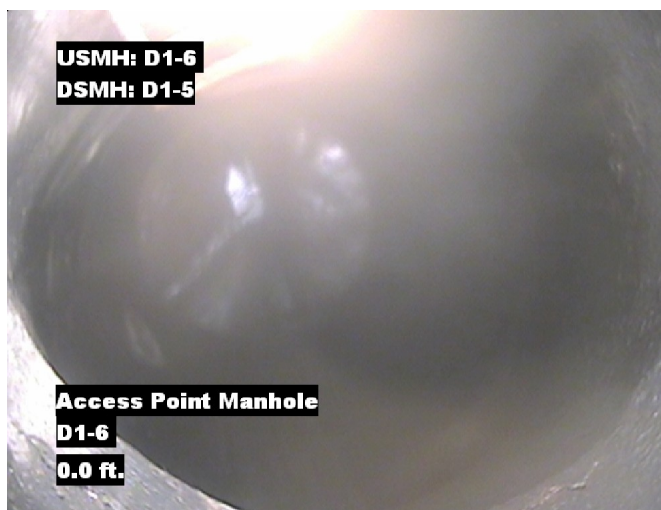
Distance: 0.0 ft. Grade: 0
Condition: Access Point Manhole
Remarks: D1-6

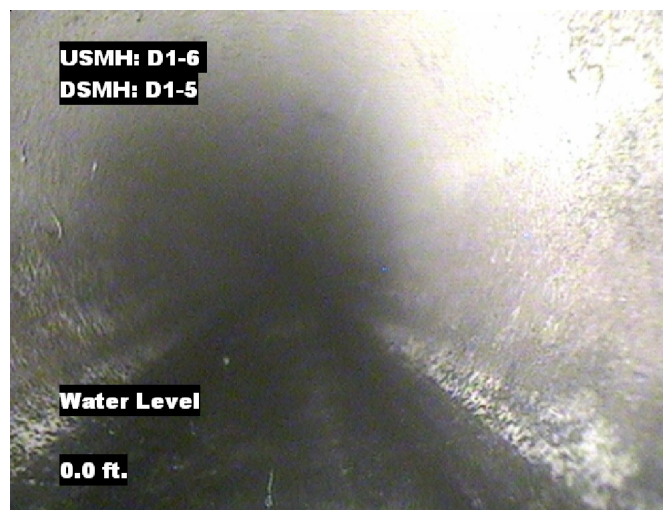
Distance: 0.0 ft. Grade: 0
Condition: Water Level
Remarks: N/A

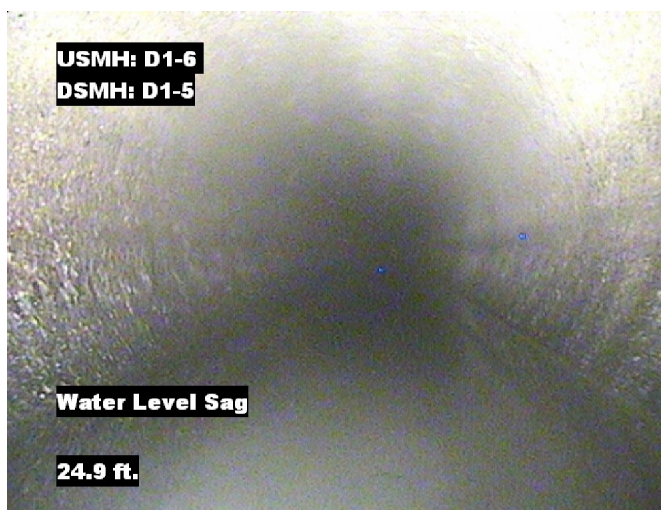
Distance: 24.9 ft. Grade: 2
Condition: Water Level Sag
Remarks: N/A

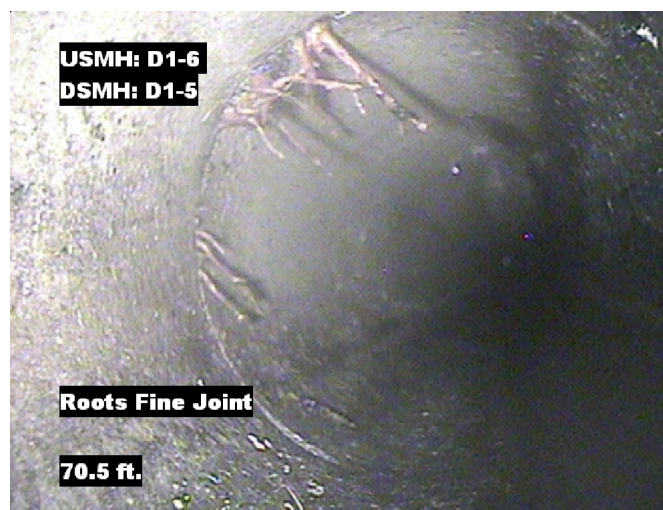
Distance: 70.5 ft. Grade: 1
Condition: Roots Fine Joint
Remarks: N/A

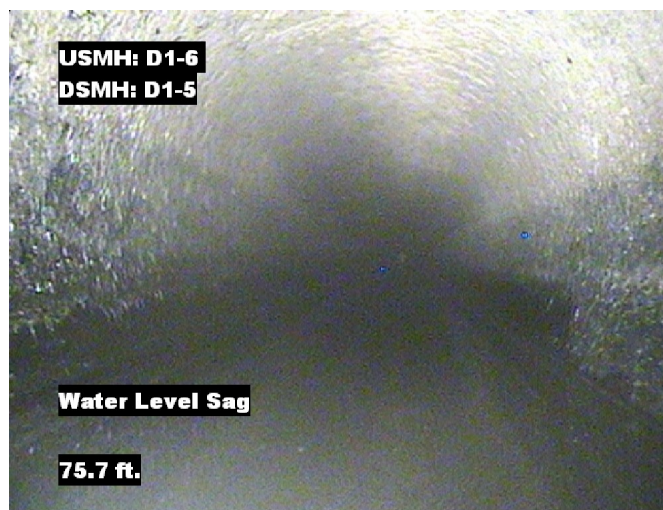
Distance: 75.7 ft. Grade: 2
Condition: Water Level Sag
Remarks: N/A

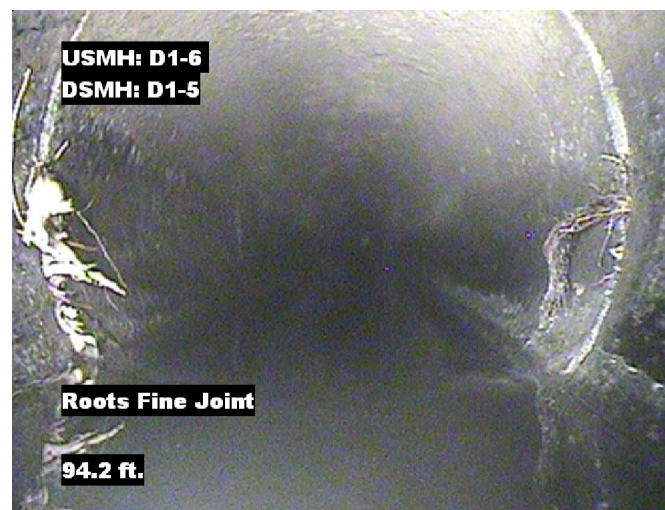
Distance: 94.2 ft. Grade: 1
Condition: Roots Fine Joint
Remarks: N/A

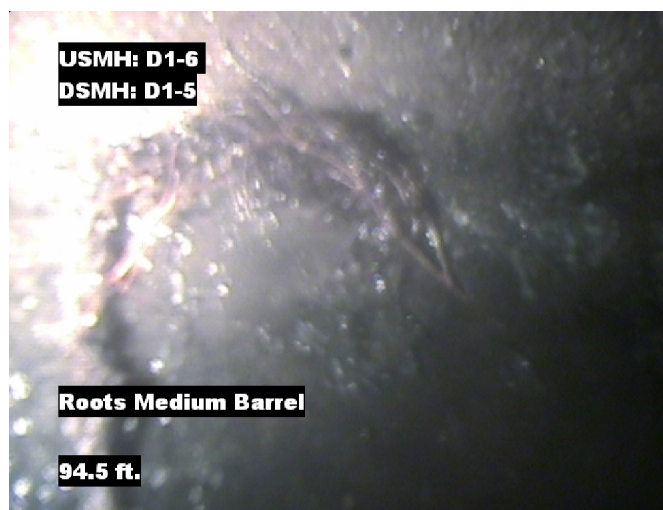
Distance: 94.5 ft. Grade: 4
Condition: Roots Medium Barrel
Remarks: N/A

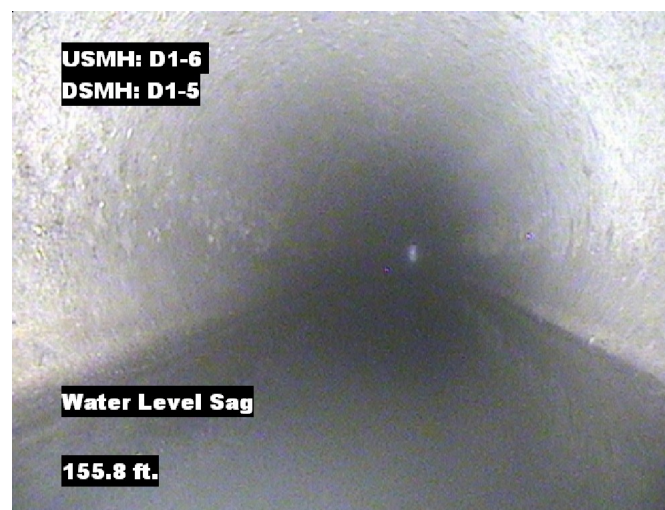
Distance: 155.8 ft. Grade: 2
Condition: Water Level Sag
Remarks: N/A

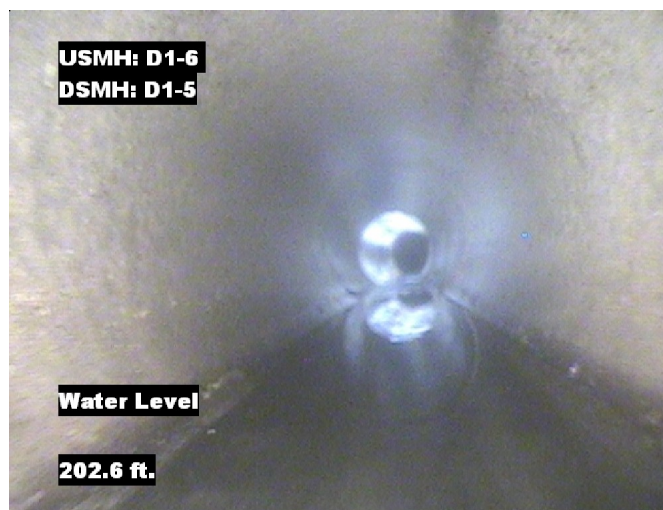
Distance: 202.4 ft. Grade: 0
Condition: Water Level
Remarks: N/A

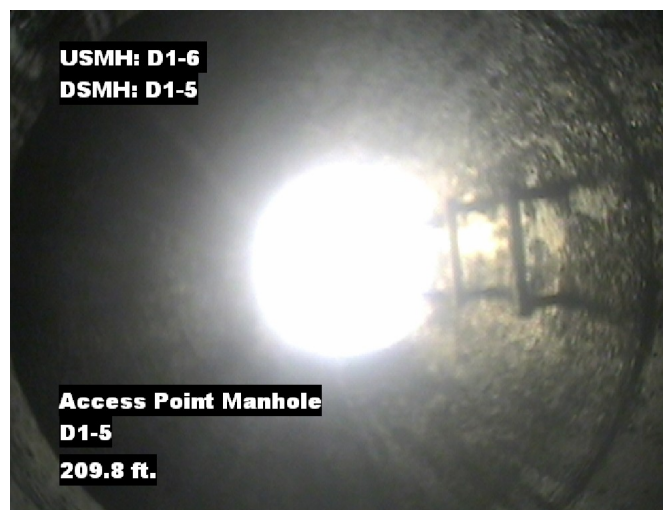
Distance: 209.8 ft. Grade: 0
Condition: Access Point Manhole
Remarks: D1-5
