Defect Listing

Pipe Segment Refere		City		Street	Mat	erial	Location C	Sewer Use	
D1-7	_D1-6	Oliver	Springs	Bennett RD	Concrete Pipe (non		Light High	Sanitary	
Upstream MH		Total Length		Year Laid	Sh	Shape		Details	
D1-7		210.6			Circ	cular			
DS Ma	anhole	Length s	surveyed	Year Renewed	Height	Width	Pipe Joint		
D1	1-6	21	0.6		8	8 8 4			
SPR	N/A	MPR	4	PO Number 4397-03 Work Order			Customer		
0001		MBDI				GRW			
SPRI	N/A	MPRI	2			Purpose			
QSR	N/A	QMR	2200	4397-02		Pre-Rehabilitation Survey			
OI	PR	Surve	yed By	Direction	D	ate	Media	alabel	
4	4	Barry_Rogers		Downstream	2015	20150708			
OF	PRI	Certificate Number		Pre-Cleaning	Time		Weather		
2		U-1012-16405		Jetting	12:37		Damp		
		Date C	leaned		End	End Time		Additional Info	
		2015	0708		2:51

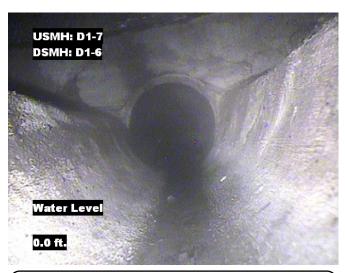
Distance: 0.0 ft. Grade: 0

Condition: Access Point Manhole

Remarks: D1-7
