## Defect Listing

Pipe Segment Refere... <b>D1-7A_D1-7</b>	City <b>Oliver Springs</b>	Street <b>Bennett Rd</b>	Material <b>Concrete Pipe (non-...</b>	Location C... <b>Light High...</b>	Sewer Use <b>Sanitary</b>
Upstream MH <b>D1-7A</b>	Total Length <b>202.3</b>	Year Laid	Shape <b>Circular</b>	Location Details <b>208 Bennet Rd</b>	
DS Manhole <b>D1-7</b>	Length surveyed <b>202.3</b>	Year Renewed	Height <b>8</b>	Width <b>8</b>	Pipe Joint... <b>4</b>

SPR <b>N/A</b>	MPR <b>N/A</b>	PO Number <b>4397-03</b>	Customer <b>GRW</b>
SPRI <b>N/A</b>	MPRI <b>N/A</b>	Work Order <b>4397-02</b>	Purpose <b>Pre-Rehabilitation Survey</b>
QSR <b>N/A</b>	QMR <b>N/A</b>		
OPR <b>N/A</b>	Surveyed By <b>Barry Rogers</b>	Direction <b>Downstream</b>	Date <b>20150708</b>
OPRI <b>N/A</b>	Certificate Number <b>U-1012-16405</b>	Pre-Cleaning <b>Jetting</b>	Time <b>12:28</b>
	Date Cleaned <b>20150708</b>	End Time <b>12:35</b>	Weather <b>Damp</b>
			Media label
			Additional Info

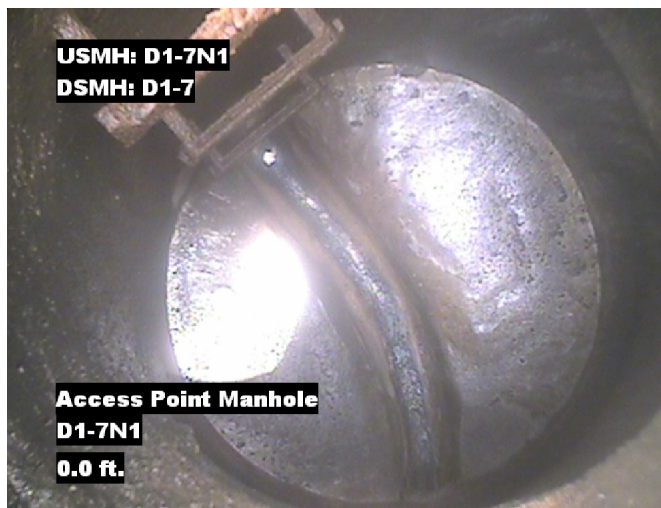
Distance: 0.0 ft. Grade: 0  
Condition: Access Point Manhole  
Remarks: D1-7A

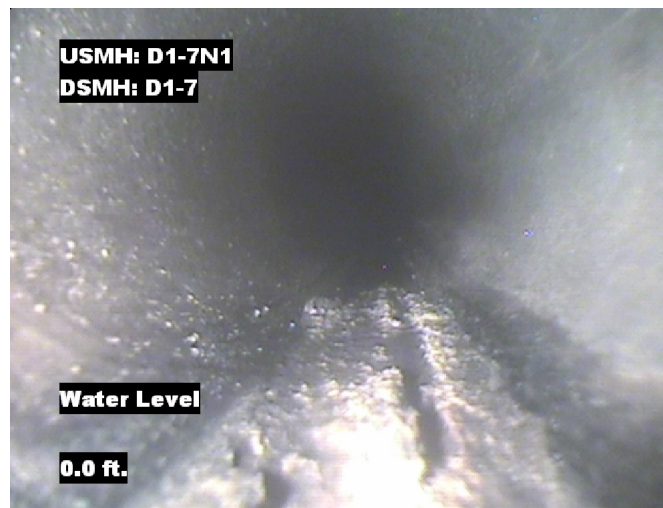
Distance: 0.0 ft. Grade: 0  
Condition: Water Level  
Remarks: N/A

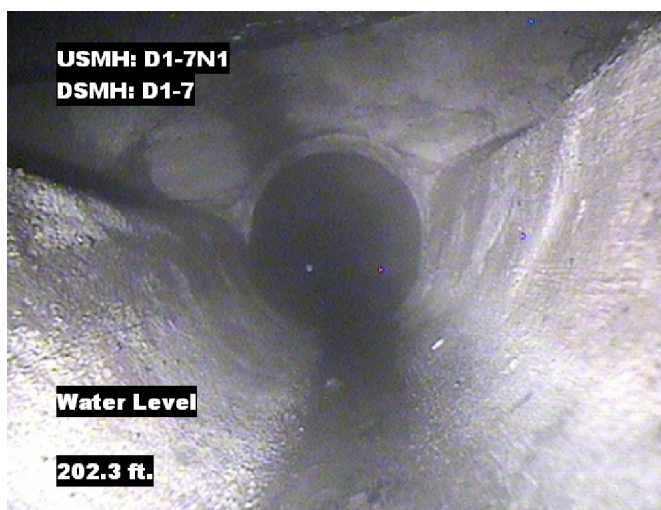
Distance: 202.3 ft. Grade: 0  
Condition: Water Level  
Remarks: N/A

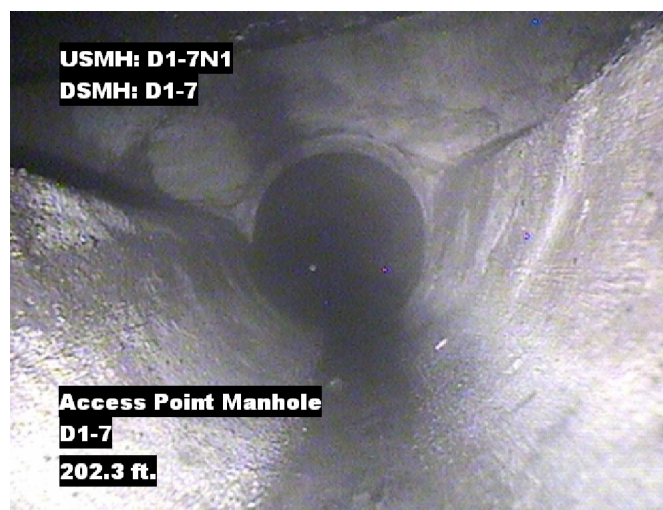
Distance: 202.3 ft. Grade: 0  
Condition: Access Point Manhole  
Remarks: D1-7
