## Defect Listing

Pipe Segment Refere... <b>D10-1_D9-4</b>	City <b>Oliver Springs</b>	Street <b>White Oak ave</b>	Material <b>Concrete Pipe (non-...</b>	Location C... <b>Light High...</b>	Sewer Use <b>Sanitary</b>
Upstream MH <b>D10-1</b>	Total Length <b>189</b>	Year Laid	Shape <b>Circular</b>	Location Details	
DS Manhole <b>D9-4</b>	Length surveyed <b>189</b>	Year Renewed	Height <b>8</b>	Width <b>8</b>	Pipe Joint... <b>4</b>

## Image Report 4/Page

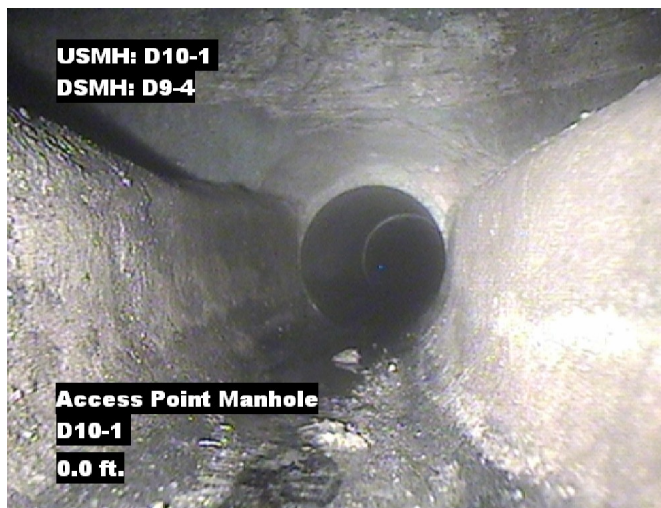
Distance: 0.0 ft. Grade: 0  
Condition: Access Point Manhole  
Remarks: D10-1

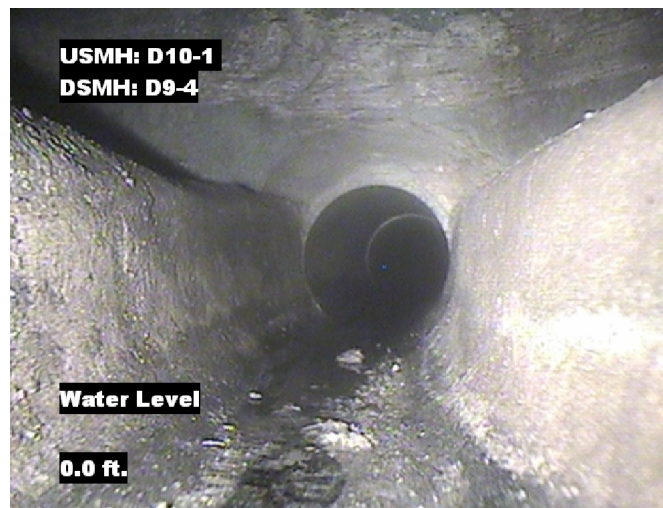
Distance: 0.0 ft. Grade: 0  
Condition: Water Level  
Remarks: N/A

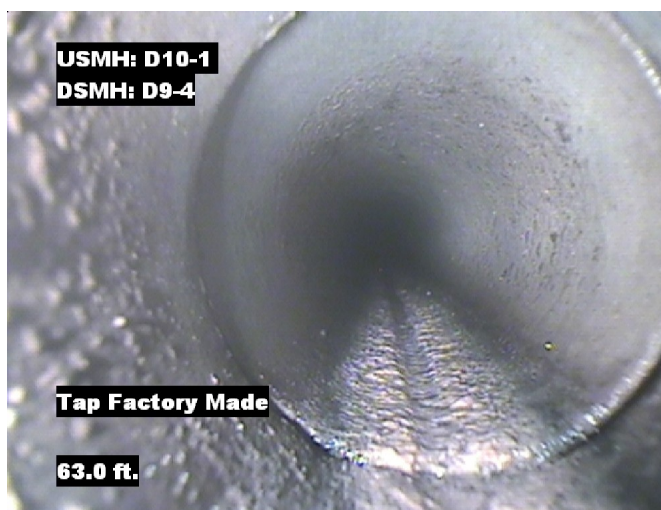
Distance: 63.0 ft. Grade: 0  
Condition: Tap Factory Made  
Remarks: N/A

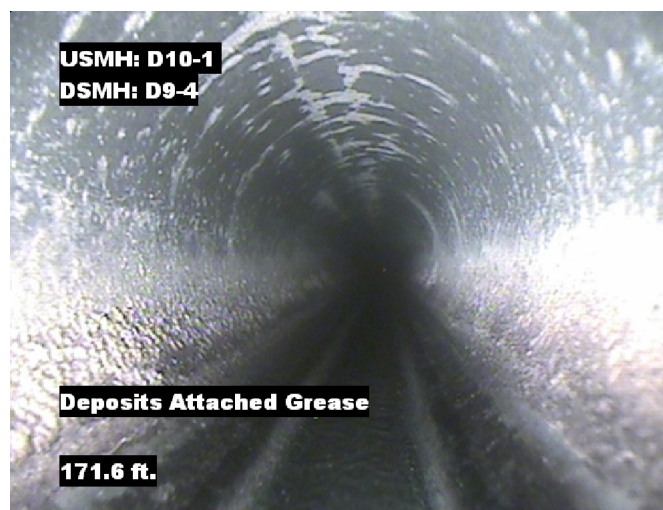
Distance: 171.6 ft. Grade: 2  
Condition: Deposits Attached Grease  
Remarks: N/A

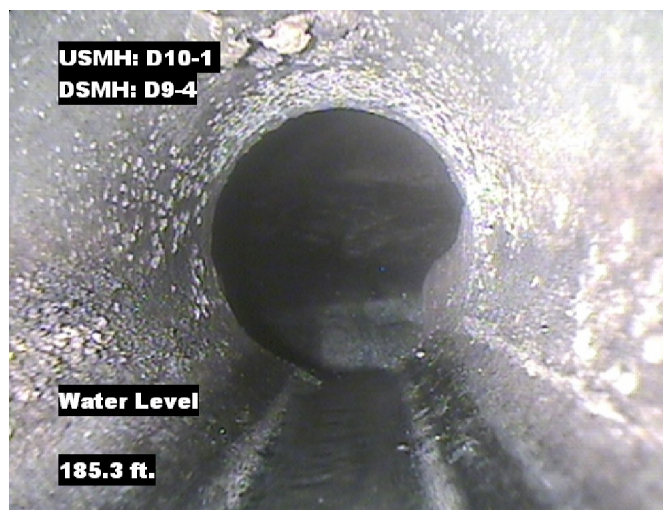
Distance: 185.3 ft. Grade: 0  
Condition: Water Level  
Remarks: N/A

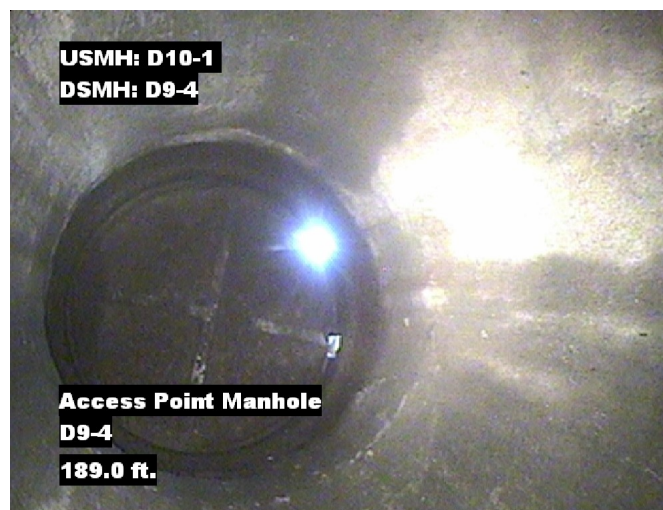
Distance: 189.0 ft. Grade: 0  
Condition: Access Point Manhole  
Remarks: D9-4
