## Defect Listing

Pipe Segment Refere... <b>D10-2_D10-1</b>	City <b>Oliver Springs</b>	Street <b>White Oak ave</b>	Material <b>Concrete Pipe (non-...</b>	Location C... <b>Light High...</b>	Sewer Use <b>Sanitary</b>
Upstream MH <b>D10-2</b>	Total Length <b>267.3</b>	Year Laid	Shape <b>Circular</b>	Location Details	
DS Manhole <b>D10-1</b>	Length surveyed <b>267.3</b>	Year Renewed	Height <b>8</b>	Width <b>8</b>	Pipe Joint... <b>4</b>

SPR <b>N/A</b>	MPR <b>2</b>	PO Number <b>4397-03</b>	Customer <b>GRW</b>
SPRI <b>N/A</b>	MPRI <b>2</b>	Work Order <b>4397-02</b>	Purpose <b>Pre-Rehabilitation Survey</b>
QSR <b>N/A</b>	QMR <b>2100</b>		
OPR <b>2</b>	Surveyed By <b>Barry Rogers</b>	Direction <b>Downstream</b>	Date <b>20150629</b>
OPRI <b>2</b>	Certificate Number <b>U-1012-16405</b>	Pre-Cleaning <b>Jetting</b>	Time <b>09:05</b>
	Date Cleaned <b>20150629</b>	End Time <b>09:22</b>	Weather <b>Dry</b>
			Additional Info

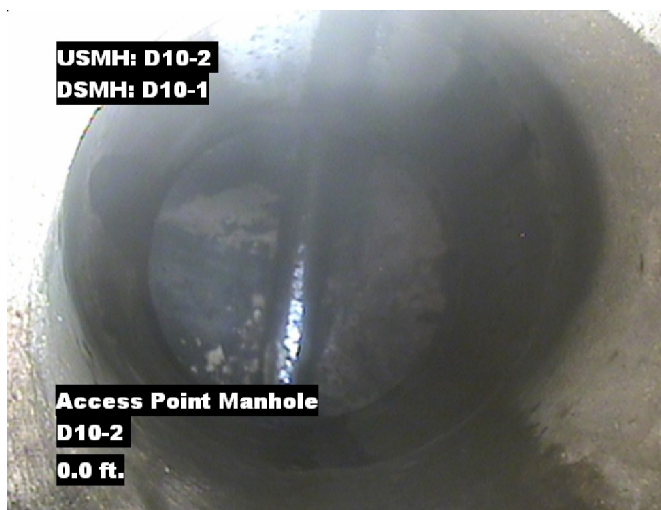
Distance: 0.0 ft. Grade: 0  
Condition: Access Point Manhole  
Remarks: D10-2

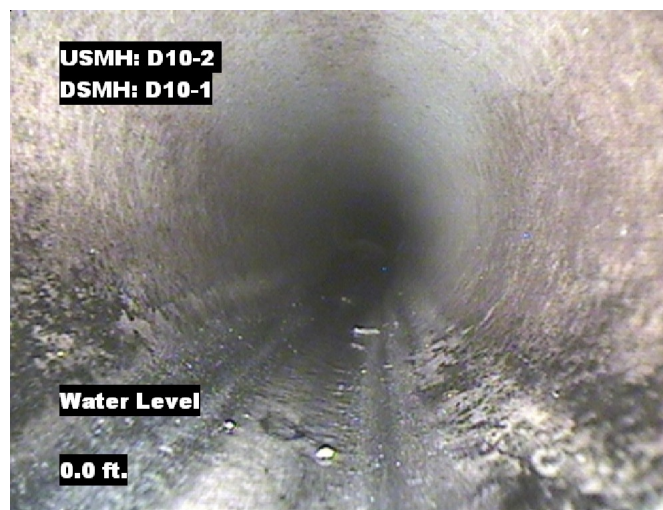
Distance: 0.0 ft. Grade: 0  
Condition: Water Level  
Remarks: N/A

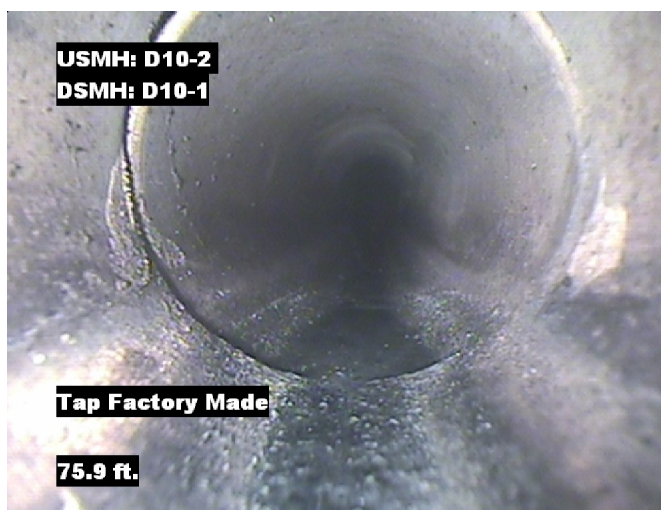
Distance: 75.9 ft. Grade: 0  
Condition: Tap Factory Made  
Remarks: N/A

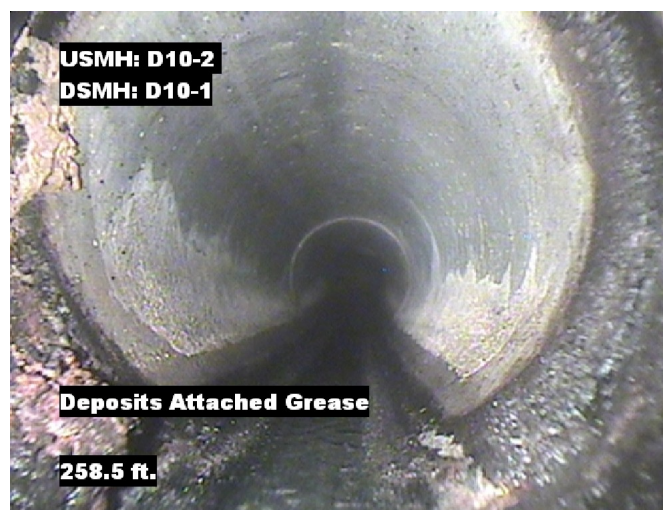
Distance: 258.5 ft. Grade: 2  
Condition: Deposits Attached Grease  
Remarks: N/A

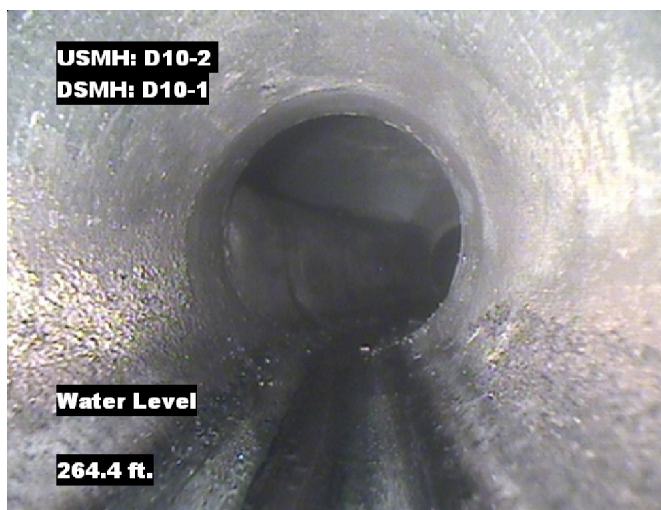
Distance: 264.4 ft. Grade: 0  
Condition: Water Level  
Remarks: N/A

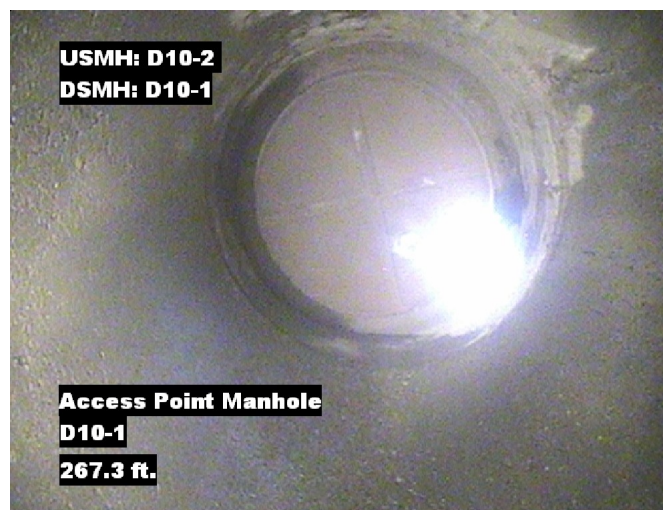
Distance: 267.3 ft. Grade: 0  
Condition: Access Point Manhole  
Remarks: D10-1
