Defect Listing

Pipe Segment Refere... D10-3_D10-2	City Oliver Springs	Street White Oak Ave	Material Concrete Pipe (non-...	Location C... Light High...	Sewer Use Sanitary
Upstream MH D10-3	Total Length 189.2	Year Laid	Shape Circular	Location Details	
DS Manhole D10-2	Length surveyed 189.2	Year Renewed	Height 8	Width 8	Pipe Joint... 4

SPR N/A	MPR 6	PO Number 4397-03	Customer GRW
SPRI N/A	MPRI 2	Work Order 4397-02	Purpose Pre-Rehabilitation Survey
QSR N/A	QMR 3121		
OPR 6	Surveyed By Barry Rogers	Direction Downstream	Date 20150629
OPRI 2	Certificate Number U-1012-16405	Pre-Cleaning Jetting	Time 08:40
	Date Cleaned 20150629	End Time 08:54	Weather Dry
			Additional Info

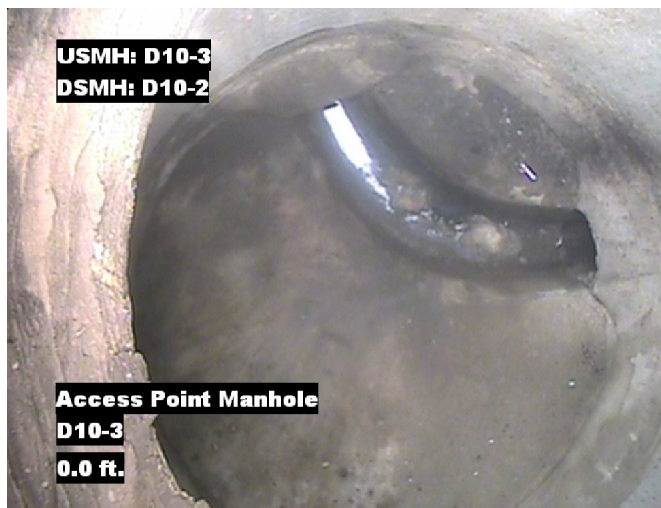
Distance: 0.0 ft. Grade: 0
Condition: Access Point Manhole
Remarks: D10-3

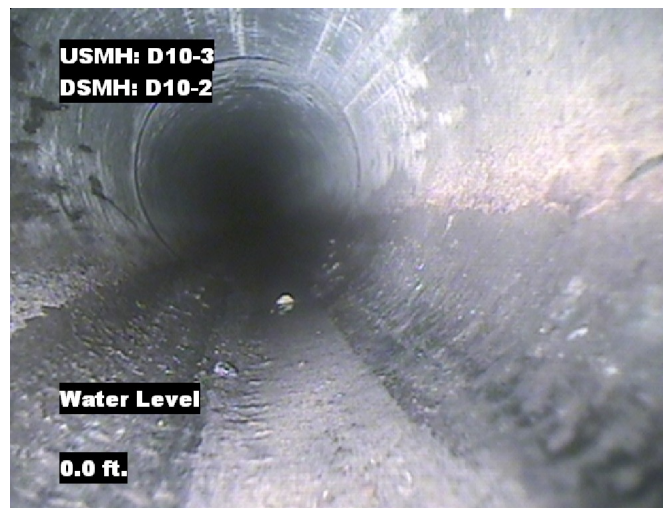
Distance: 0.0 ft. Grade: 0
Condition: Water Level
Remarks: N/A

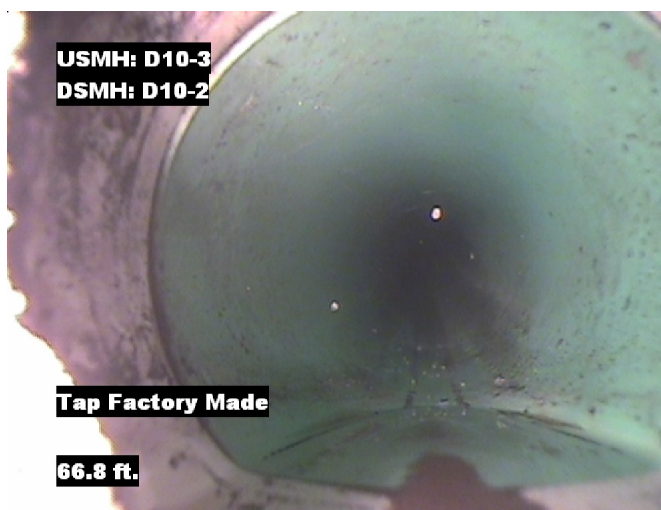
Distance: 66.8 ft. Grade: 0
Condition: Tap Factory Made
Remarks: N/A

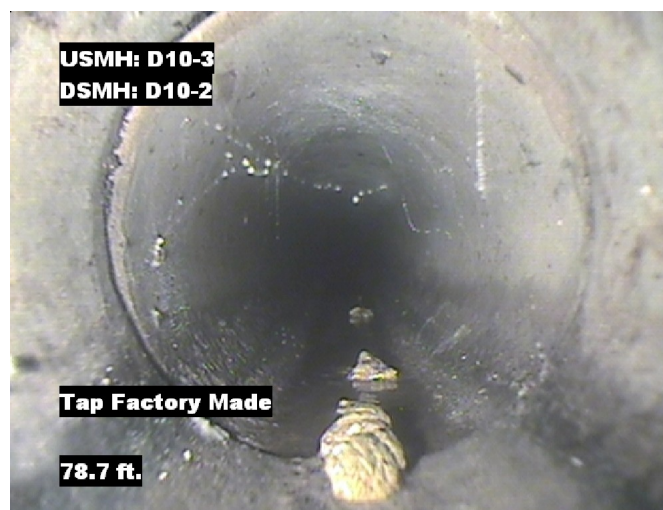
Distance: 78.7 ft. Grade: 0
Condition: Tap Factory Made
Remarks: N/A

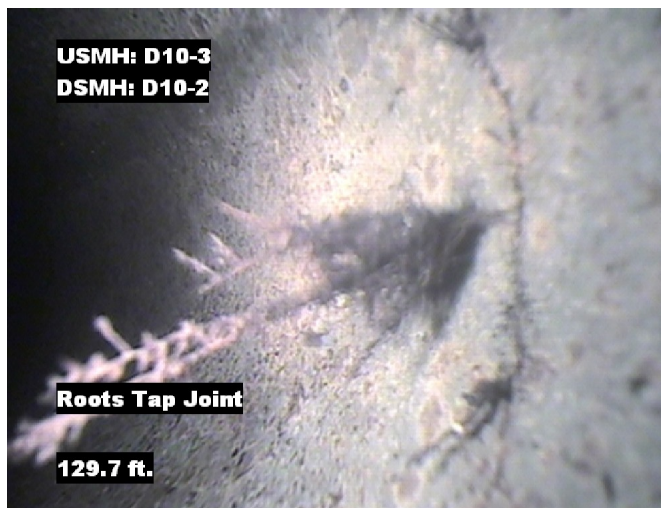
Distance: 129.7 ft. Grade: 2
Condition: Roots Tap Joint
Remarks: N/A

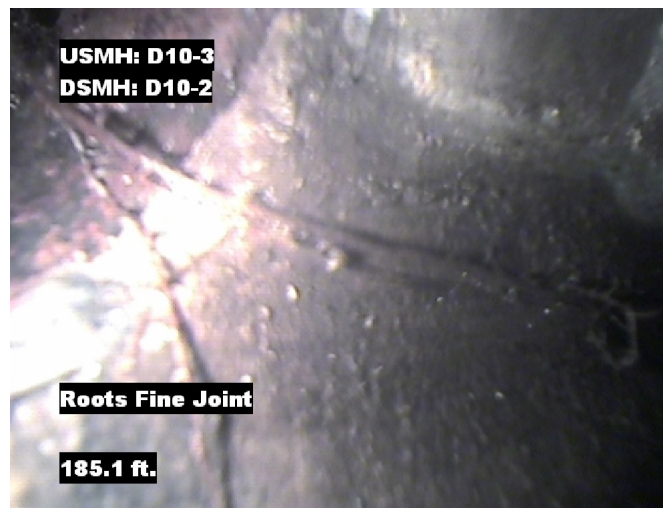
Distance: 185.1 ft. Grade: 1
Condition: Roots Fine Joint
Remarks: N/A

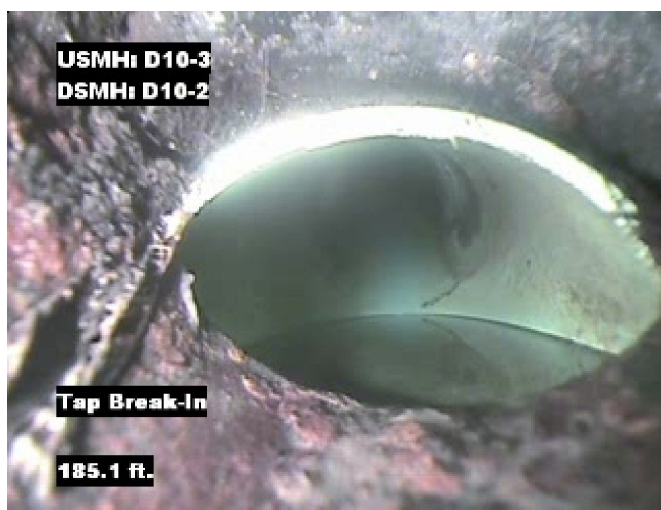
Distance: 185.1 ft. Grade: 3
Condition: Tap Break-In Defective
Remarks: tap has fallen and is defective

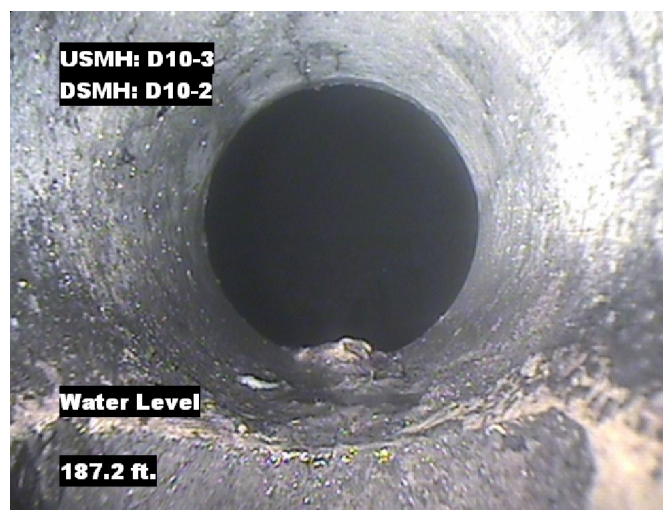
Distance: 187.2 ft. Grade: 0
Condition: Water Level
Remarks: N/A

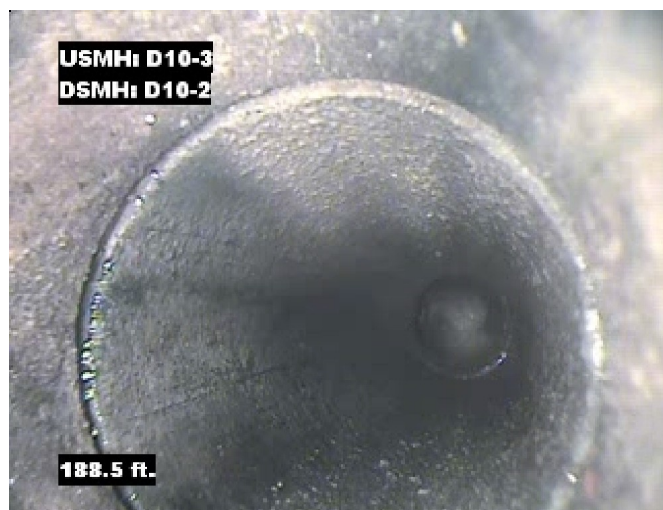
Distance: 188.5 ft. Grade: 0
Condition: Tap Factory Made
Remarks: Drop Line

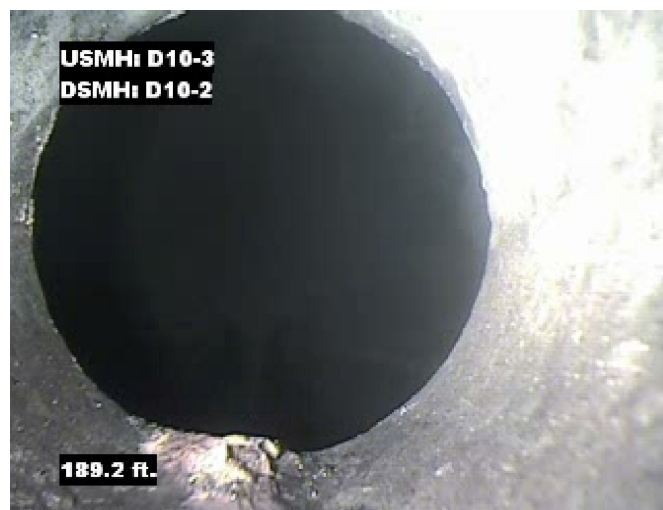
Distance: 189.2 ft. Grade: 0
Condition: Access Point Manhole
Remarks: D10-2
