## Defect Listing

Pipe Segment Refere... <b>D11-1_D-17-1</b>	City <b>Oliver Springs</b>	Street <b>Airport Rd</b>	Material <b>Concrete Pipe (non-...</b>	Location C... <b>Light High...</b>	Sewer Use <b>Sanitary</b>
Upstream MH <b>D11-1</b>	Total Length <b>160.8</b>	Year Laid	Shape <b>Circular</b>	Location Details	
DS Manhole <b>D-17-1</b>	Length surveyed <b>160.8</b>	Year Renewed	Height <b>8</b>	Width <b>8</b>	Pipe Joint... <b>4</b>

SPR <b>N/A</b>	MPR <b>N/A</b>	PO Number <b>4397-03</b>		Customer <b>GRW</b>	
SPRI <b>N/A</b>	MPRI <b>N/A</b>	Work Order <b>4397-02</b>		Purpose <b>Pre-Rehabilitation Survey</b>	
QSR <b>N/A</b>	QMR <b>N/A</b>				
OPR <b>N/A</b>	Surveyed By <b>Barry Rogers</b>	Direction <b>Downstream</b>	Date <b>20150701</b>	Media label	
OPRI <b>N/A</b>	Certificate Number <b>U-1012-16405</b>	Pre-Cleaning <b>Jetting</b>	Time <b>10:44</b>	Weather <b>Saturated</b>	
Date Cleaned <b>20150701</b>			End Time <b>10:50</b>	Additional Info

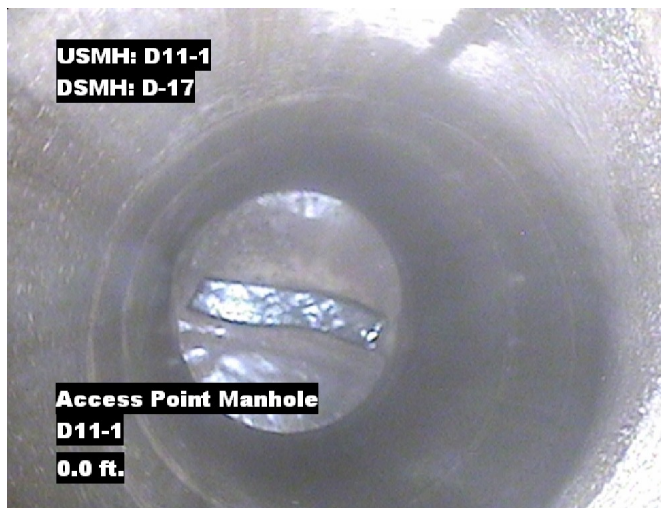
Distance: 0.0 ft. Grade: 0  
Condition: Access Point Manhole  
Remarks: D11-1

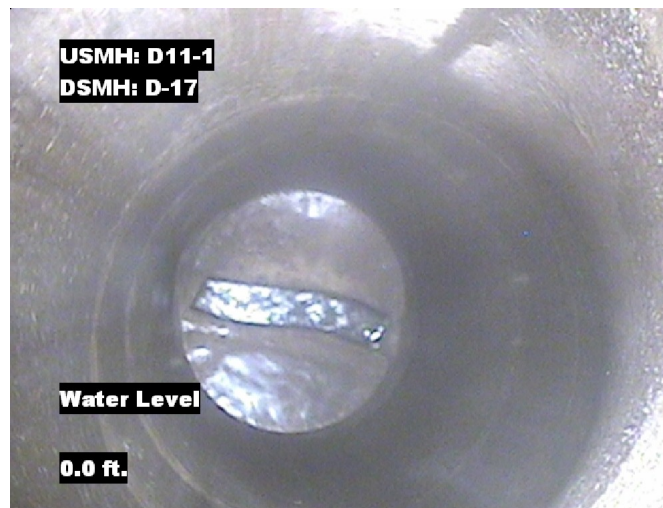
Distance: 0.0 ft. Grade: 0  
Condition: Water Level  
Remarks: N/A

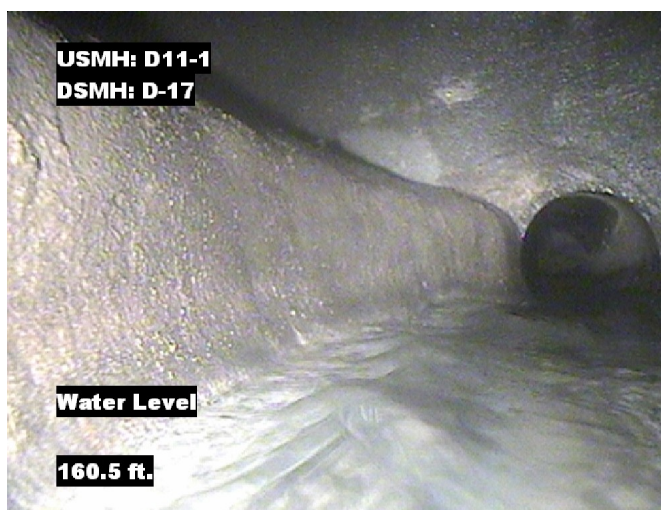
Distance: 160.5 ft. Grade: 0  
Condition: Water Level  
Remarks: N/A

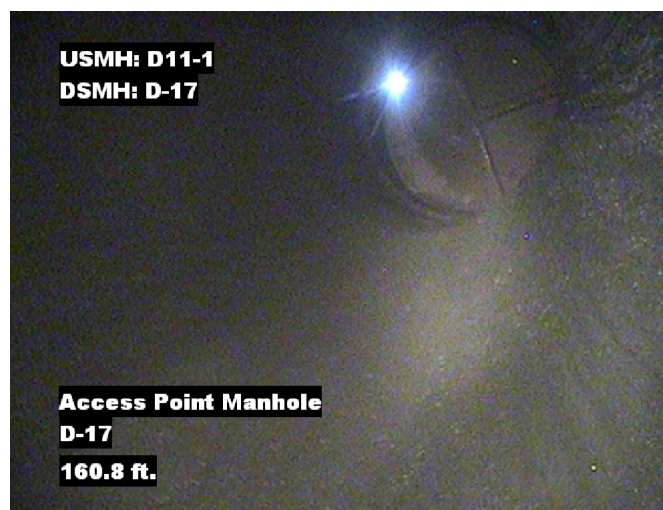
Distance: 160.8 ft. Grade: 0  
Condition: Access Point Manhole  
Remarks: D17-1
