## Defect Listing

Pipe Segment Refere... <b>D11-10_D11-9</b>	City <b>Oliver Springs</b>	Street <b>Norwood Dr</b>	Material <b>Concrete Pipe (non-...</b>	Location C... <b>Light High...</b>	Sewer Use <b>Sanitary</b>
Upstream MH <b>D11-10</b>	Total Length <b>330.3</b>	Year Laid	Shape <b>Circular</b>	Location Details	
DS Manhole <b>D11-9</b>	Length surveyed <b>330.3</b>	Year Renewed	Height <b>8</b>	Width <b>8</b>	Pipe Joint... <b>4</b>

SPR <b>2</b>	MPR <b>N/A</b>	PO Number <b>4397-03</b>	Customer <b>GRW</b>
SPRI <b>1</b>	MPRI <b>N/A</b>	Work Order <b>4397-02</b>	Purpose <b>Pre-Rehabilitation Survey</b>
QSR <b>1200</b>	QMR <b>N/A</b>		
OPR <b>2</b>	Surveyed By <b>Barry Rogers</b>	Direction <b>Downstream</b>	Date <b>20150622</b>
OPRI <b>1</b>	Certificate Number <b>U-1012-16405</b>	Pre-Cleaning <b>Jetting</b>	Time <b>15:14</b>
	Date Cleaned <b>20150622</b>	End Time <b>15:25</b>	Weather <b>Very Dry</b>
			Media label
			Additional Info

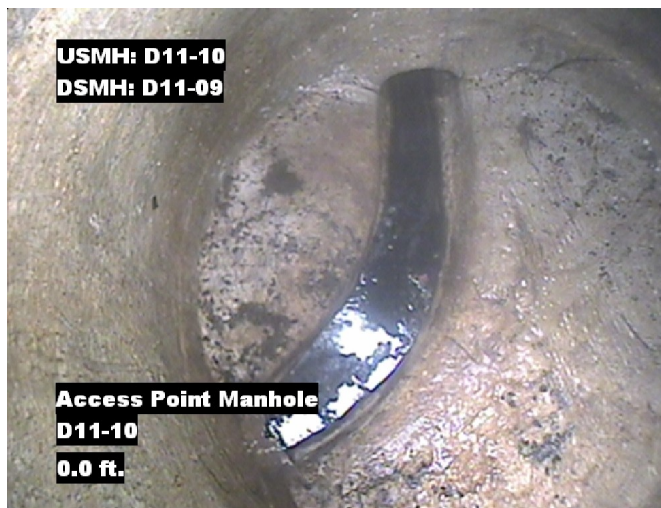
Distance: 0.0 ft. Grade: 0  
Condition: Access Point Manhole  
Remarks: D11-10

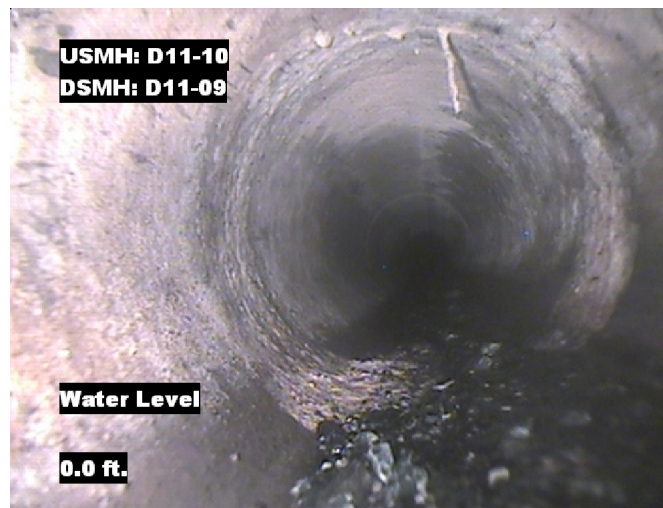
Distance: 0.0 ft. Grade: 0  
Condition: Water Level  
Remarks: N/A

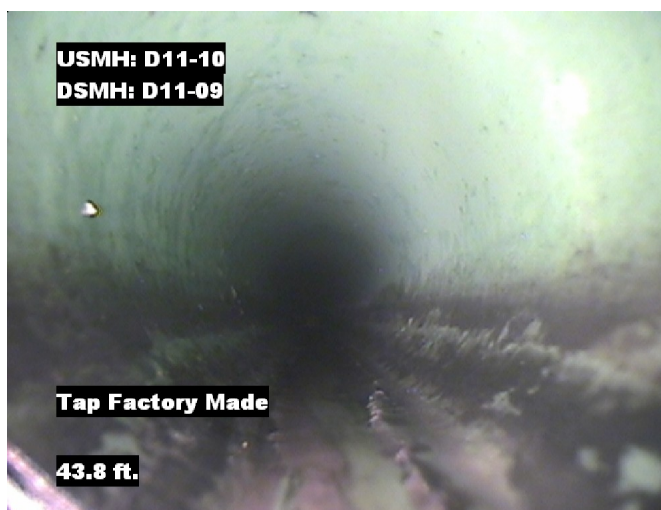
Distance: 43.8 ft. Grade: 0  
Condition: Tap Factory Made  
Remarks: N/A

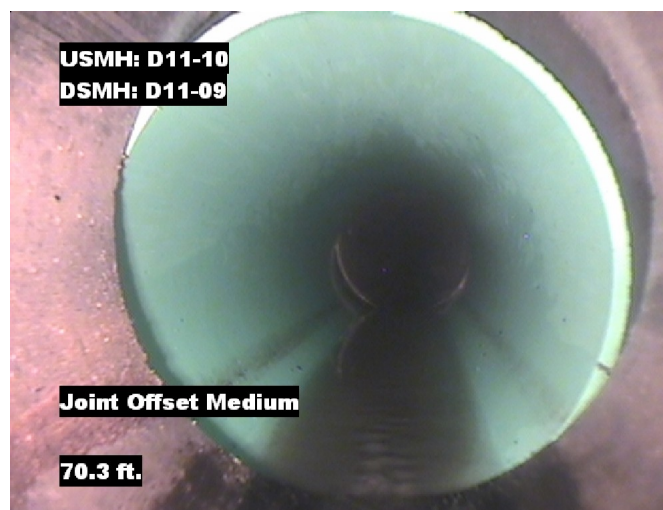
Distance: 70.3 ft. Grade: 1  
Condition: Joint Offset Medium  
Remarks: N/A

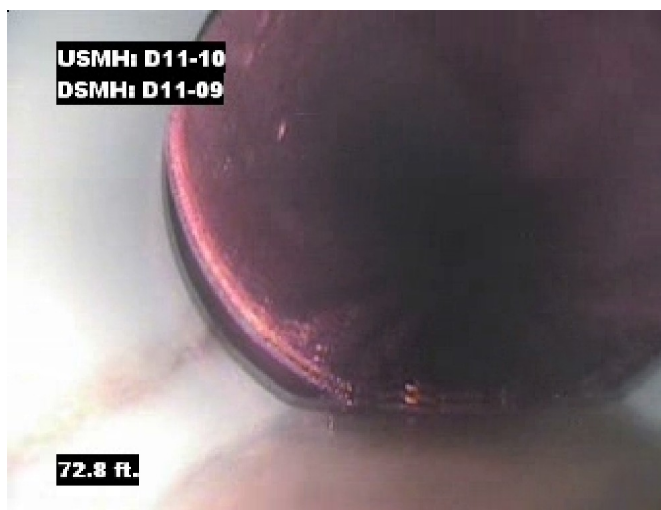
Distance: 72.8 ft. Grade: 1  
Condition: Joint Offset Medium  
Remarks: N/A

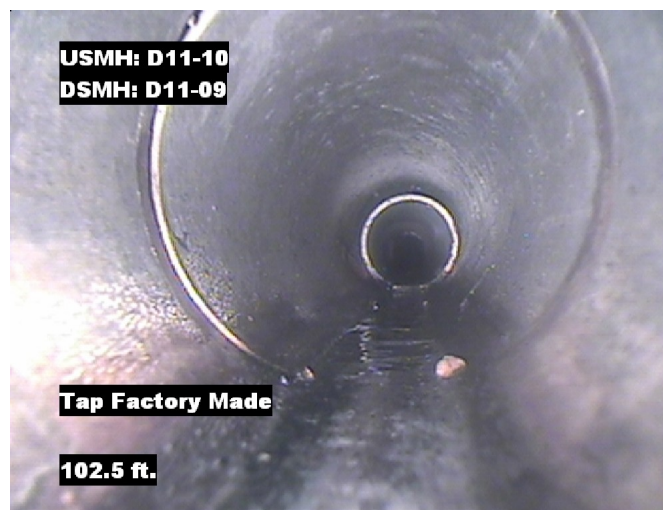
Distance: 102.5 ft. Grade: 0  
Condition: Tap Factory Made  
Remarks: N/A

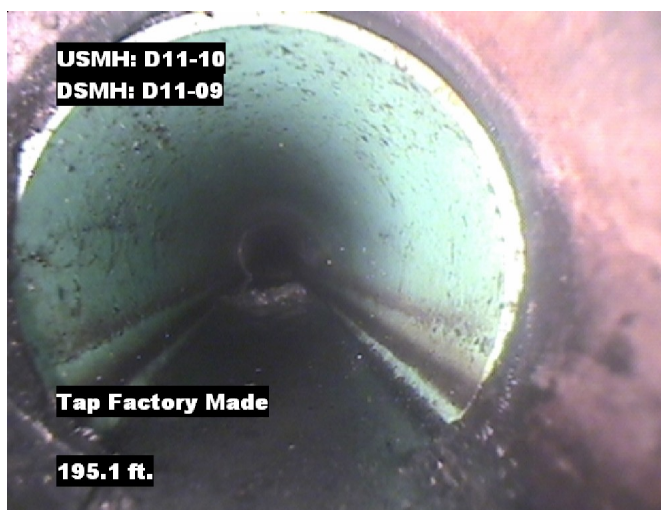
Distance: 195.1 ft. Grade: 0  
Condition: Tap Factory Made  
Remarks: N/A

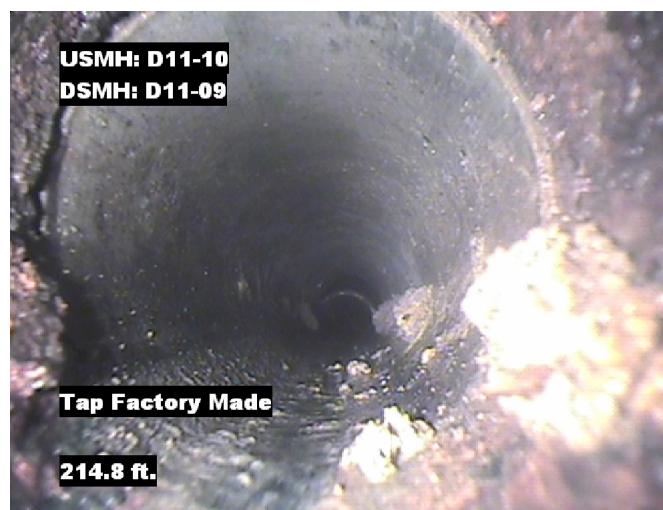
Distance: 214.8 ft. Grade: 0  
Condition: Tap Factory Made  
Remarks: N/A

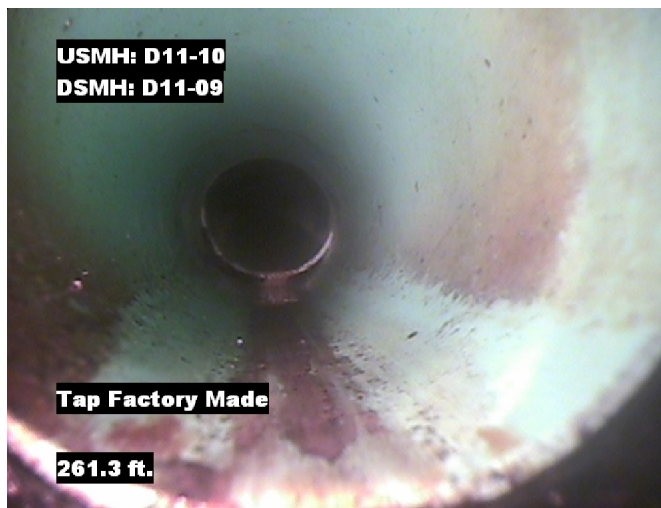
Distance: 261.3 ft. Grade: 0  
Condition: Tap Factory Made  
Remarks: N/A

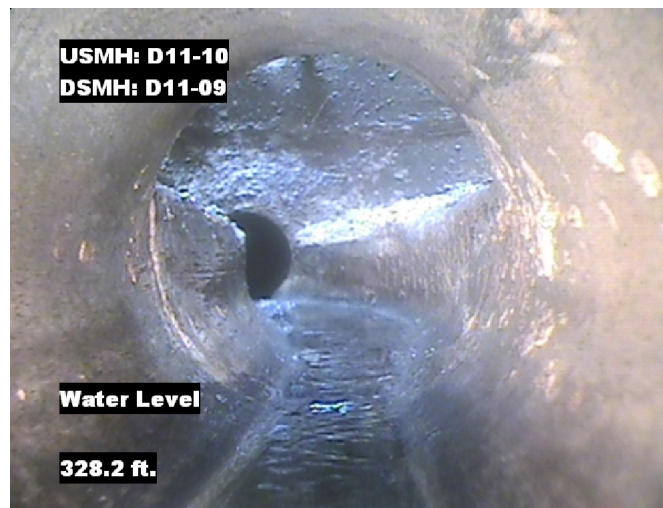
Distance: 328.2 ft. Grade: 0  
Condition: Water Level  
Remarks: N/A

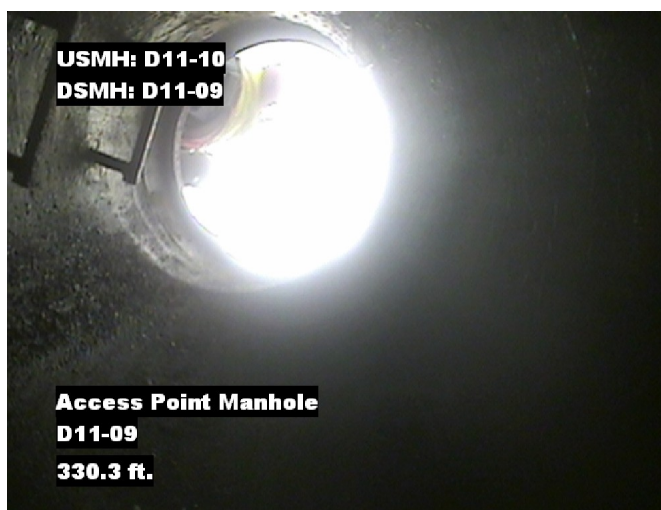
Distance: 330.3 ft. Grade: 0  
Condition: Access Point Manhole  
Remarks: D11-09
