Defect Listing

Pipe Segment Refere... D11-11_D11-10	City Oliver Springs	Street Norwood	Material Concrete Pipe (non-...	Location C... Light High...	Sewer Use Sanitary
Upstream MH D11-11	Total Length 187.7	Year Laid	Shape Circular	Location Details	
DS Manhole D11-10	Length surveyed 187.7	Year Renewed	Height 8	Width 8	Pipe Joint... 4

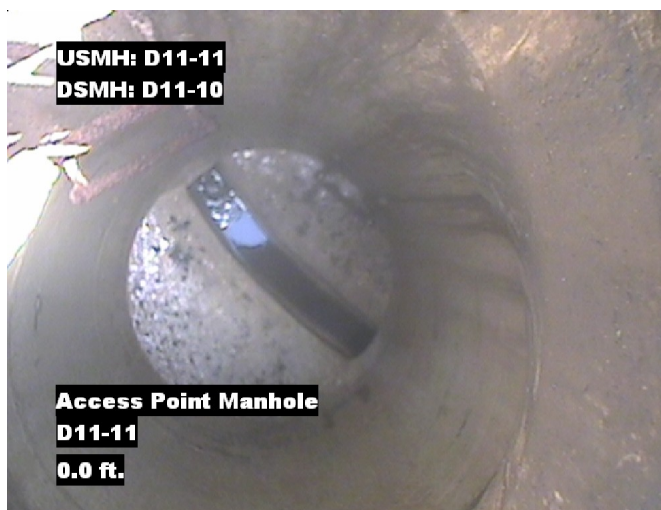
Distance: 0.0 ft. Grade: 0
Condition: Access Point Manhole
Remarks: D11-11

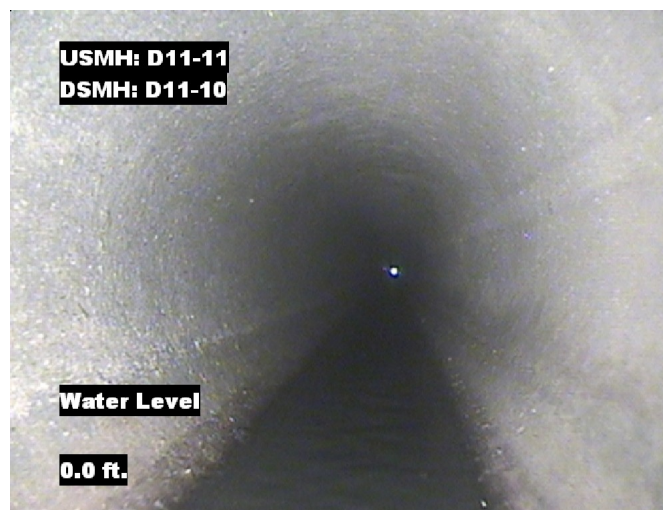
Distance: 0.0 ft. Grade: 0
Condition: Water Level
Remarks: N/A

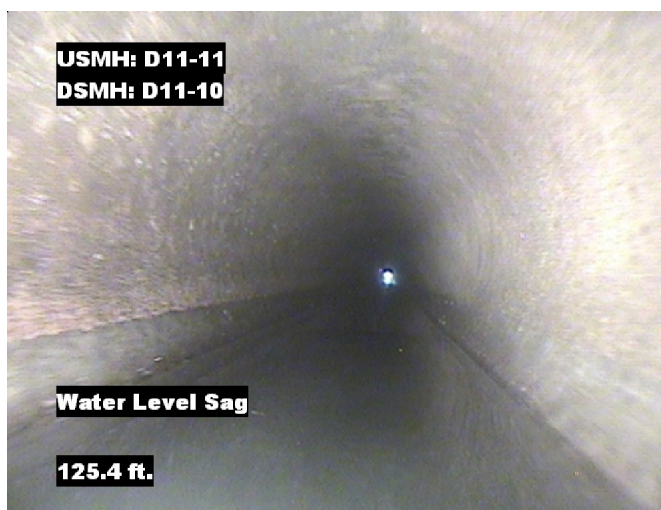
Distance: 125.3 ft. Grade: 2
Condition: Water Level Sag
Remarks: N/A

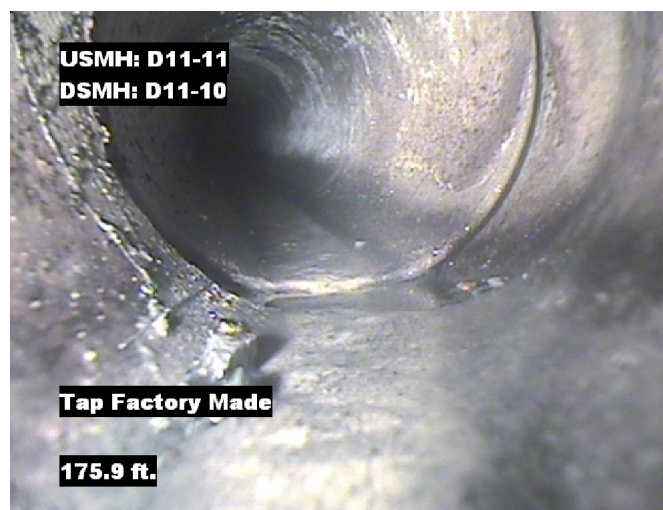
Distance: 175.9 ft. Grade: 0
Condition: Tap Factory Made
Remarks: N/A

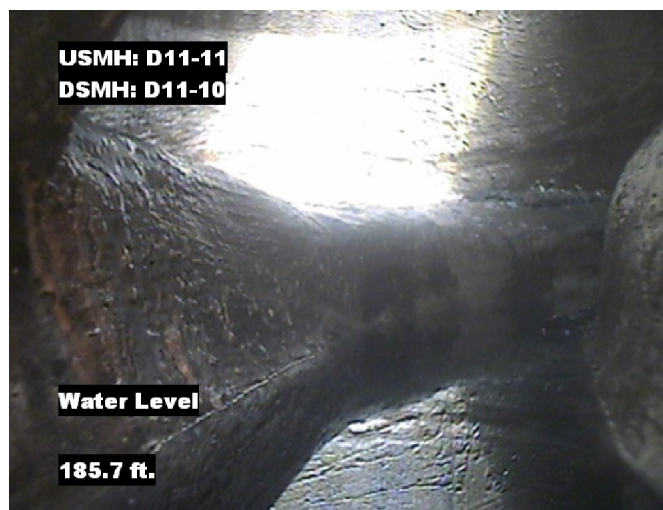
Distance: 185.7 ft. Grade: 0
Condition: Water Level
Remarks: N/A

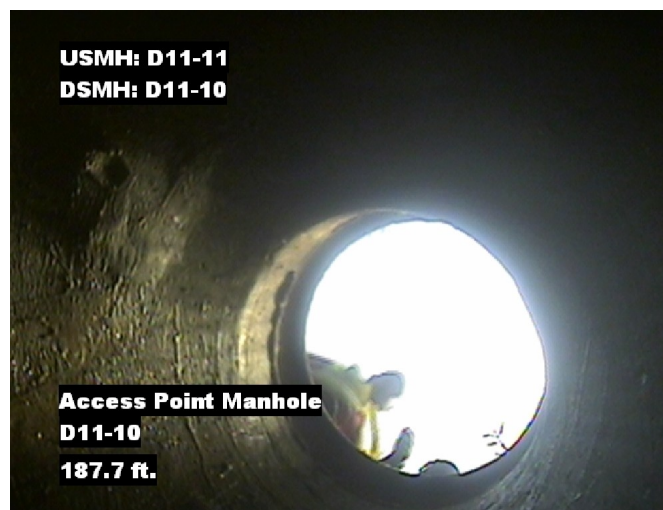
Distance: 187.7 ft. Grade: 0
Condition: Access Point Manhole
Remarks: D11-10
