## Defect Listing

Pipe Segment Refere... <b>D11-12_D11-11</b>	City <b>Oliver Springs</b>	Street <b>Norwood Dr</b>	Material <b>Concrete Pipe (non-...</b>	Location C... <b>Light High...</b>	Sewer Use <b>Sanitary</b>
Upstream MH <b>D11-12</b>	Total Length <b>324.4</b>	Year Laid	Shape <b>Circular</b>	Location Details	
DS Manhole <b>D11-11</b>	Length surveyed <b>324.4</b>	Year Renewed	Height <b>8</b>	Width <b>8</b>	Pipe Joint... <b>4</b>

SPR <b>N/A</b>	MPR <b>4</b>	PO Number <b>4397-03</b>	Customer <b>GRW</b>
SPRI <b>N/A</b>	MPRI <b>2</b>	Work Order <b>4397-02</b>	Purpose <b>Pre-Rehabilitation Survey</b>
QSR <b>N/A</b>	QMR <b>2200</b>		
OPR <b>4</b>	Surveyed By <b>Barry Rogers</b>	Direction <b>Downstream</b>	Date <b>20150622</b>
OPRI <b>2</b>	Certificate Number <b>U-1012-16405</b>	Pre-Cleaning <b>Jetting</b>	Time <b>13:43</b>
	Date Cleaned <b>20150622</b>	End Time <b>13:54</b>	Weather <b>Very Dry</b>
			Media label
			Additional Info

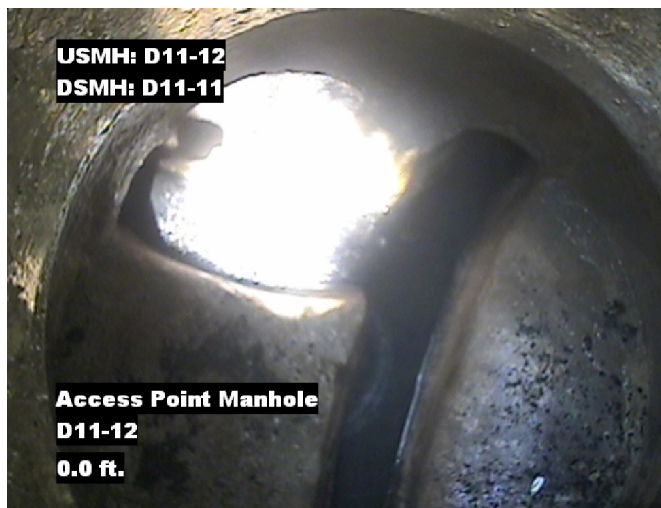
Distance: 0.0 ft. Grade: 0  
Condition: Access Point Manhole  
Remarks: D11-12

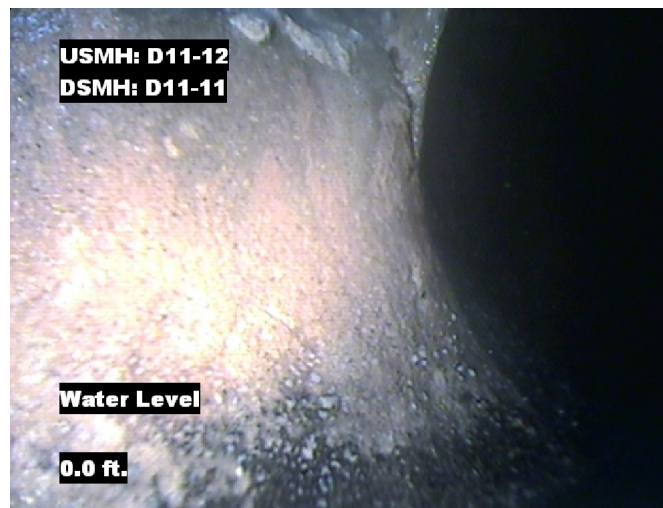
Distance: 0.0 ft. Grade: 0  
Condition: Water Level  
Remarks: N/A

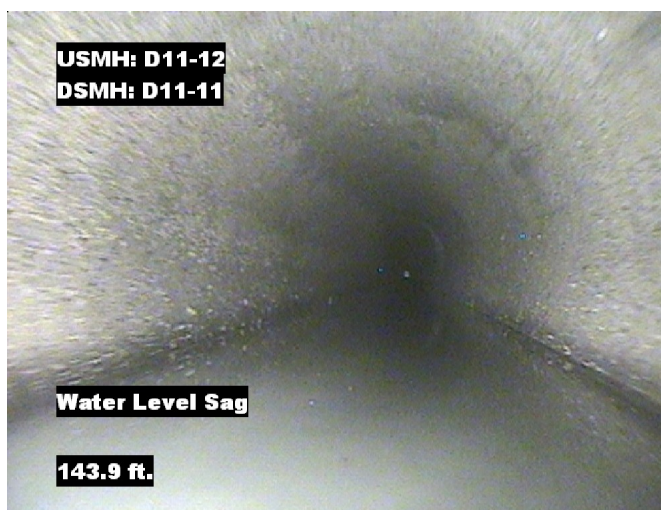
Distance: 143.7 ft. Grade: 2  
Condition: Water Level Sag  
Remarks: N/A

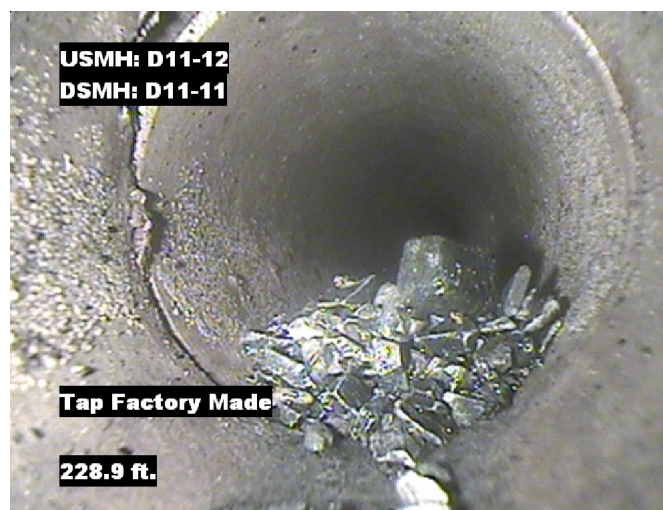
Distance: 228.9 ft. Grade: 0  
Condition: Tap Factory Made  
Remarks: N/A

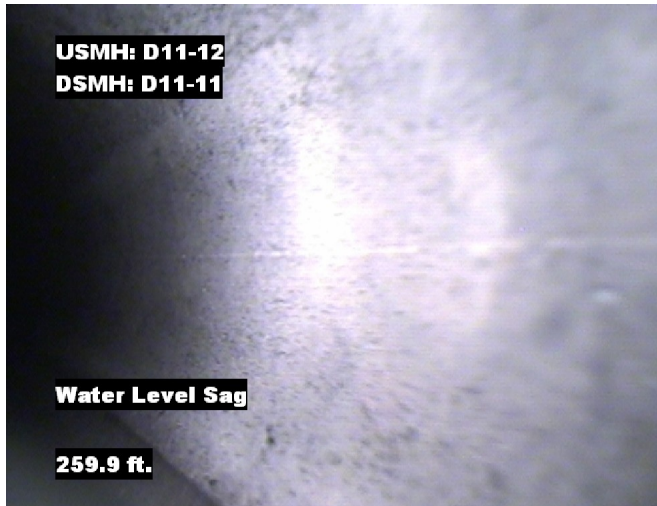
Distance: 259.9 ft. Grade: 2  
Condition: Water Level Sag  
Remarks: N/A

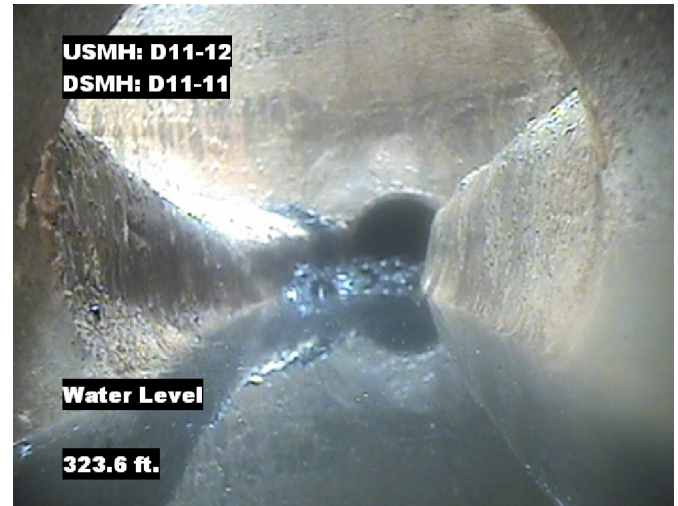
Distance: 323.6 ft. Grade: 0  
Condition: Water Level  
Remarks: N/A

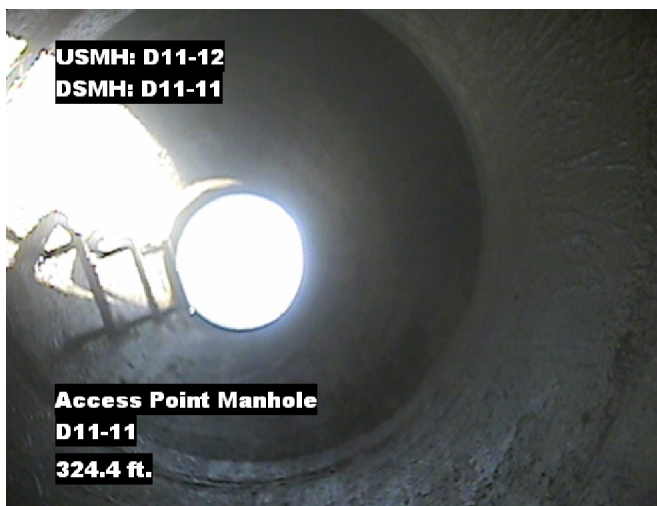
Distance: 324.4 ft. Grade: 0  
Condition: Access Point Manhole  
Remarks: D11-11
