Defect Listing

Pipe Segment Refere... D11-13_D11-12	City Oliver Springs	Street 491 England Dr	Material Concrete Pipe (non-...	Location C... Light High...	Sewer Use Sanitary
Upstream MH D11-13	Total Length 254.7	Year Laid	Shape Circular	Location Details in the street	
DS Manhole D11-12	Length surveyed 254.7	Year Renewed	Height 8	Width 8	Pipe Joint... 4

SPR N/A	MPR 8	PO Number 4397-03	Customer GRW
SPRI N/A	MPRI 4	Work Order 4397-02	Purpose Pre-Rehabilitation Survey
QSR N/A	QMR 4200		
OPR 8	Surveyed By David_brown	Direction Downstream	Date 20150620
OPRI 4	Certificate Number U-607-5202	Pre-Cleaning Heavy Cleaning	Time 16:30
	Date Cleaned 20150620	End Time 16:49	Additional Info Manhole D11-13 was ...

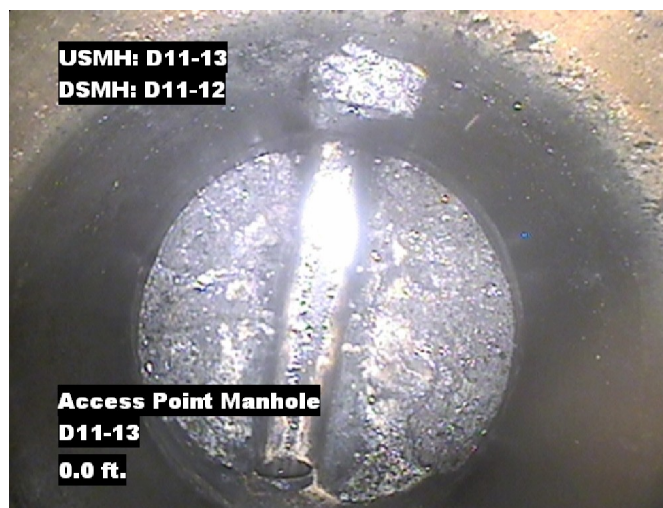
Distance: 0.0 ft. Grade: 0
Condition: Access Point Manhole
Remarks: D11-13

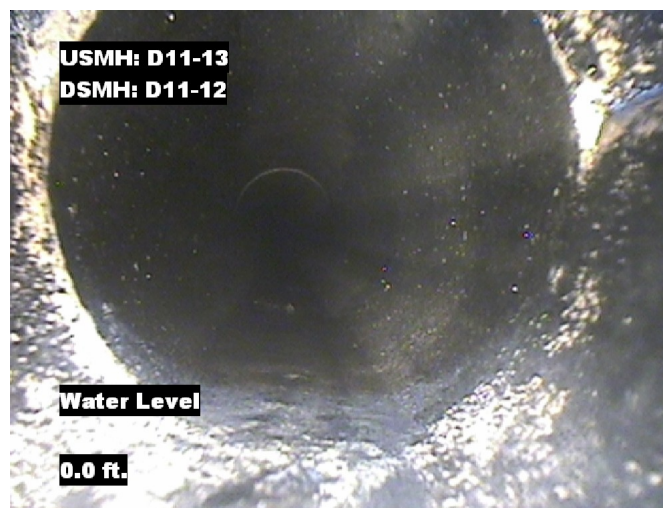
Distance: 0.0 ft. Grade: 0
Condition: Water Level
Remarks: N/A

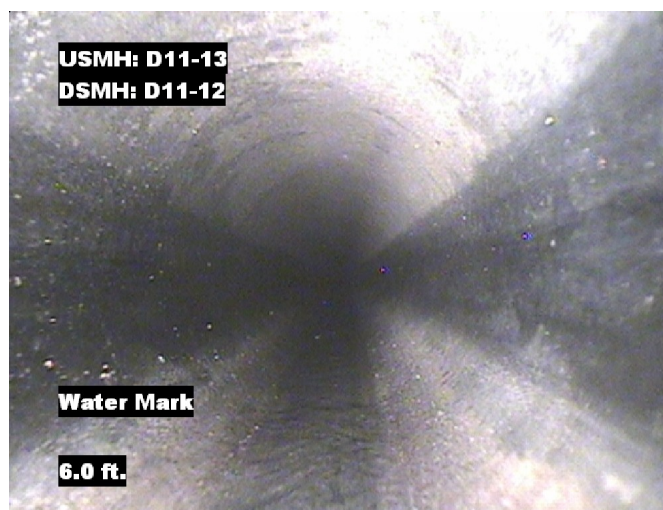
Distance: 6.0 ft. Grade: 4
Condition: Water Mark
Remarks: N/A

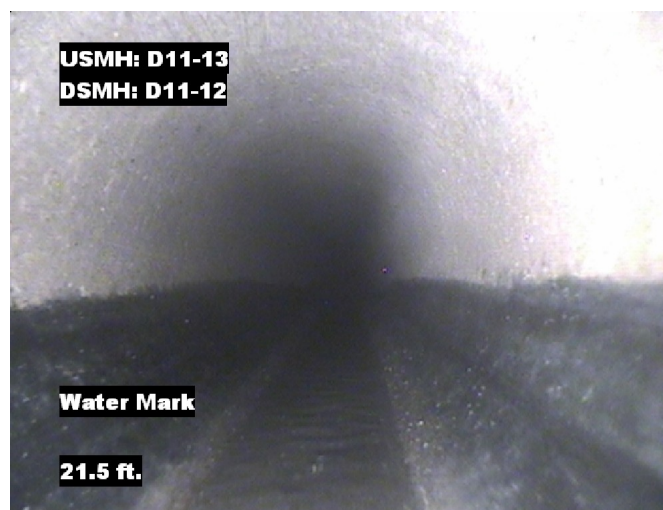
Distance: 21.5 ft. Grade: 4
Condition: Water Mark
Remarks: N/A

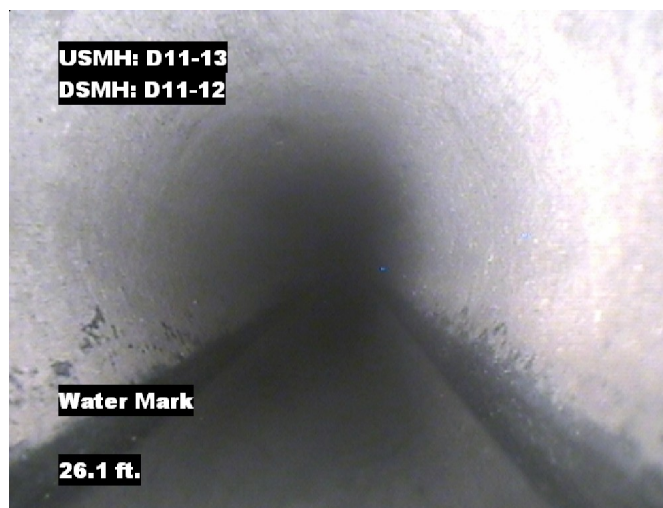
Distance: 26.1 ft. Grade: 0
Condition: Water Mark
Remarks: N/A

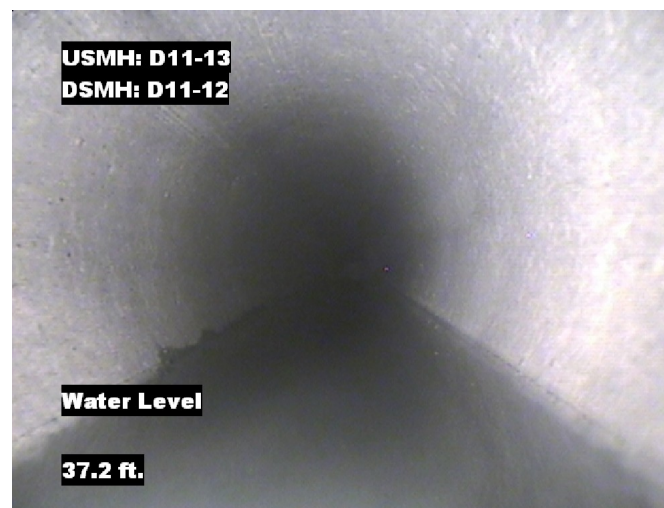
Distance: 37.2 ft. Grade: 0
Condition: Water Level
Remarks: N/A

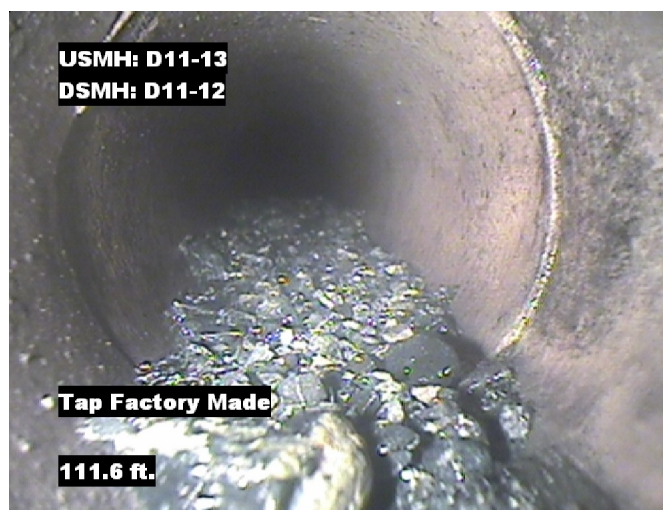
Distance: 111.6 ft. Grade: 0
Condition: Tap Factory Made
Remarks: N/A

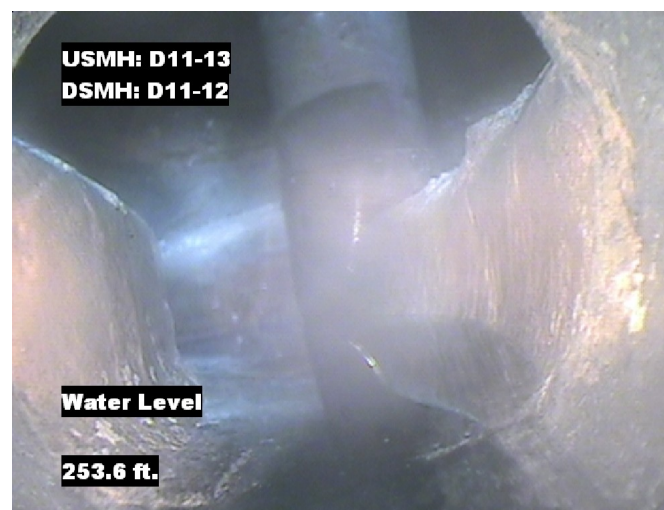
Distance: 253.6 ft. Grade: 0
Condition: Water Level
Remarks: N/A

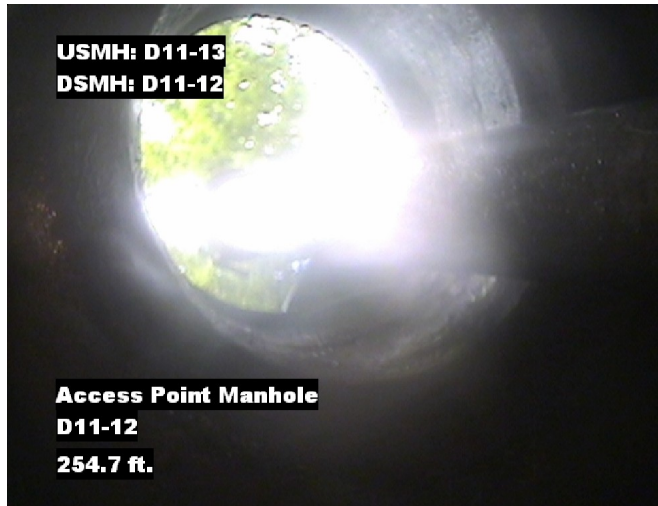
Distance: 254.7 ft. Grade: 0
Condition: Access Point Manhole
Remarks: D11-12
