Defect Listing

Pipe Segment Refere... D11-14_D11-13	City Oliver Springs	Street England Dr	Material Concrete Pipe (non-...	Location C... Light High...	Sewer Use Sanitary
Upstream MH D11-14	Total Length 315.2	Year Laid	Shape Circular	Location Details England Dr	
DS Manhole D11-13	Length surveyed 1.4	Year Renewed	Height 8	Width 8	Pipe Joint... 4

SPR N/A	MPR N/A	PO Number 4397-03		Customer GRW	
SPRI N/A	MPRI N/A	Work Order 4397-02		Purpose Pre-Rehabilitation Survey	
QSR N/A	QMR N/A				
OPR N/A	Surveyed By Barry Rogers	Direction Upstream	Date 20150622	Media label	
OPRI N/A	Certificate Number U-1012-16405	Pre-Cleaning No Pre-Cleaning	Time 11:45	Weather Damp	
Date Cleaned			End Time 11:47	Additional Info

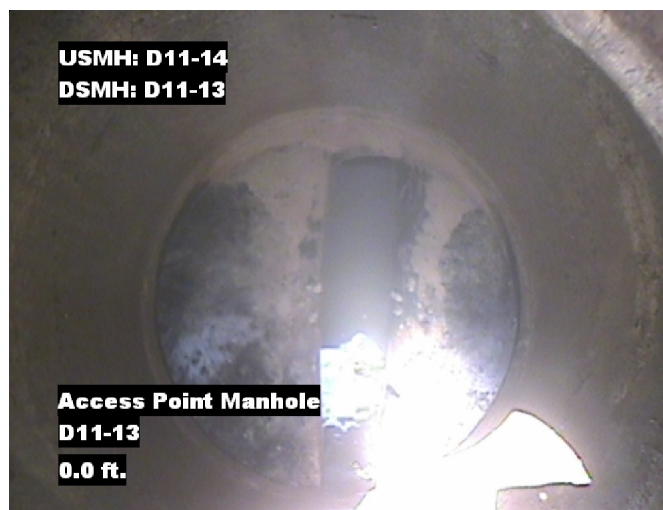
Distance: 0.0 ft. Grade: 0
Condition: Access Point Manhole
Remarks: D11-13

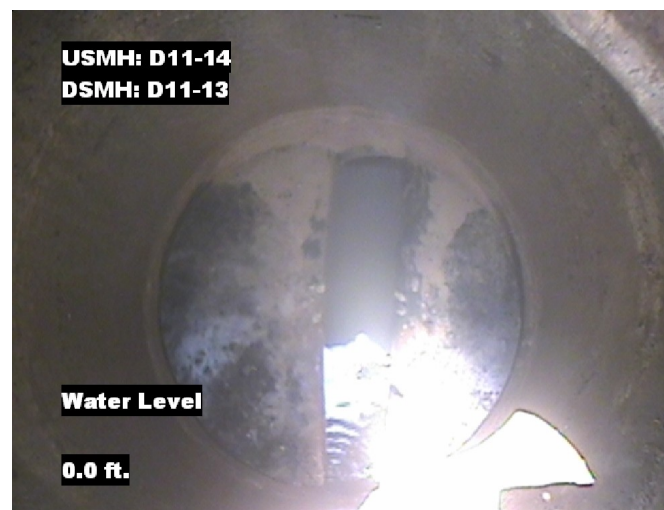
Distance: 0.0 ft. Grade: 0
Condition: Water Level
Remarks: N/A

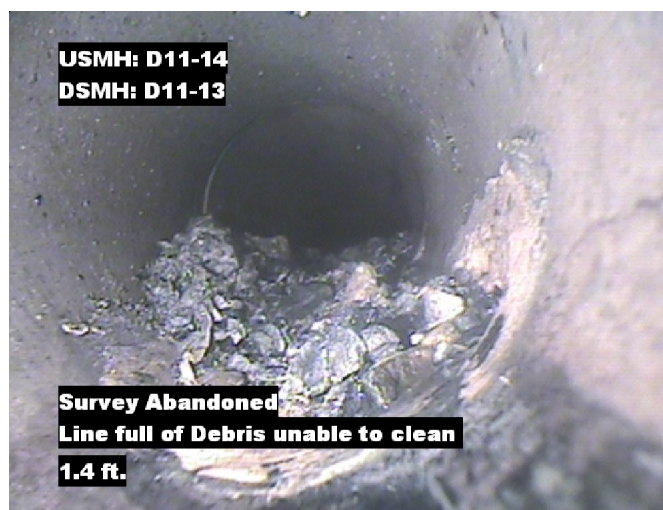
Distance: 1.4 ft. Grade: 0
Condition: Survey Abandoned
Remarks: Line full of Debris unable to clean
