Defect Listing

Pipe Segment Refere... D11-2_D11-1	City Oliver Springs	Street Airport Rd	Material Other	Location C... Light High...	Sewer Use Sanitary
Upstream MH D11-2	Total Length 322	Year Laid	Shape Circular	Location Details	
DS Manhole D11-1	Length surveyed 322	Year Renewed	Height 8	Width 8	Pipe Joint... N/A

Image Report 4/Page

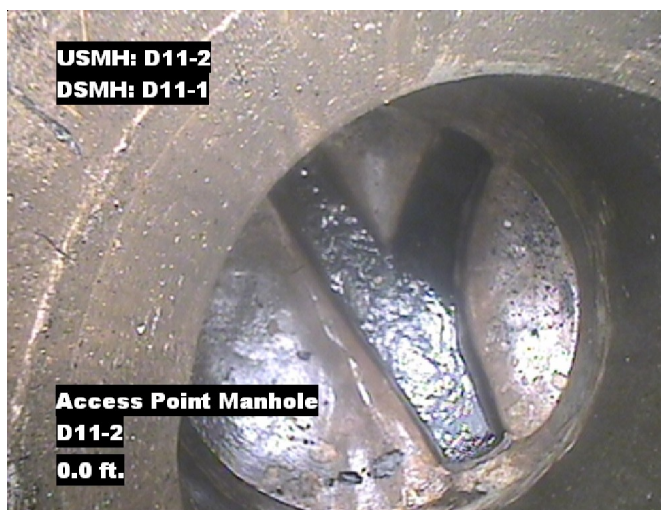
Distance: 0.0 ft. Grade: 0
Condition: Access Point Manhole
Remarks: D11-2

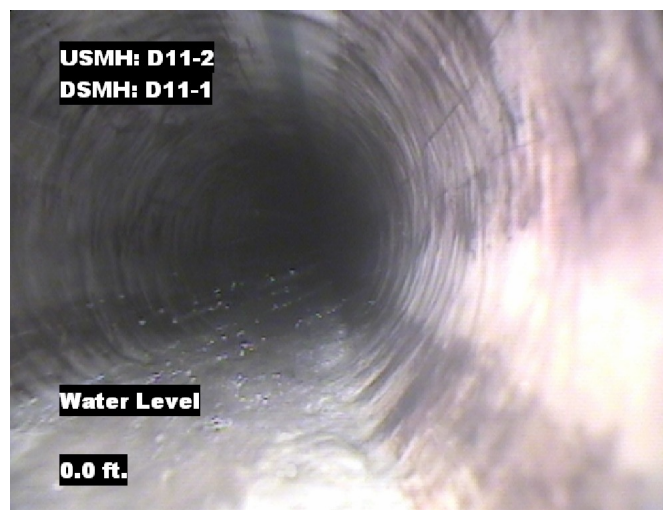
Distance: 0.0 ft. Grade: 0
Condition: Water Level
Remarks: N/A

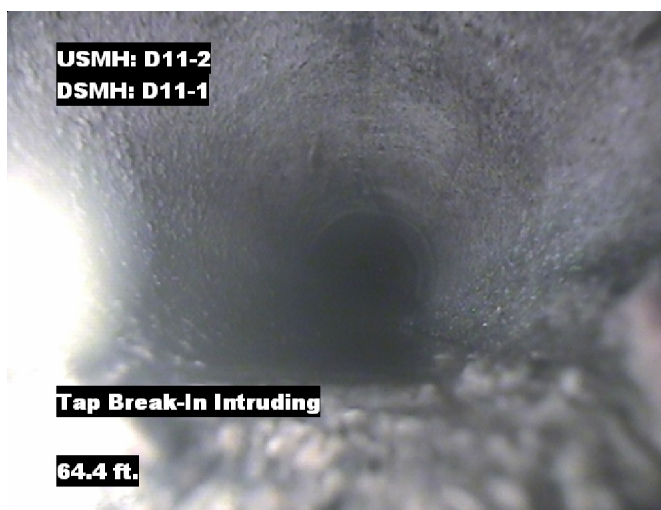
Distance: 64.4 ft. Grade: 2
Condition: Tap Break-In Intruding
Remarks: N/A

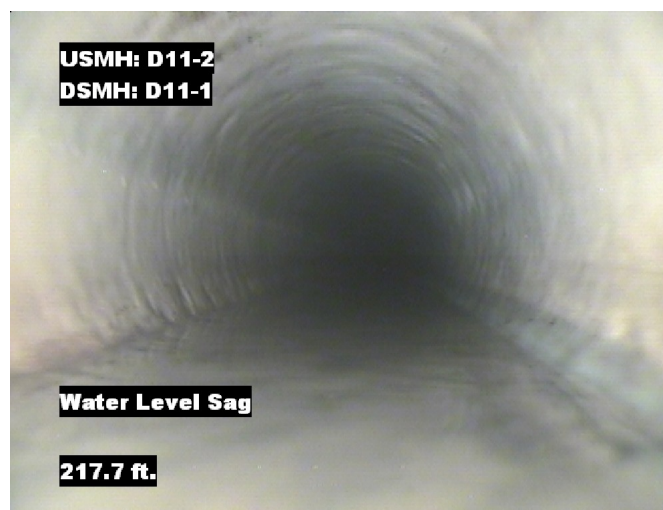
Distance: 217.6 ft. Grade: 2
Condition: Water Level Sag
Remarks: N/A

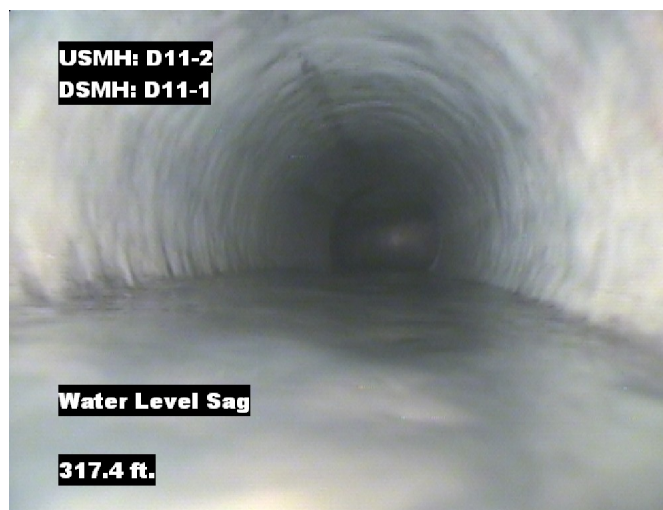
Distance: 317.3 ft. Grade: 2
Condition: Water Level Sag
Remarks: N/A

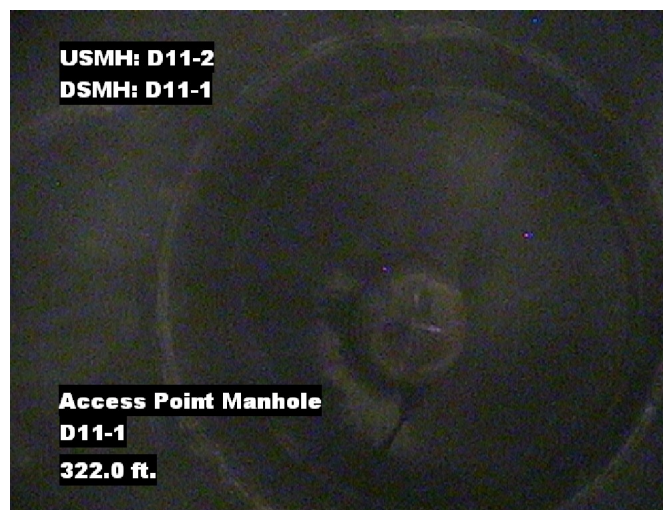
Distance: 322.0 ft. Grade: 0
Condition: Access Point Manhole
Remarks: D11-1
