## Defect Listing

Pipe Segment Refere... <b>D11-2A_D11-2</b>	City <b>Oliver Springs</b>	Street <b>Airport Rd</b>	Material <b>Other</b>	Location C... <b>Light High...</b>	Sewer Use <b>Sanitary</b>
Upstream MH <b>D11-2A</b>	Total Length <b>193.1</b>	Year Laid	Shape <b>Circular</b>	Location Details <b>Rd</b>	
DS Manhole <b>D11-2</b>	Length surveyed <b>193.1</b>	Year Renewed	Height <b>8</b>	Width <b>8</b>	Pipe Joint... <b>N/A</b>

SPR <b>N/A</b>	MPR <b>N/A</b>	PO Number <b>4397-03</b>	Customer <b>GRW</b>
SPRI <b>N/A</b>	MPRI <b>N/A</b>	Work Order <b>4397-02</b>	Purpose <b>Pre-Rehabilitation Survey</b>
QSR <b>N/A</b>	QMR <b>N/A</b>		
OPR <b>N/A</b>	Surveyed By <b>Barry Rogers</b>	Direction <b>Downstream</b>	Date <b>20150701</b>
OPRI <b>N/A</b>	Certificate Number <b>U-1012-16405</b>	Pre-Cleaning <b>Jetting</b>	Time <b>09:32</b>
	Date Cleaned <b>20150701</b>	End Time <b>09:42</b>	Weather <b>Saturated</b>
			Media label
			Additional Info

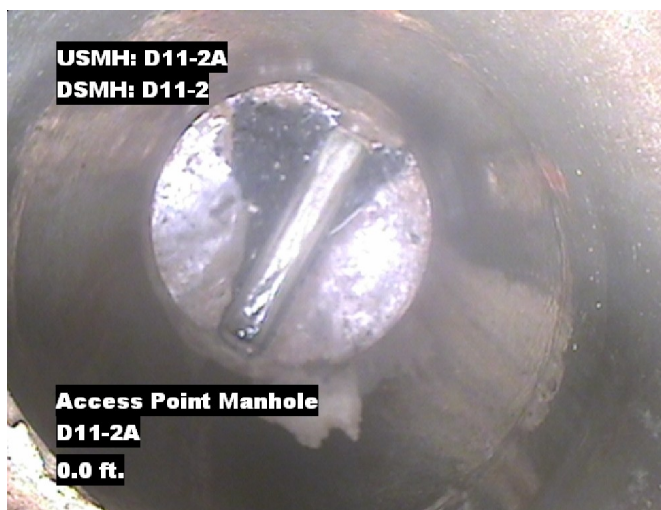
Distance: 0.0 ft. Grade: 0  
Condition: Access Point Manhole  
Remarks: D11-2A

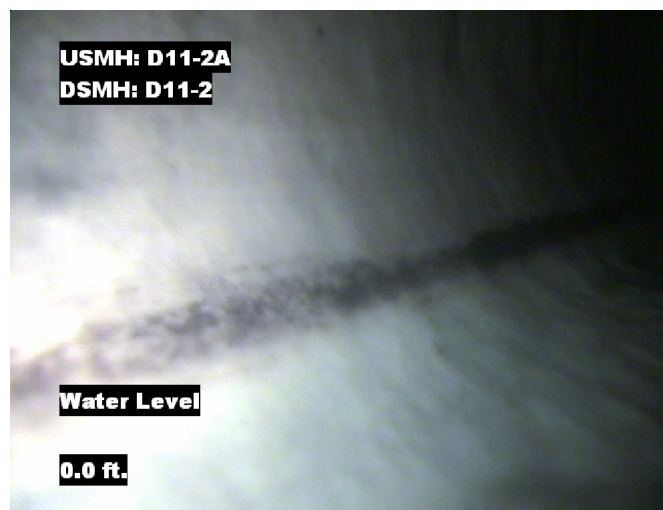
Distance: 0.0 ft. Grade: 0  
Condition: Water Level  
Remarks: N/A

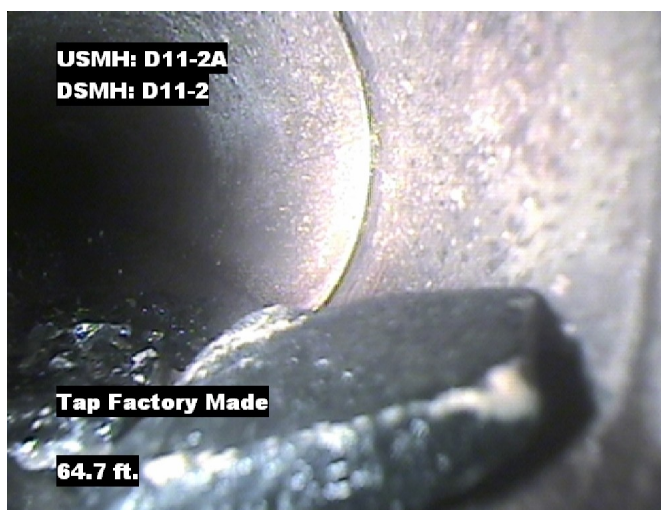
Distance: 64.7 ft. Grade: 0  
Condition: Tap Factory Made  
Remarks: N/A

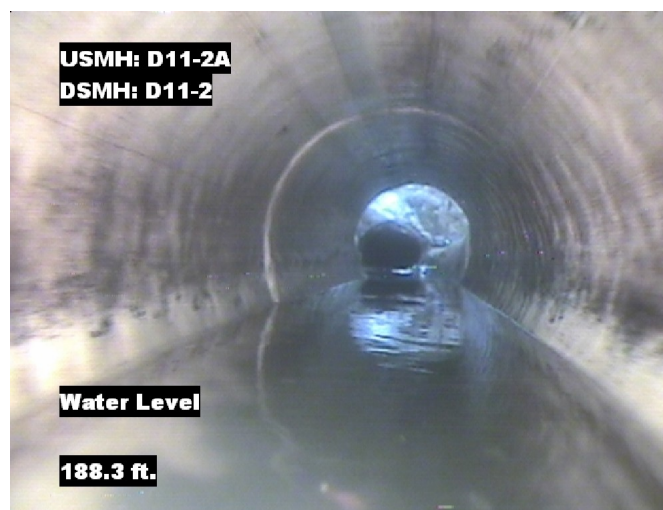
Distance: 188.3 ft. Grade: 0  
Condition: Water Level  
Remarks: N/A

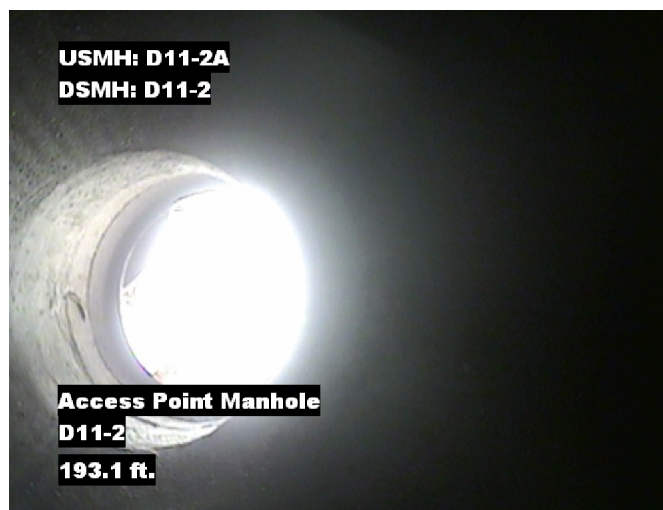
Distance: 193.1 ft. Grade: 0  
Condition: Access Point Manhole  
Remarks: D11-2
