## Defect Listing

Pipe Segment Refere... <b>D11-2B_D11-2A</b>	City <b>Oliver Springs</b>	Street <b>Airport Rd</b>	Material <b>Other</b>	Location C... <b>Light High...</b>	Sewer Use <b>Sanitary</b>
Upstream MH <b>D11-2B</b>	Total Length <b>81.3</b>	Year Laid	Shape <b>Circular</b>	Location Details	
DS Manhole <b>D11-2A</b>	Length surveyed <b>81.3</b>	Year Renewed	Height <b>8</b>	Width <b>8</b>	Pipe Joint... <b>N/A</b>

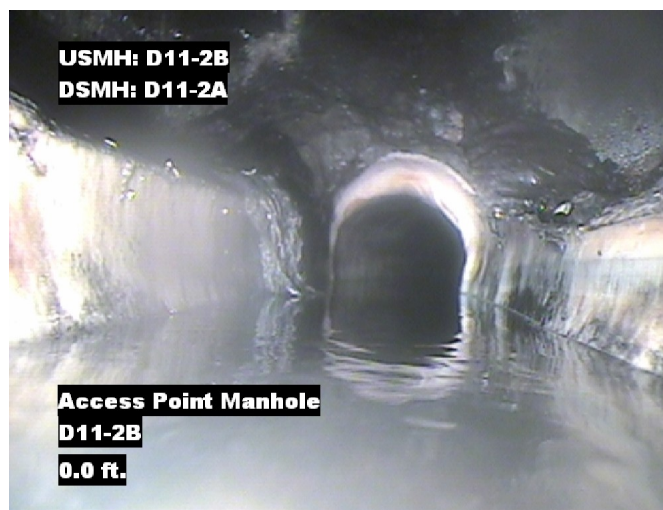
Distance: 0.0 ft. Grade: 0  
Condition: Access Point Manhole  
Remarks: D11-2B

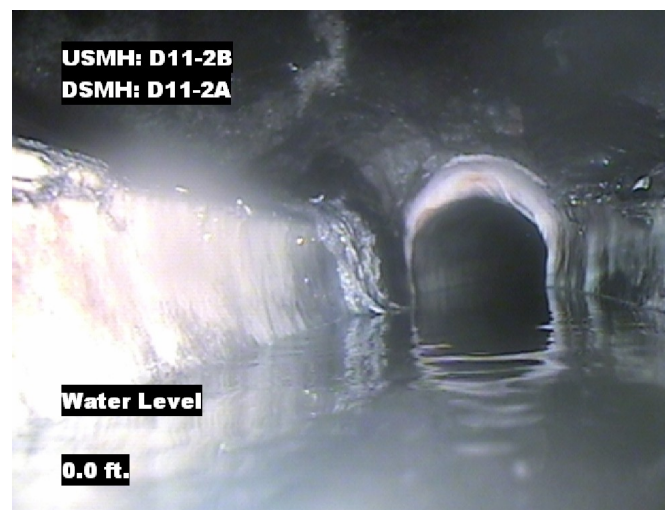
Distance: 0.0 ft. Grade: 0  
Condition: Water Level  
Remarks: N/A

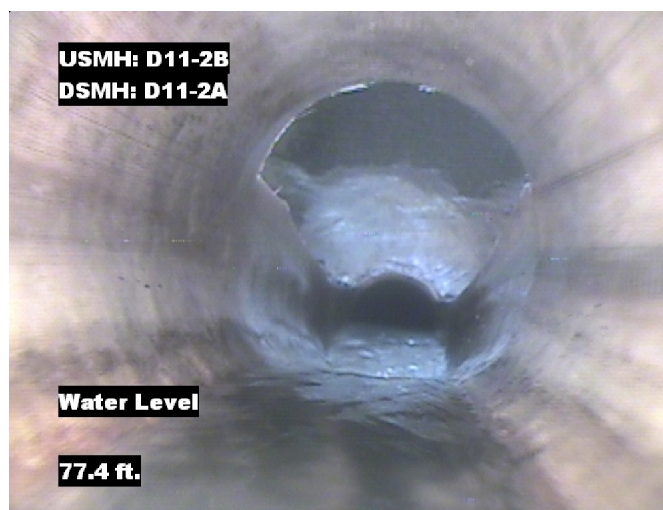
Distance: 77.3 ft. Grade: 0  
Condition: Water Level  
Remarks: N/A

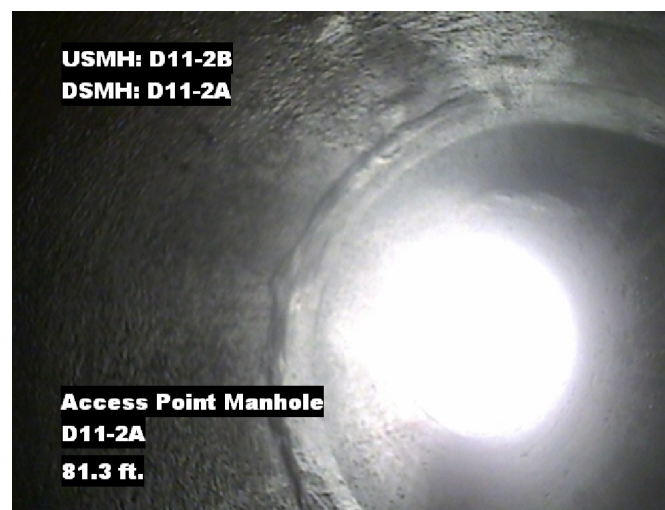
Distance: 81.3 ft. Grade: 0  
Condition: Access Point Manhole  
Remarks: D11-2A
