Defect Listing

Pipe Segment Refere... D11-3_D11-2B	City Oliver Springs	Street Airport Rd	Material Concrete Pipe (non-...	Location C... Light High...	Sewer Use Sanitary
Upstream MH D11-3	Total Length 108.2	Year Laid	Shape Circular	Location Details	
DS Manhole D11-2B	Length surveyed 108.2	Year Renewed	Height 8	Width 8	Pipe Joint... 4

SPR N/A	MPR 2	PO Number 4397-03	Customer GRW
SPRI N/A	MPRI 2	Work Order 4397-02	Purpose Pre-Rehabilitation Survey
QSR N/A	QMR 2100		
OPR 2	Surveyed By Barry Rogers	Direction Downstream	Date 20150701
OPRI 2	Certificate Number U-1012-16405	Pre-Cleaning Jetting	Time 08:50
	Date Cleaned 20150701	End Time 09:05	Weather Saturated
			Media label
			Additional Info

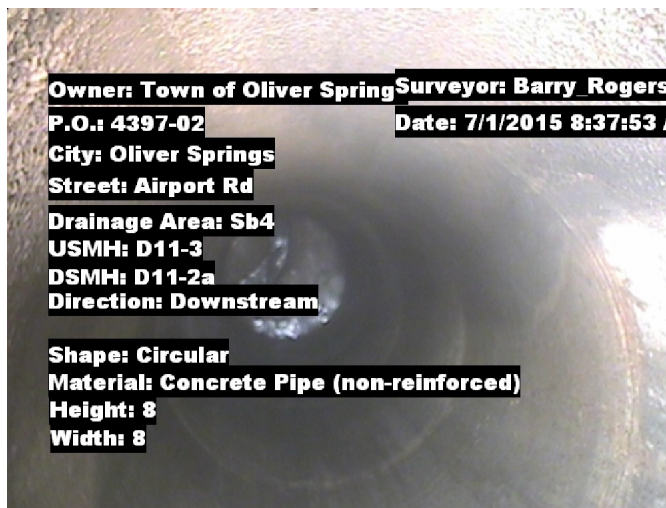
Distance: 0.0 ft. Grade: 0
Condition: Access Point Manhole
Remarks: D11-3

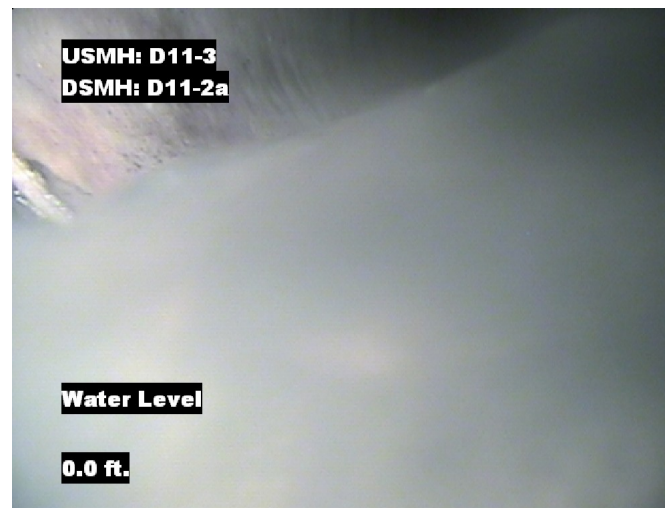
Distance: 0.0 ft. Grade: 0
Condition: Water Level
Remarks: N/A

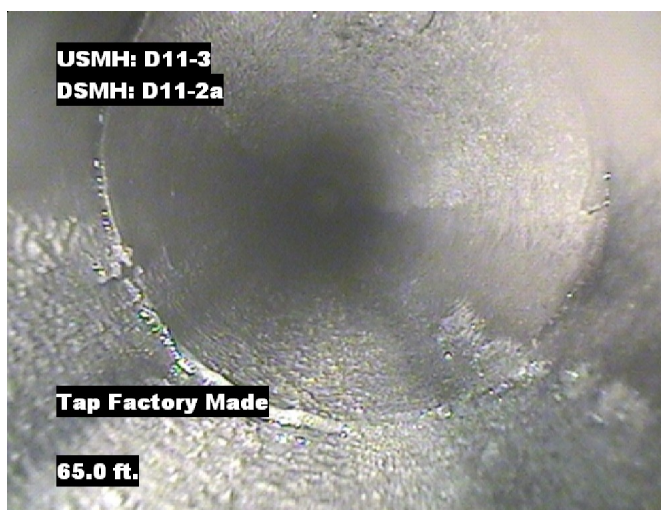
Distance: 65.0 ft. Grade: 0
Condition: Tap Factory Made
Remarks: N/A

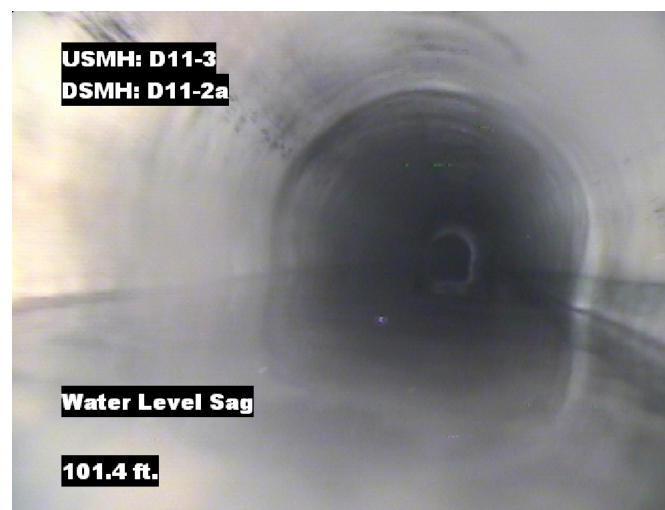
Distance: 101.3 ft. Grade: 2
Condition: Water Level Sag
Remarks: N/A

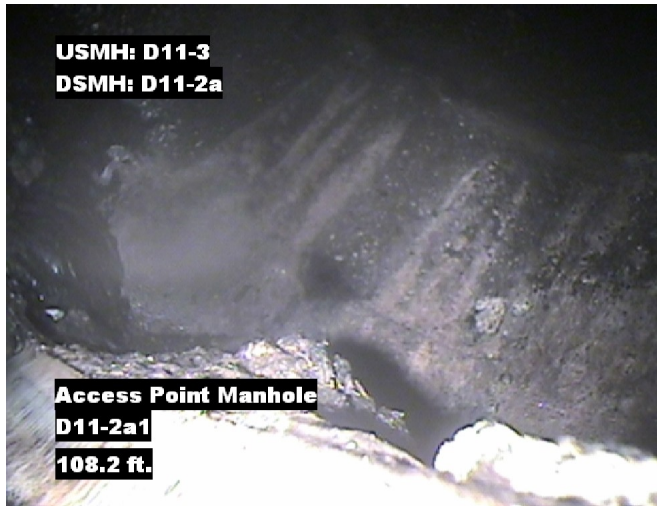
Distance: 108.2 ft. Grade: 0
Condition: Access Point Manhole
Remarks: D11-2a1
