Defect Listing

Pipe Segment Refere... D11-4_D11-3	City Oliver Springs	Street Norwood Dr	Material Concrete Pipe (non-...	Location C... Light High...	Sewer Use Sanitary
Upstream MH D11-4	Total Length 277	Year Laid	Shape Circular	Location Details	
DS Manhole D11-3	Length surveyed 277	Year Renewed	Height 8	Width 8	Pipe Joint... 4

SPR N/A	MPR 6	PO Number 4397-03	Customer GRW
SPRI N/A	MPRI 2	Work Order 4397-02	Purpose Pre-Rehabilitation Survey
QSR N/A	QMR 2300		
OPR 6	Surveyed By Barry Rogers	Direction Downstream	Date 20150701
OPRI 2	Certificate Number U-1012-16405	Pre-Cleaning Jetting	Time 07:55
	Date Cleaned 20150701	End Time 08:31	Weather Saturated
			Media label
			Additional Info

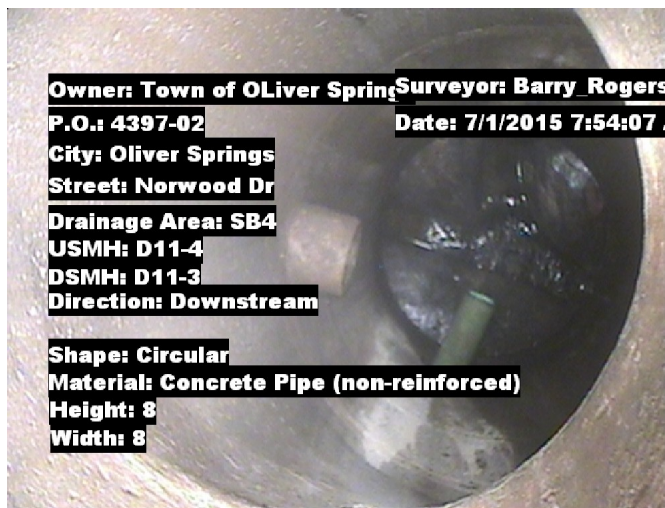
Distance: 0.0 ft. Grade: 0
Condition: Access Point Manhole
Remarks: D11-4

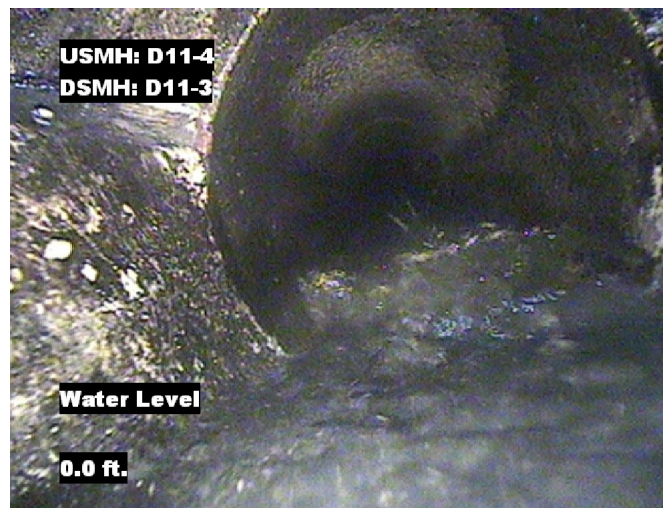
Distance: 0.0 ft. Grade: 0
Condition: Water Level
Remarks: N/A

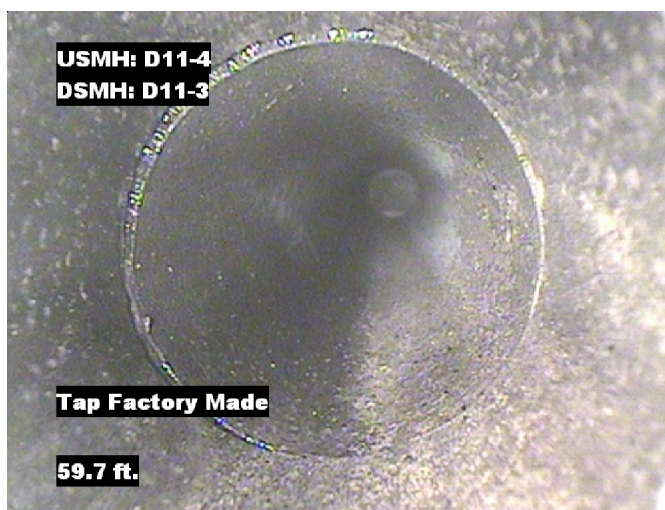
Distance: 59.7 ft. Grade: 0
Condition: Tap Factory Made
Remarks: N/A

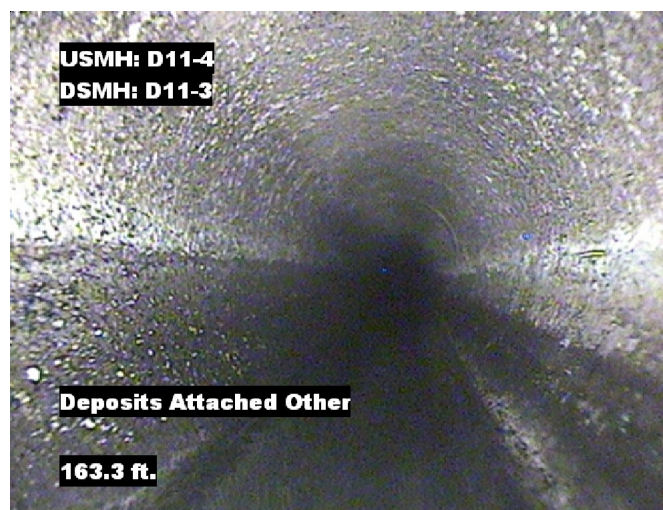
Distance: 163.3 ft. Grade: 2
Condition: Deposits Attached Other
Remarks: N/A

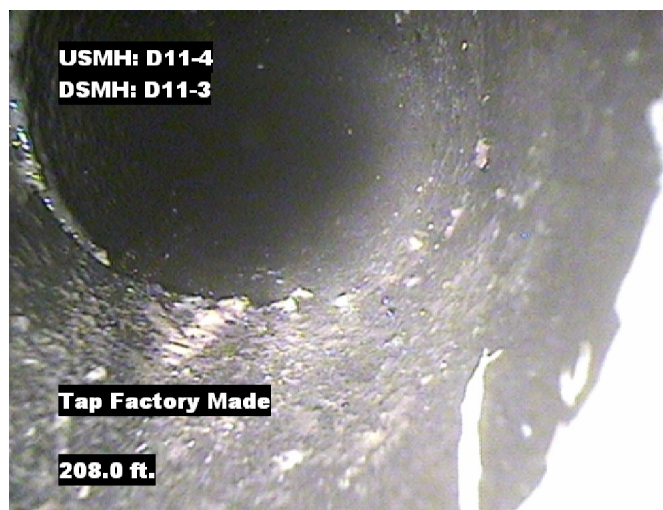
Distance: 208.0 ft. Grade: 0
Condition: Tap Factory Made
Remarks: N/A

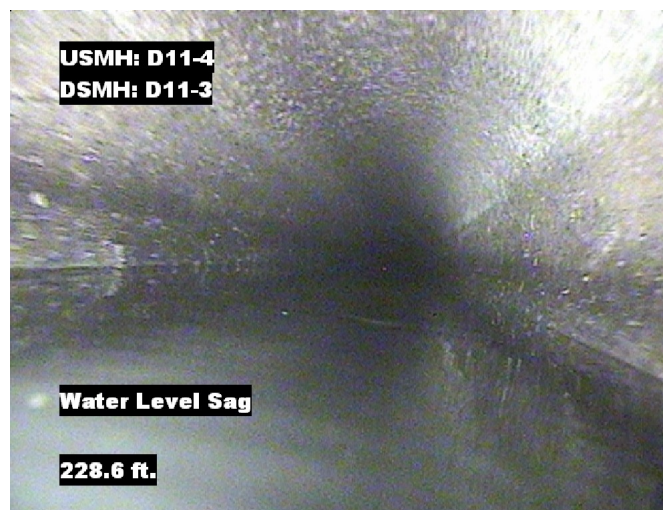
Distance: 228.6 ft. Grade: 2
Condition: Water Level Sag
Remarks: N/A

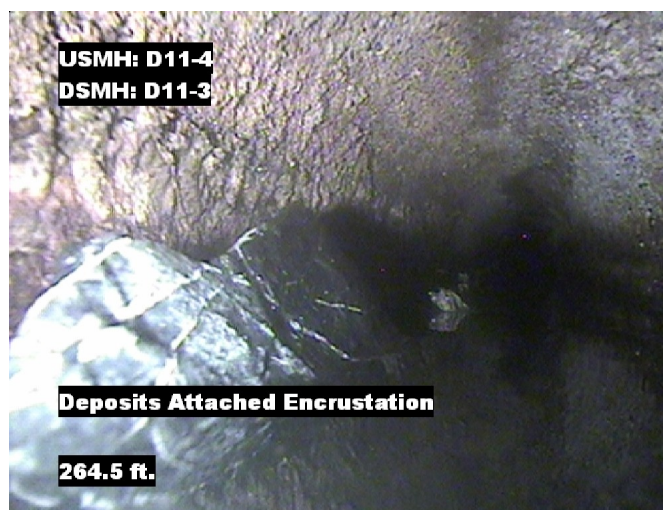
Distance: 264.5 ft. Grade: 2
Condition: Deposits Attached Encrustation
Remarks: N/A

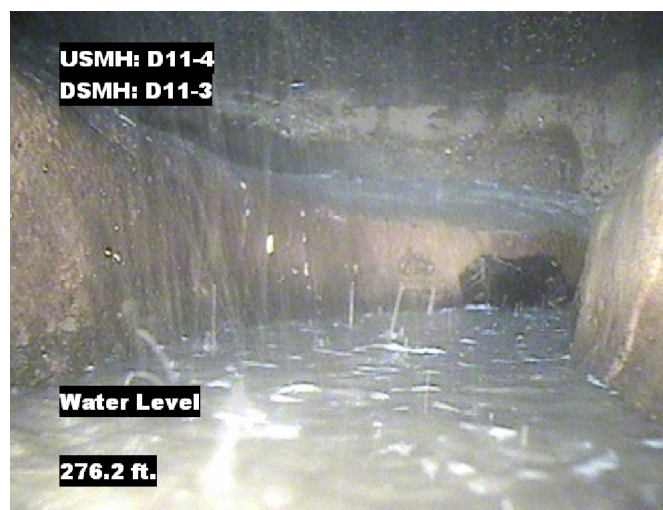
Distance: 276.2 ft. Grade: 0
Condition: Water Level
Remarks: N/A

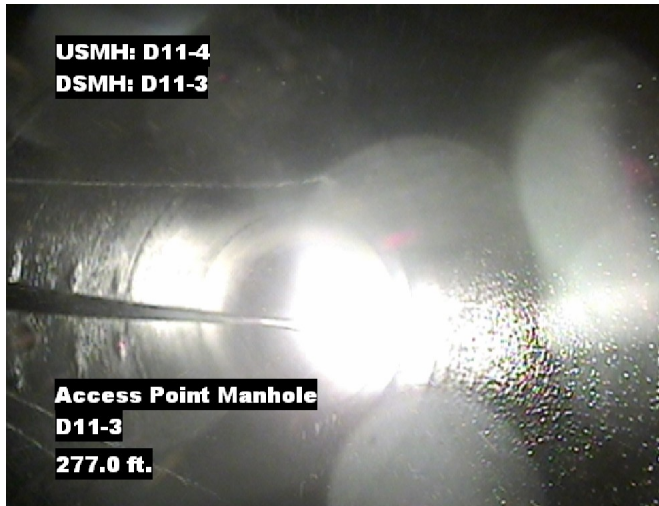
Distance: 277.0 ft. Grade: 0
Condition: Access Point Manhole
Remarks: D11-3
