Defect Listing

Pipe Segment Refere... D11-5_D11-4	City Oliver Springs	Street Nonwood Dr	Material Concrete Pipe (non-...	Location C... Light High...	Sewer Use Sanitary
Upstream MH D11-5	Total Length 266.5	Year Laid	Shape Circular	Location Details	
DS Manhole D11-4	Length surveyed 266.5	Year Renewed	Height 8	Width 8	Pipe Joint... 4

SPR 8	MPR N/A	PO Number 4397-03	Customer GRW
SPRI 4	MPRI N/A	Work Order 4397-02	Purpose Pre-Rehabilitation Survey
QSR 5131	QMR N/A		
OPR 8	Surveyed By Barry Rogers	Direction Downstream	Date 20150626
OPRI 4	Certificate Number U-1012-16405	Pre-Cleaning Jetting	Time 12:33
	Date Cleaned 20150626	End Time 13:07	Weather Dry
			Media label
			Additional Info

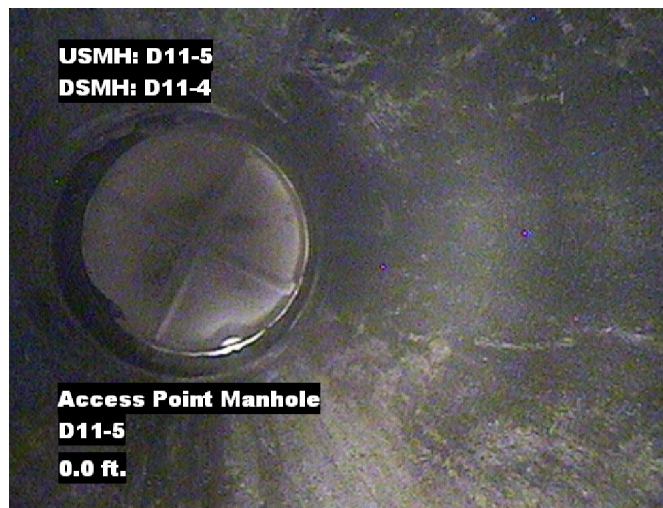
Distance: 0.0 ft. Grade: 0
Condition: Access Point Manhole
Remarks: D11-5

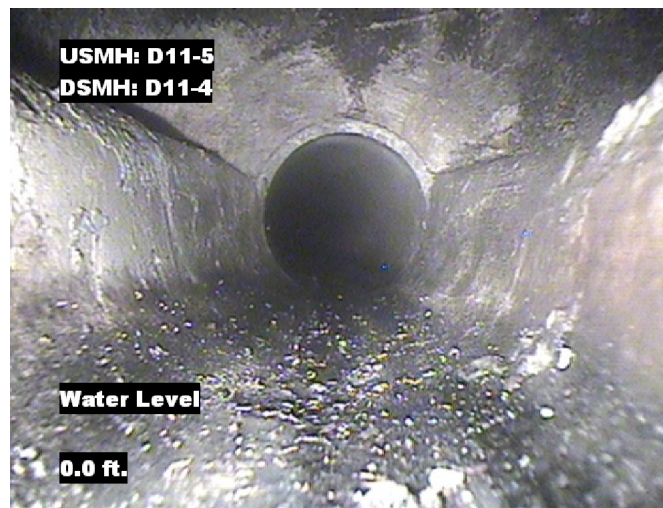
Distance: 0.0 ft. Grade: 0
Condition: Water Level
Remarks: N/A

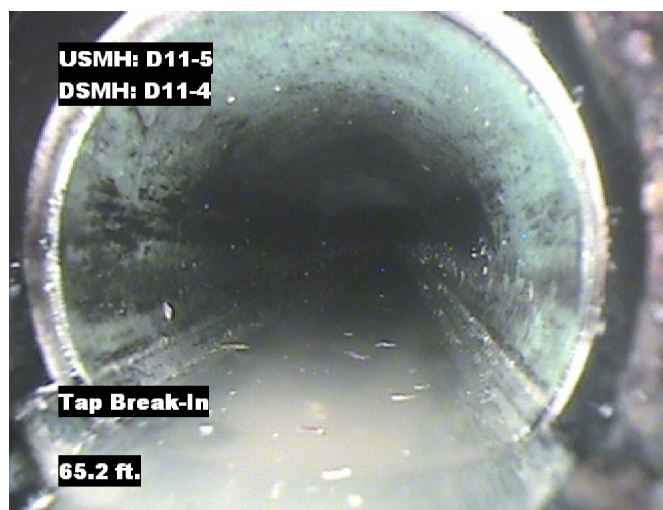
Distance: 65.2 ft. Grade: 0
Condition: Tap Break-In
Remarks: N/A

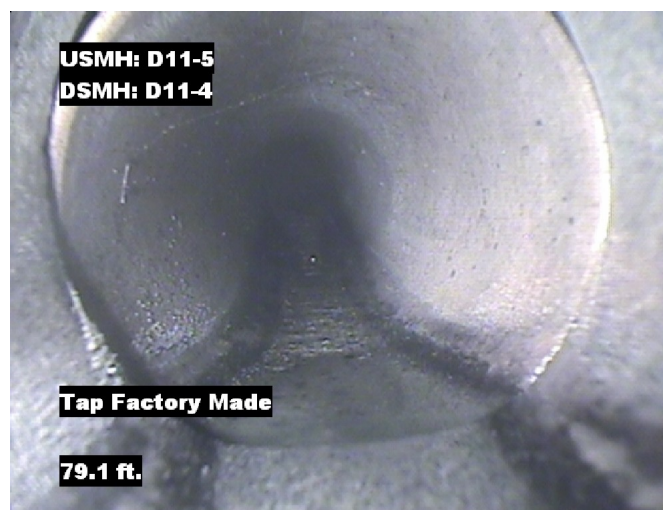
Distance: 79.1 ft. Grade: 0
Condition: Tap Factory Made
Remarks: N/A

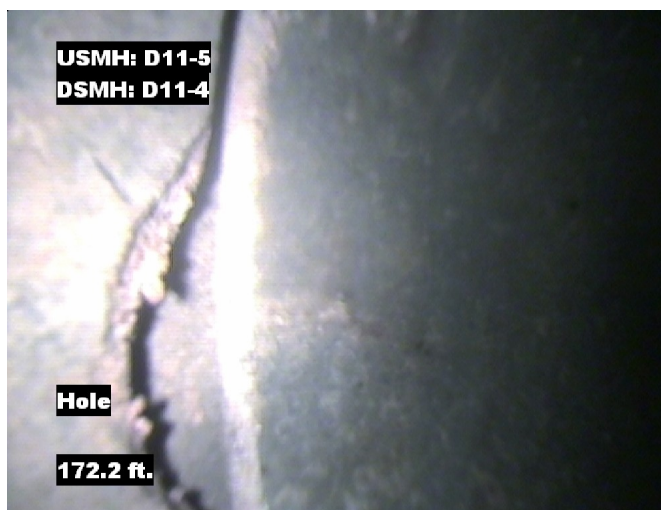
Distance: 172.2 ft. Grade: 3
Condition: Hole
Remarks: N/A

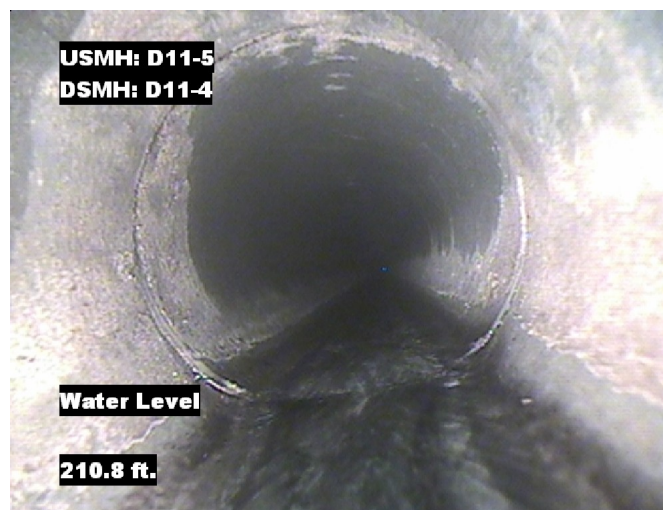
Distance: 210.8 ft. Grade: 0
Condition: Water Level
Remarks: N/A

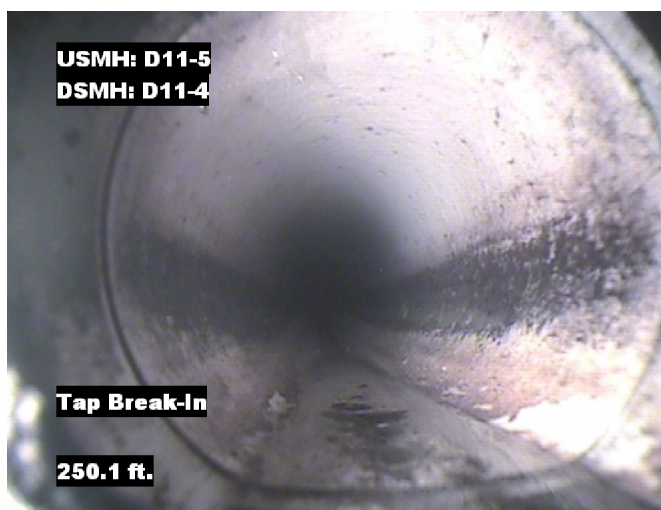
Distance: 250.1 ft. Grade: 0
Condition: Tap Break-In
Remarks: N/A

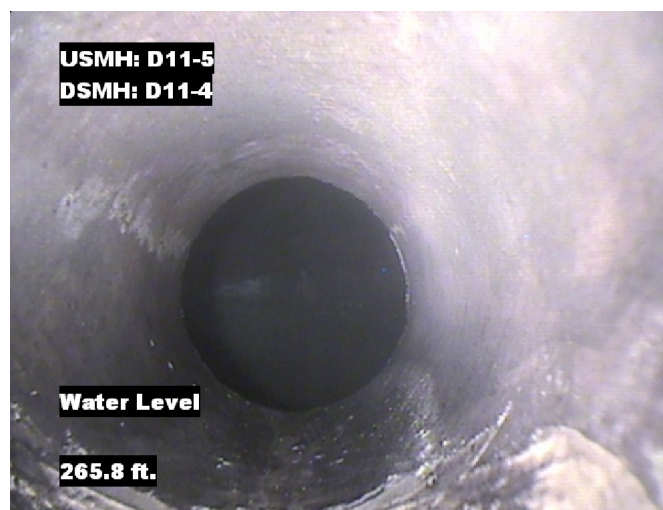
Distance: 265.8 ft. Grade: 0
Condition: Water Level
Remarks: N/A

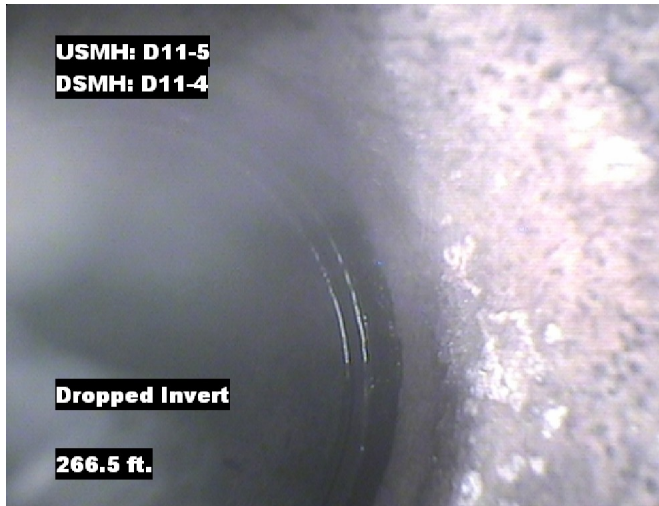
Distance: 266.5 ft. Grade: 5
Condition: Dropped Invert
Remarks: N/A

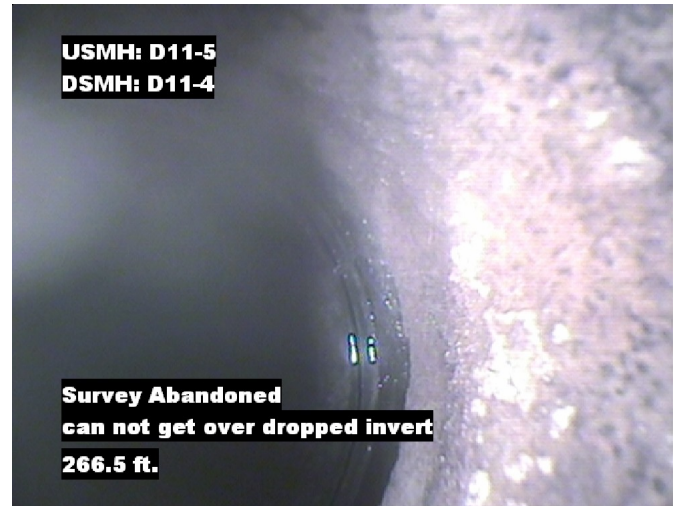
Distance: 266.5 ft. Grade: 0
Condition: Survey Abandoned
Remarks: can not get over dropped invert
