Defect Listing

Pipe Segment Refere... D11-6_D11-5	City Oliver Springs	Street Norwood Dr	Material Concrete Pipe (non-...	Location C... Light High...	Sewer Use Sanitary
Upstream MH D11-6	Total Length 227.6	Year Laid	Shape Circular	Location Details	
DS Manhole D11-5	Length surveyed 227.6	Year Renewed	Height 8	Width 8	Pipe Joint... 4

SPR N/A	MPR N/A	PO Number 4397-03	Customer GRW
SPRI N/A	MPRI N/A	Work Order 4397-02	Purpose Pre-Rehabilitation Survey
QSR N/A	QMR N/A		
OPR N/A	Surveyed By Barry Rogers	Direction Downstream	Date 20150626
OPRI N/A	Certificate Number U-1012-16405	Pre-Cleaning Jetting	Time 12:11
	Date Cleaned 20150626	End Time 12:27	Weather Dry
			Media label
			Additional Info

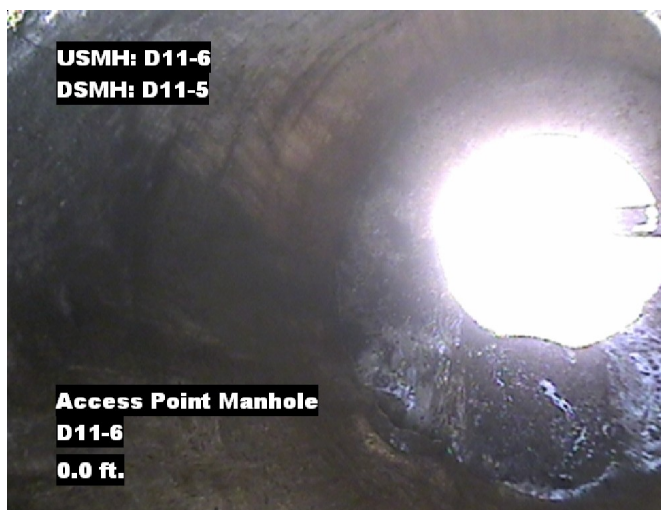
Distance: 0.0 ft. Grade: 0
Condition: Access Point Manhole
Remarks: D11-6

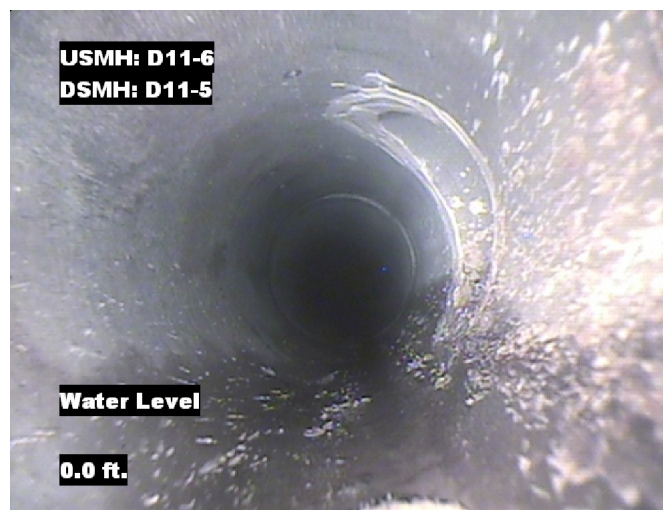
Distance: 0.0 ft. Grade: 0
Condition: Water Level
Remarks: N/A

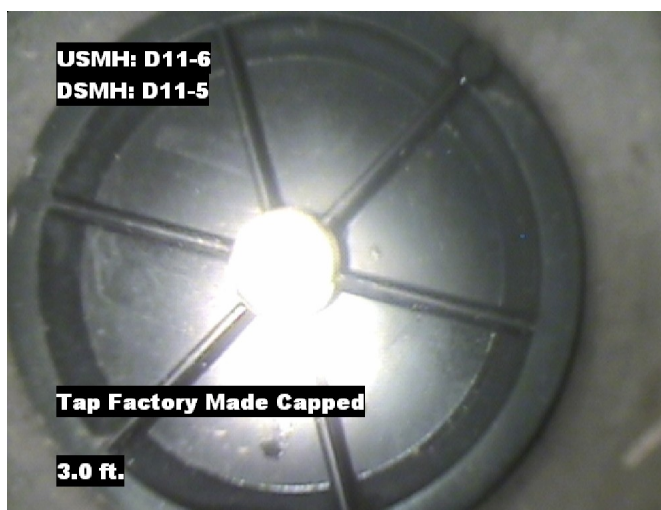
Distance: 3.0 ft. Grade: 0
Condition: Tap Factory Made Capped
Remarks: N/A

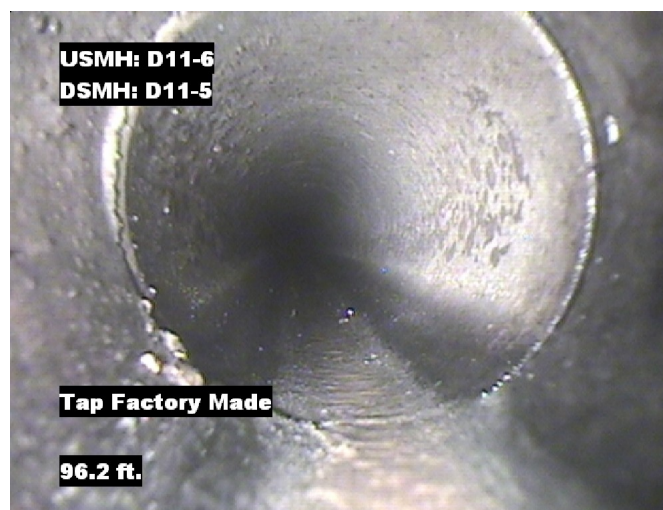
Distance: 96.2 ft. Grade: 0
Condition: Tap Factory Made
Remarks: N/A

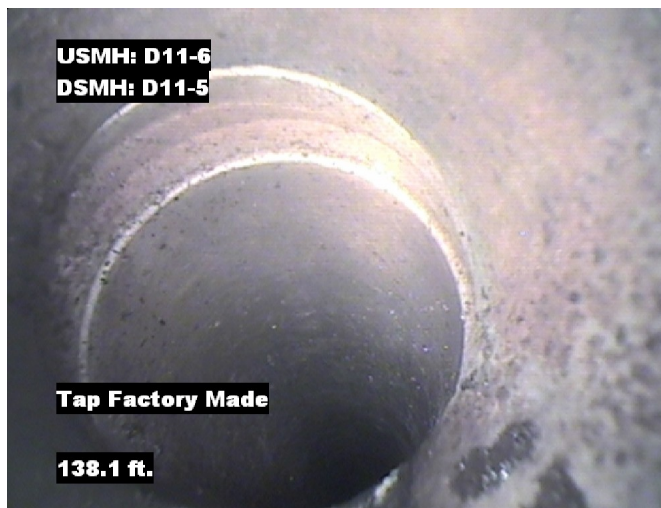
Distance: 138.1 ft. Grade: 0
Condition: Tap Factory Made
Remarks: N/A

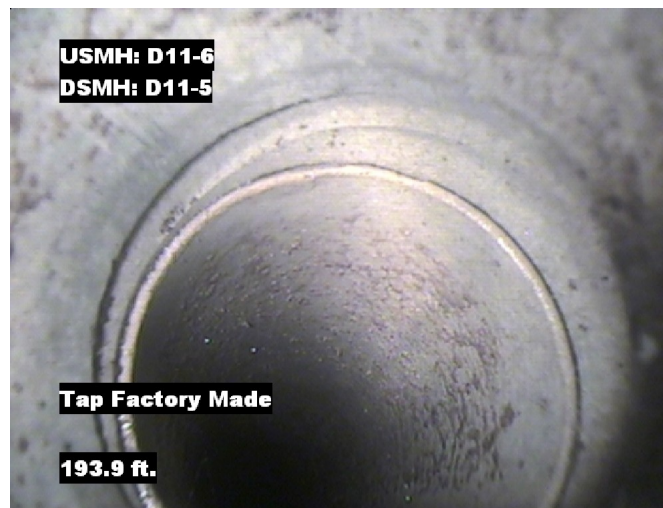
Distance: 193.9 ft. Grade: 0
Condition: Tap Factory Made
Remarks: N/A

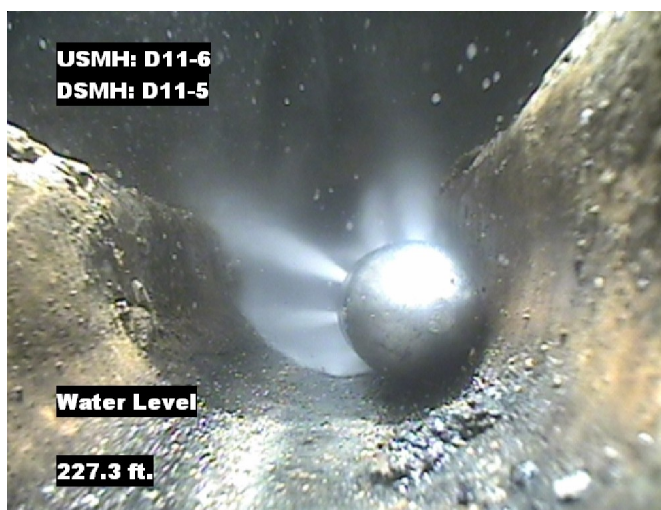
Distance: 227.3 ft. Grade: 0
Condition: Water Level
Remarks: N/A

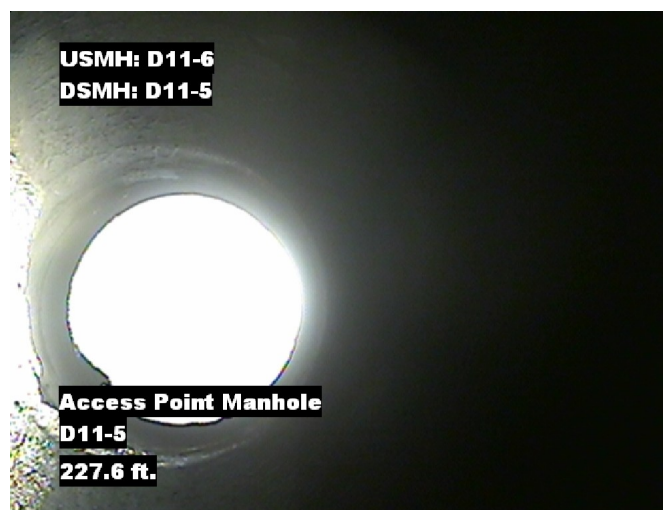
Distance: 227.6 ft. Grade: 0
Condition: Access Point Manhole
Remarks: D11-5
