## Defect Listing

Pipe Segment Refere... <b>D11-7_D11-8</b>	City <b>Oliver Springs</b>	Street <b>Norwood Dr</b>	Material <b>Concrete Pipe (non-...</b>	Location C... <b>Light High...</b>	Sewer Use <b>Sanitary</b>
Upstream MH <b>D11-7</b>	Total Length <b>118.2</b>	Year Laid	Shape <b>Circular</b>	Location Details	
DS Manhole <b>D11-8</b>	Length surveyed <b>118.2</b>	Year Renewed	Height <b>8</b>	Width <b>8</b>	Pipe Joint... <b>4</b>

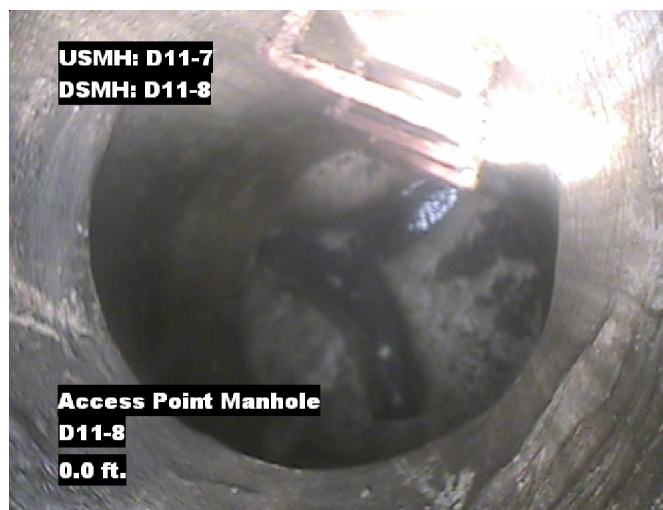
Distance: 0.0 ft. Grade: 0  
Condition: Access Point Manhole  
Remarks: D11-8

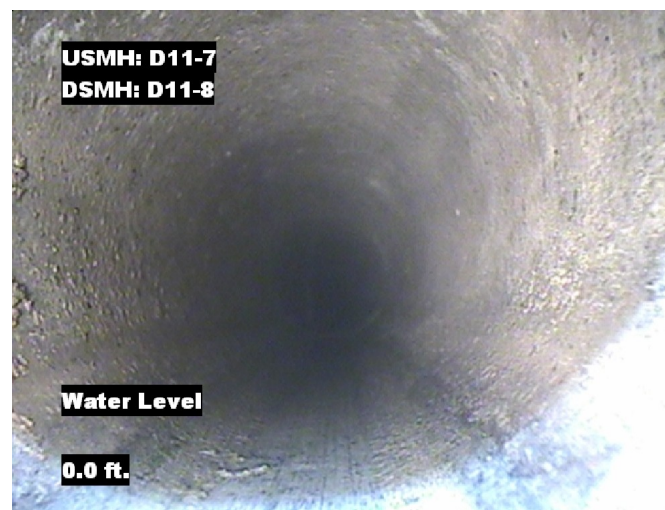
Distance: 0.0 ft. Grade: 0  
Condition: Water Level  
Remarks: N/A

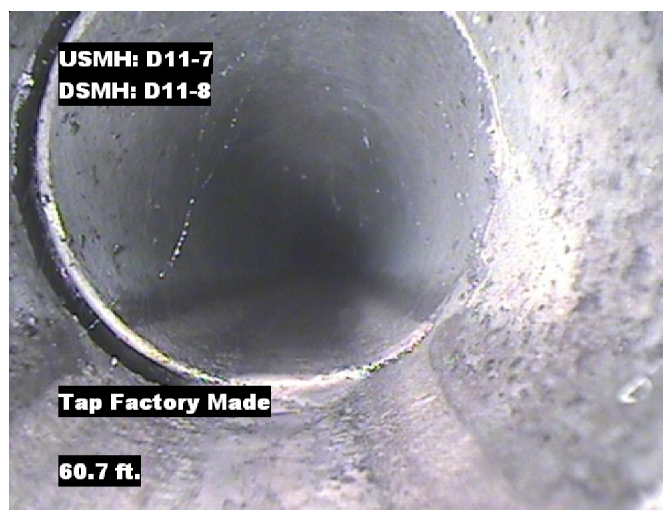
Distance: 60.7 ft. Grade: 0  
Condition: Tap Factory Made  
Remarks: N/A

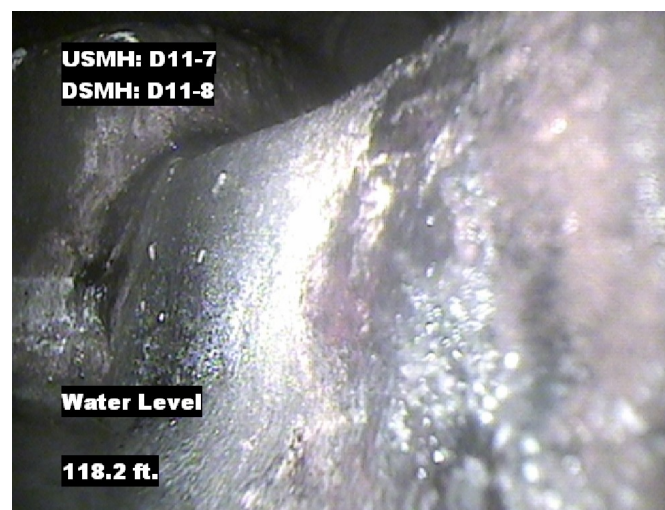
Distance: 118.2 ft. Grade: 0  
Condition: Water Level  
Remarks: N/A

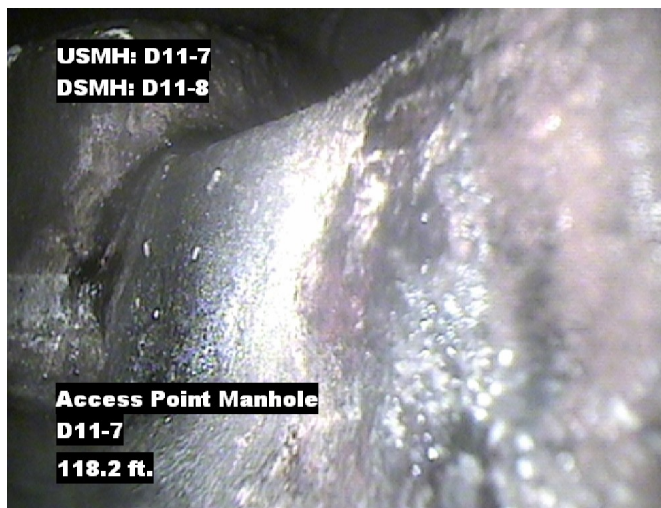
Distance: 118.2 ft.      Grade: 0  
Condition: Access Point Manhole  
Remarks: D11-7
