## Defect Listing

Pipe Segment Refere... <b>D11-8_D13-1</b>	City <b>Oliver Springs</b>	Street <b>Norwood Dr</b>	Material <b>Concrete Pipe (non-...</b>	Location C... <b>Light High...</b>	Sewer Use <b>Sanitary</b>
Upstream MH <b>D11-8</b>	Total Length <b>194.3</b>	Year Laid	Shape <b>Circular</b>	Location Details	
DS Manhole <b>D13-1</b>	Length surveyed <b>194.3</b>	Year Renewed	Height <b>8</b>	Width <b>8</b>	Pipe Joint... <b>4</b>

## Image Report 4/Page

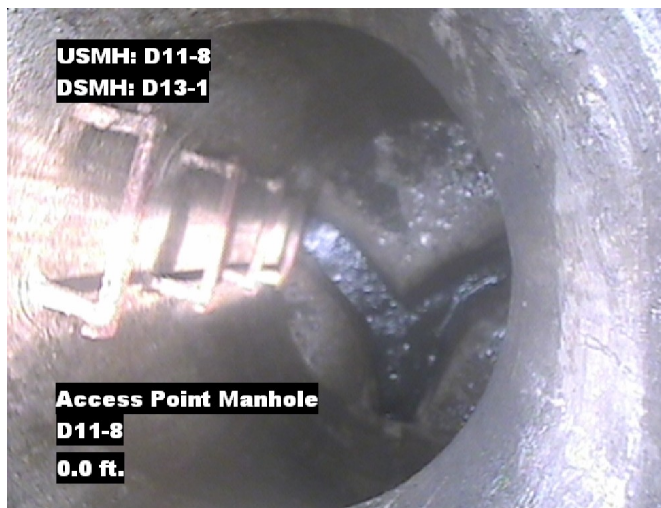
Distance: 0.0 ft. Grade: 0  
Condition: Access Point Manhole  
Remarks: D11-8

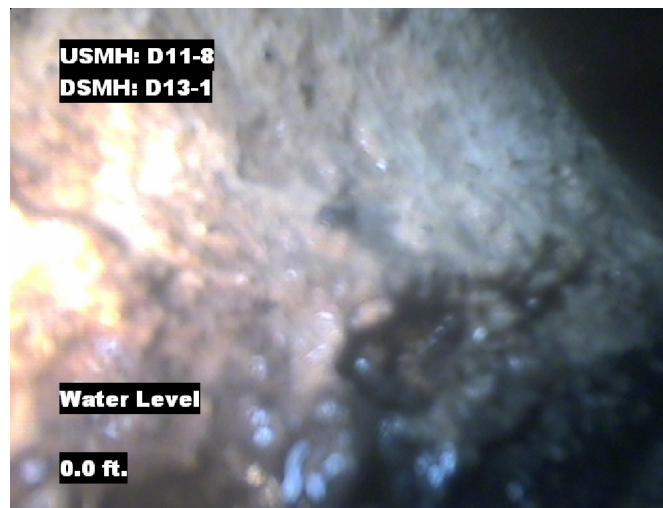
Distance: 0.0 ft. Grade: 0  
Condition: Water Level  
Remarks: N/A

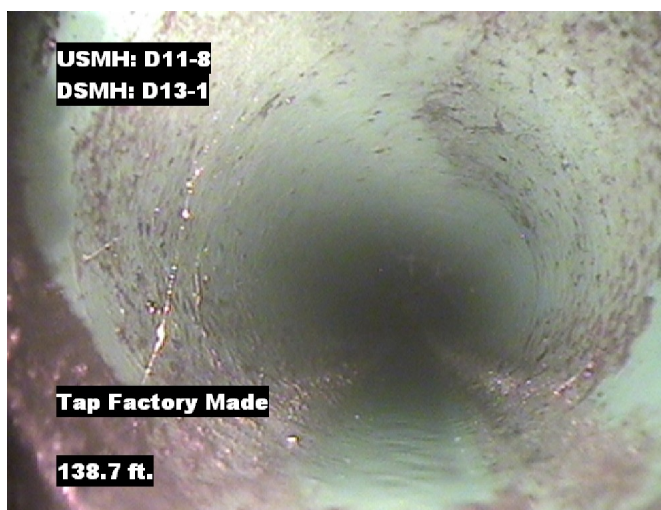
Distance: 138.7 ft. Grade: 0  
Condition: Tap Factory Made  
Remarks: N/A

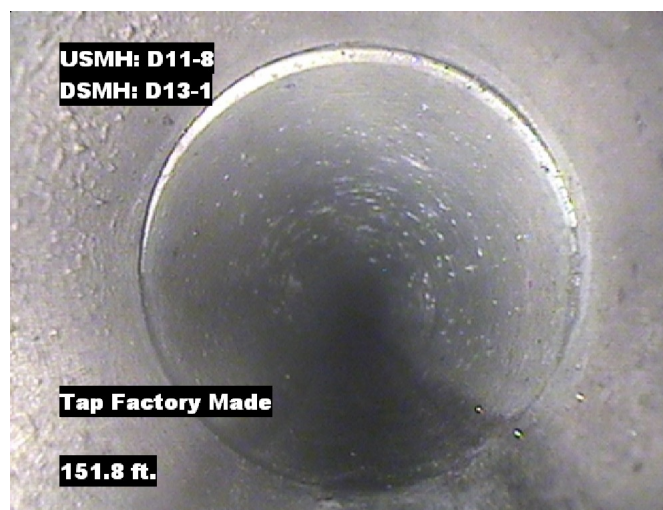
Distance: 151.8 ft. Grade: 0  
Condition: Tap Factory Made  
Remarks: N/A

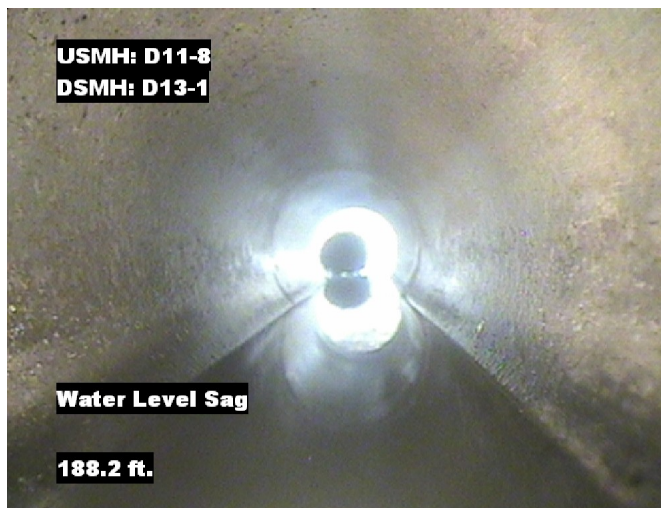
Distance: 188.2 ft. Grade: 2  
Condition: Water Level Sag  
Remarks: N/A

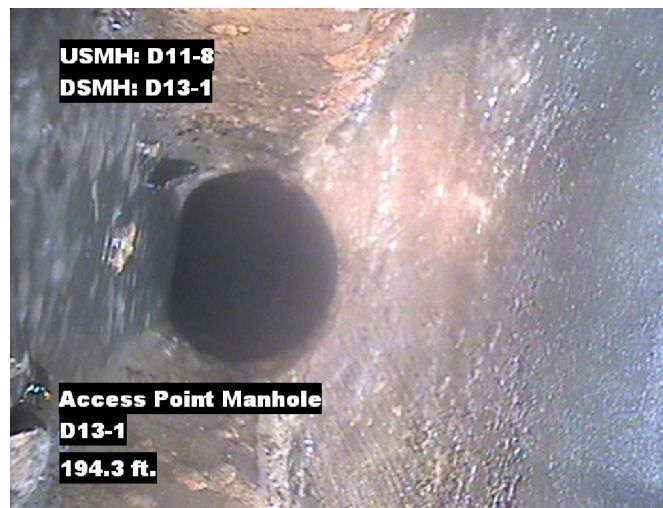
Distance: 194.3 ft. Grade: 0  
Condition: Access Point Manhole  
Remarks: D13-1
