Defect Listing

Pipe Segment Refere... D11-9_D11-8	City Oliver Springs	Street Norwood	Material Concrete Pipe (non-...	Location C... Light High...	Sewer Use Sanitary
Upstream MH D11-9	Total Length 191.2	Year Laid	Shape Circular	Location Details	
DS Manhole D11-8	Length surveyed 191.2	Year Renewed	Height 8	Width 8	Pipe Joint... 4

SPR N/A	MPR 2	PO Number 4397-03	Customer GRW
SPRI N/A	MPRI 2	Work Order 4397-02	Purpose Pre-Rehabilitation Survey
QSR N/A	QMR 2100		
OPR 2	Surveyed By Barry Rogers	Direction Downstream	Date 20150623
OPRI 2	Certificate Number U-1012-16405	Pre-Cleaning Jetting	Time 08:01
	Date Cleaned 20150623	End Time 08:11	Weather Very Dry
			Media label
			Additional Info

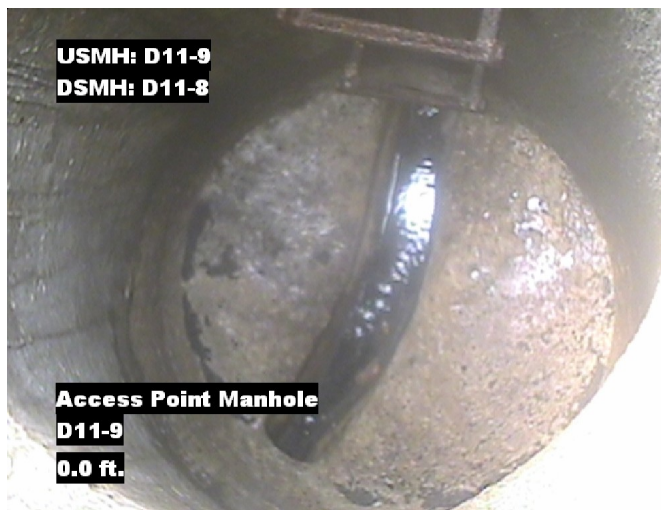
Distance: 0.0 ft. Grade: 0
Condition: Access Point Manhole
Remarks: D11-9

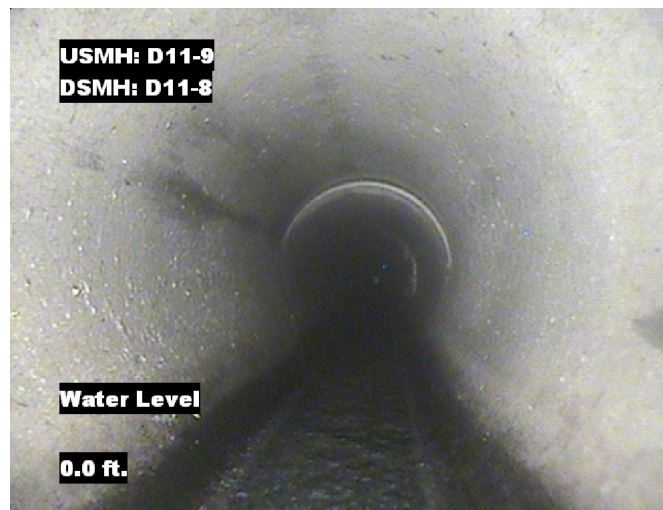
Distance: 0.0 ft. Grade: 0
Condition: Water Level
Remarks: N/A

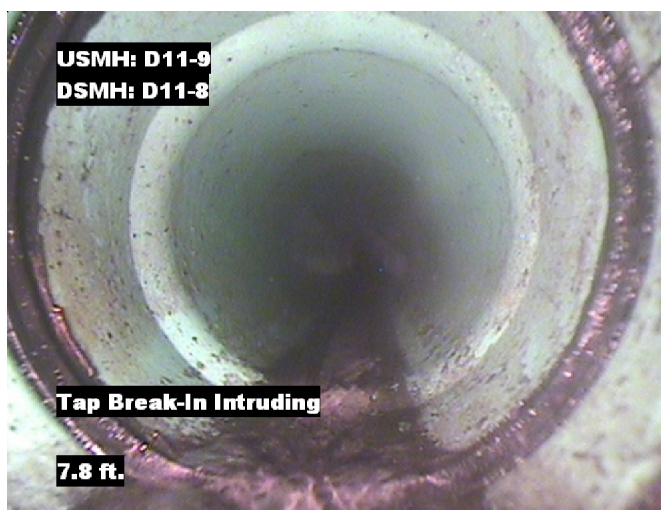
Distance: 7.8 ft. Grade: 2
Condition: Tap Break-In Intruding
Remarks: N/A

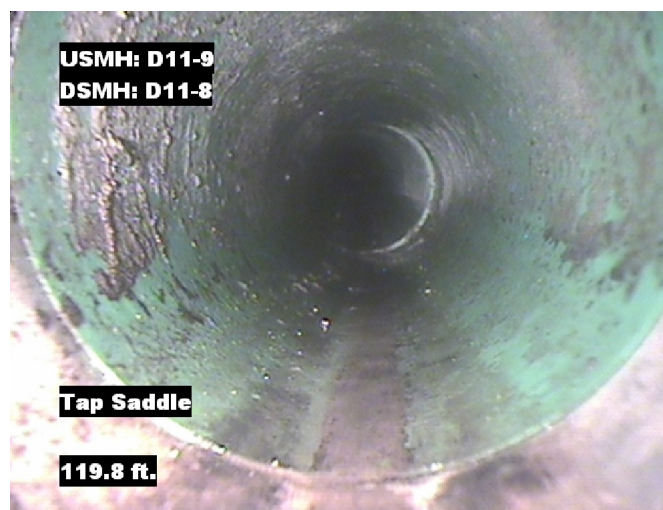
Distance: 119.8 ft. Grade: 0
Condition: Tap Saddle
Remarks: N/A

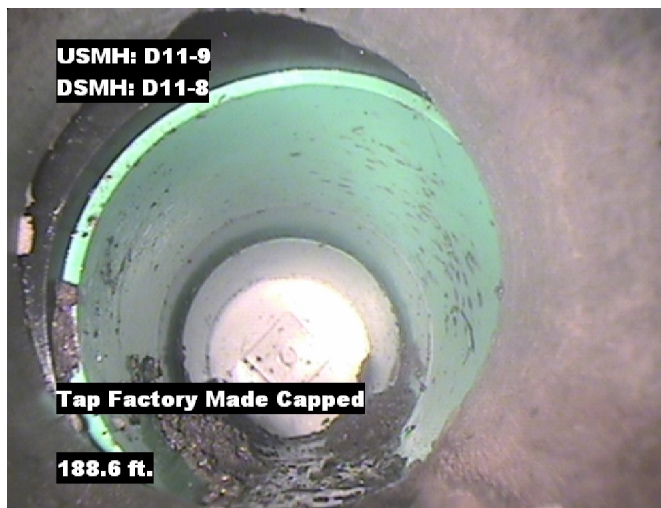
Distance: 188.6 ft. Grade: 0
Condition: Tap Factory Made Capped
Remarks: N/A

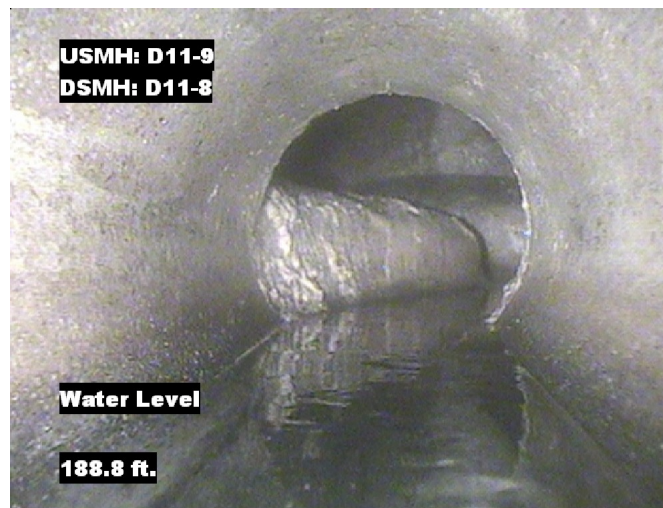
Distance: 188.8 ft. Grade: 0
Condition: Water Level
Remarks: N/A

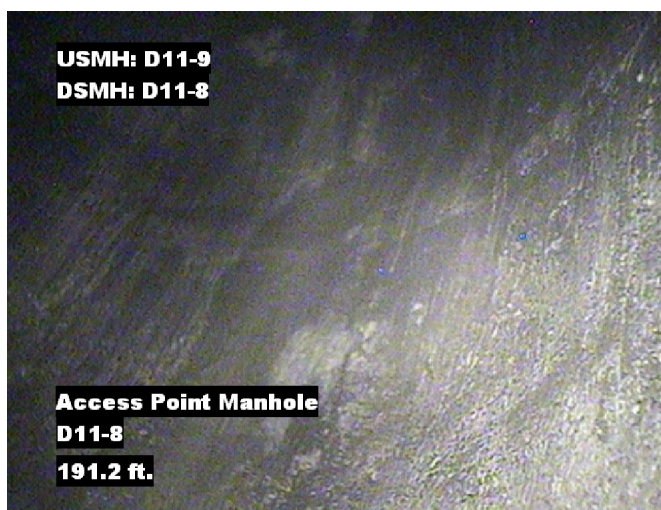
Distance: 191.2 ft. Grade: 0
Condition: Access Point Manhole
Remarks: D11-8
