## Defect Listing

| Pipe Segment Refere...<br><b>D12-1_D11-12</b> | City<br><b>Oliver Springs</b> | Street<br><b>Norwood Dr</b> | Material<br><b>Concrete Pipe (non-...</b> | Location C...<br><b>Light High...</b> | Sewer Use<br><b>Sanitary</b> |

| SPRI<br><b>2</b> | MPRI<br><b>N/A</b> | Work Order<br><b>4397-02</b> | Purpose<br><b>Pre-Rehabilitation Survey</b> |

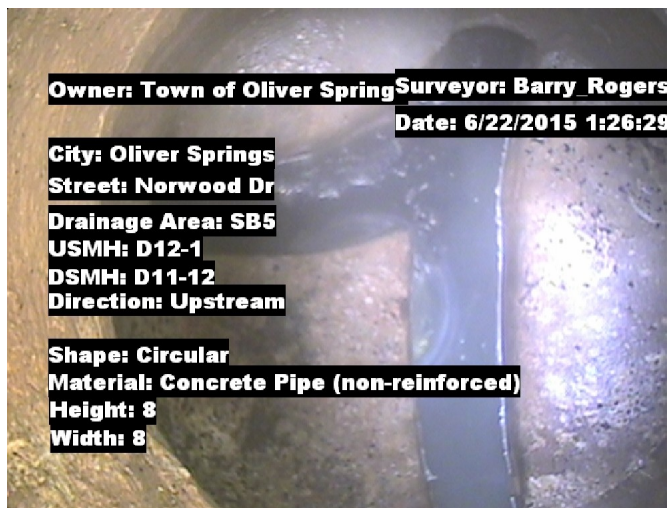
Distance: 0.0 ft. Grade: 0  
Condition: Access Point Manhole  
Remarks: D11-12

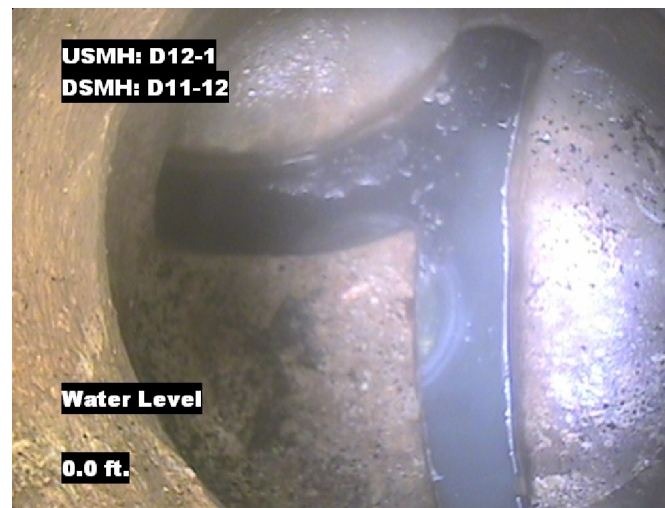
| Distance | Condition | Cont. Dfct. | Values | | | Joint | Clock Position | | Grade |
|---|---|---|---|---|---|---|---|---|---|
| 0.0 ft. | Water Level | | | | 5 | <input type="checkbox"/> | | | |

Distance: 0.0 ft. Grade: 0  
Condition: Water Level  
Remarks: N/A

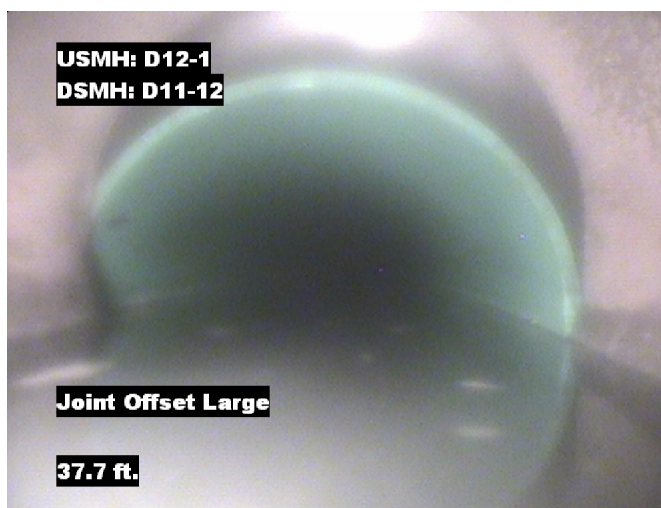
| Distance | Condition | Cont. Dfct. | Values | | | Joint | Clock Position | | Grade |
|---|---|---|---|---|---|---|---|---|---|
| 37.7 ft. | Joint Offset Large | | | | 0 | <input type="checkbox"/> | | | 2 |

Distance: 37.7 ft. Grade: 2  
Condition: Joint Offset Large  
Remarks: N/A

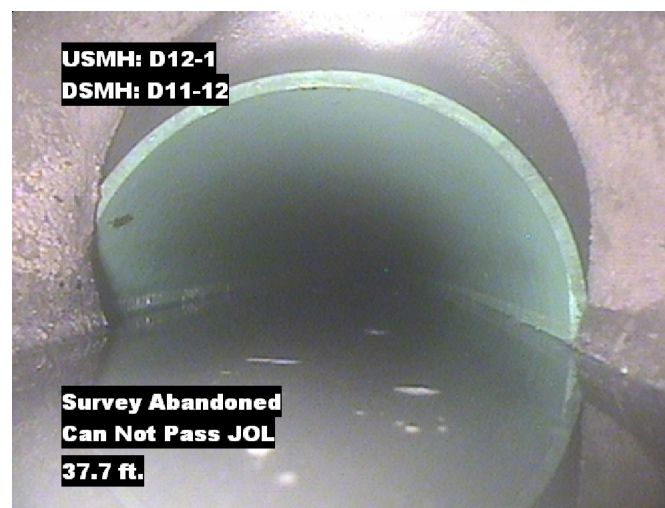
| Distance | Condition | Cont. Dfct. | Values | | | Joint | Clock Position | | Grade |
|---|---|---|---|---|---|---|---|---|---|
| 37.7 ft. | Survey Abandoned | | | | 0 | <input type="checkbox"/> | | | |
| Remarks: Can Not Pass JOL | | | | | | | | | |

Distance: 37.7 ft. Grade: 0  
Condition: Survey Abandoned  
Remarks: Can Not Pass JOL
